28 October 2022

Project No: LTC22215

Gould Developments Limited

**RE: SHALLOW SOIL TEST REPORT
LOT 211, 138 & 5/144 DUNNS CROSSING ROAD**

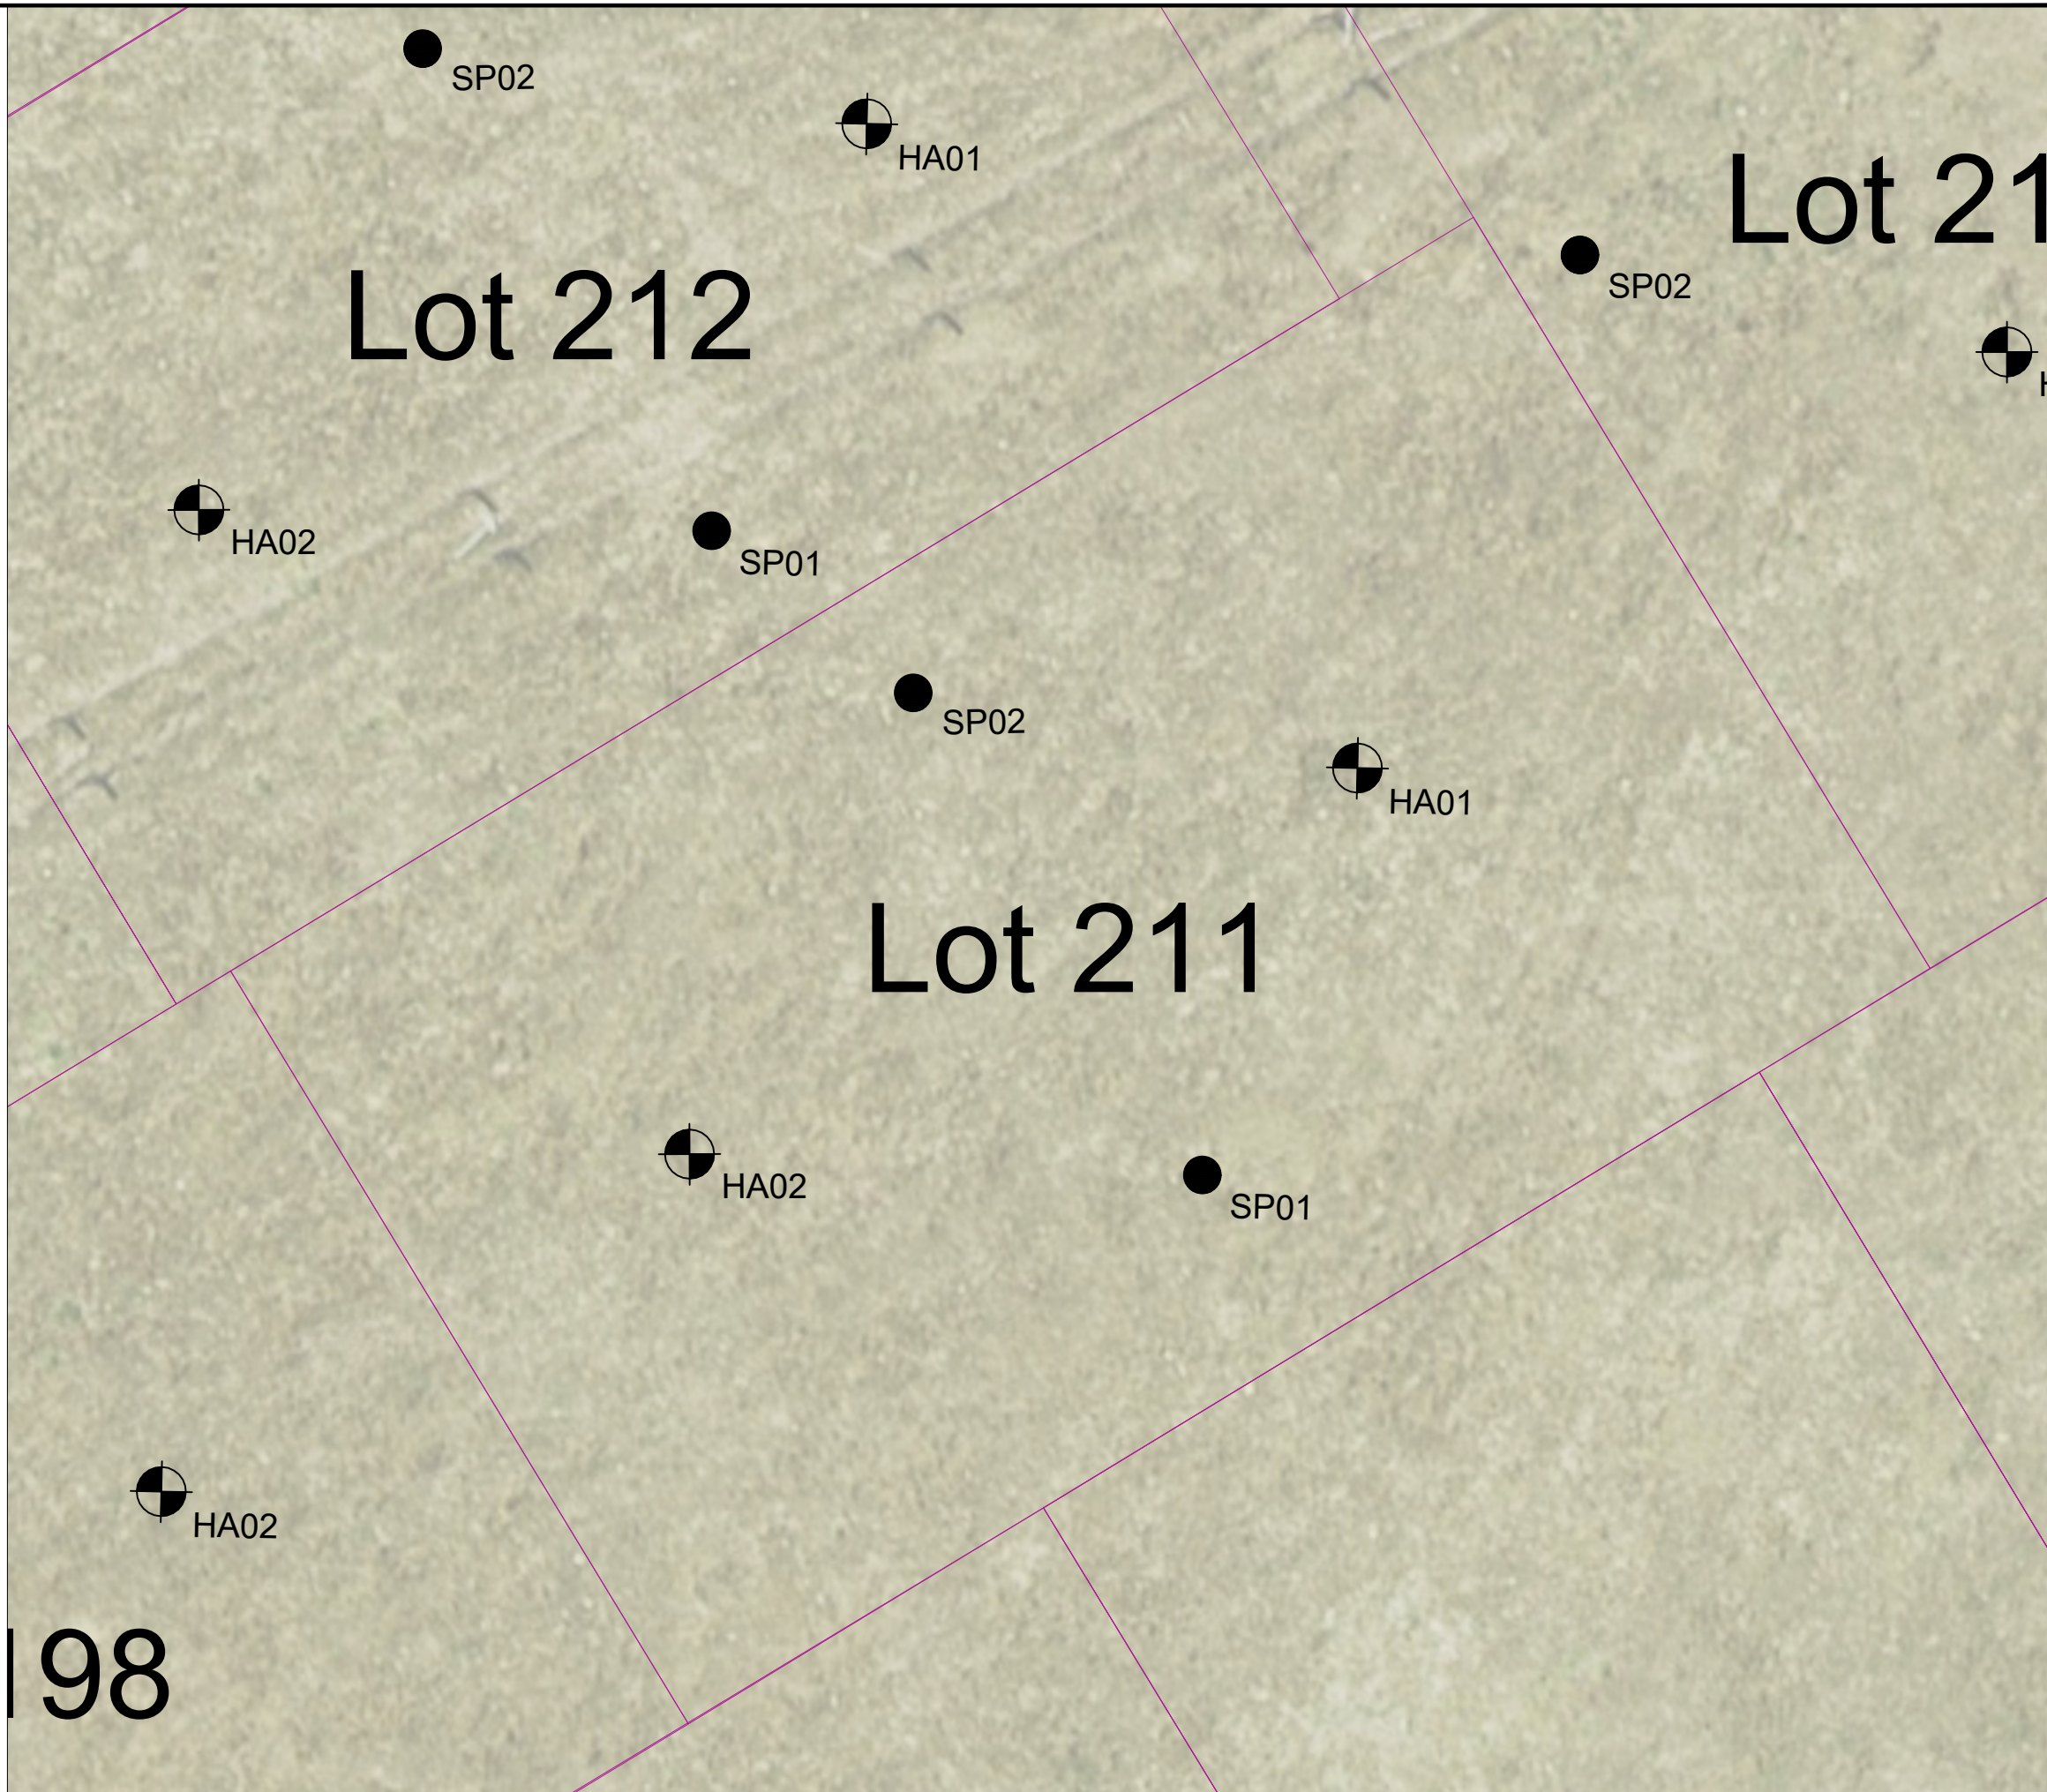
Test Location Plan
Lot 211, 138 Dunns Crossing Road
ROLLESTON

LandTech investigated the site on 26 October 2022, comprising two hand auger holes with corresponding Scala Penetrometer tests and two additional Scala Penetrometer tests. The test locations were measured from lot boundaries and/or surveyed centre pegs and are approximate only. The test locations are shown on the LandTech *Test Location Plan*, Drawing No. Lot 211/ TLP attached to this report.

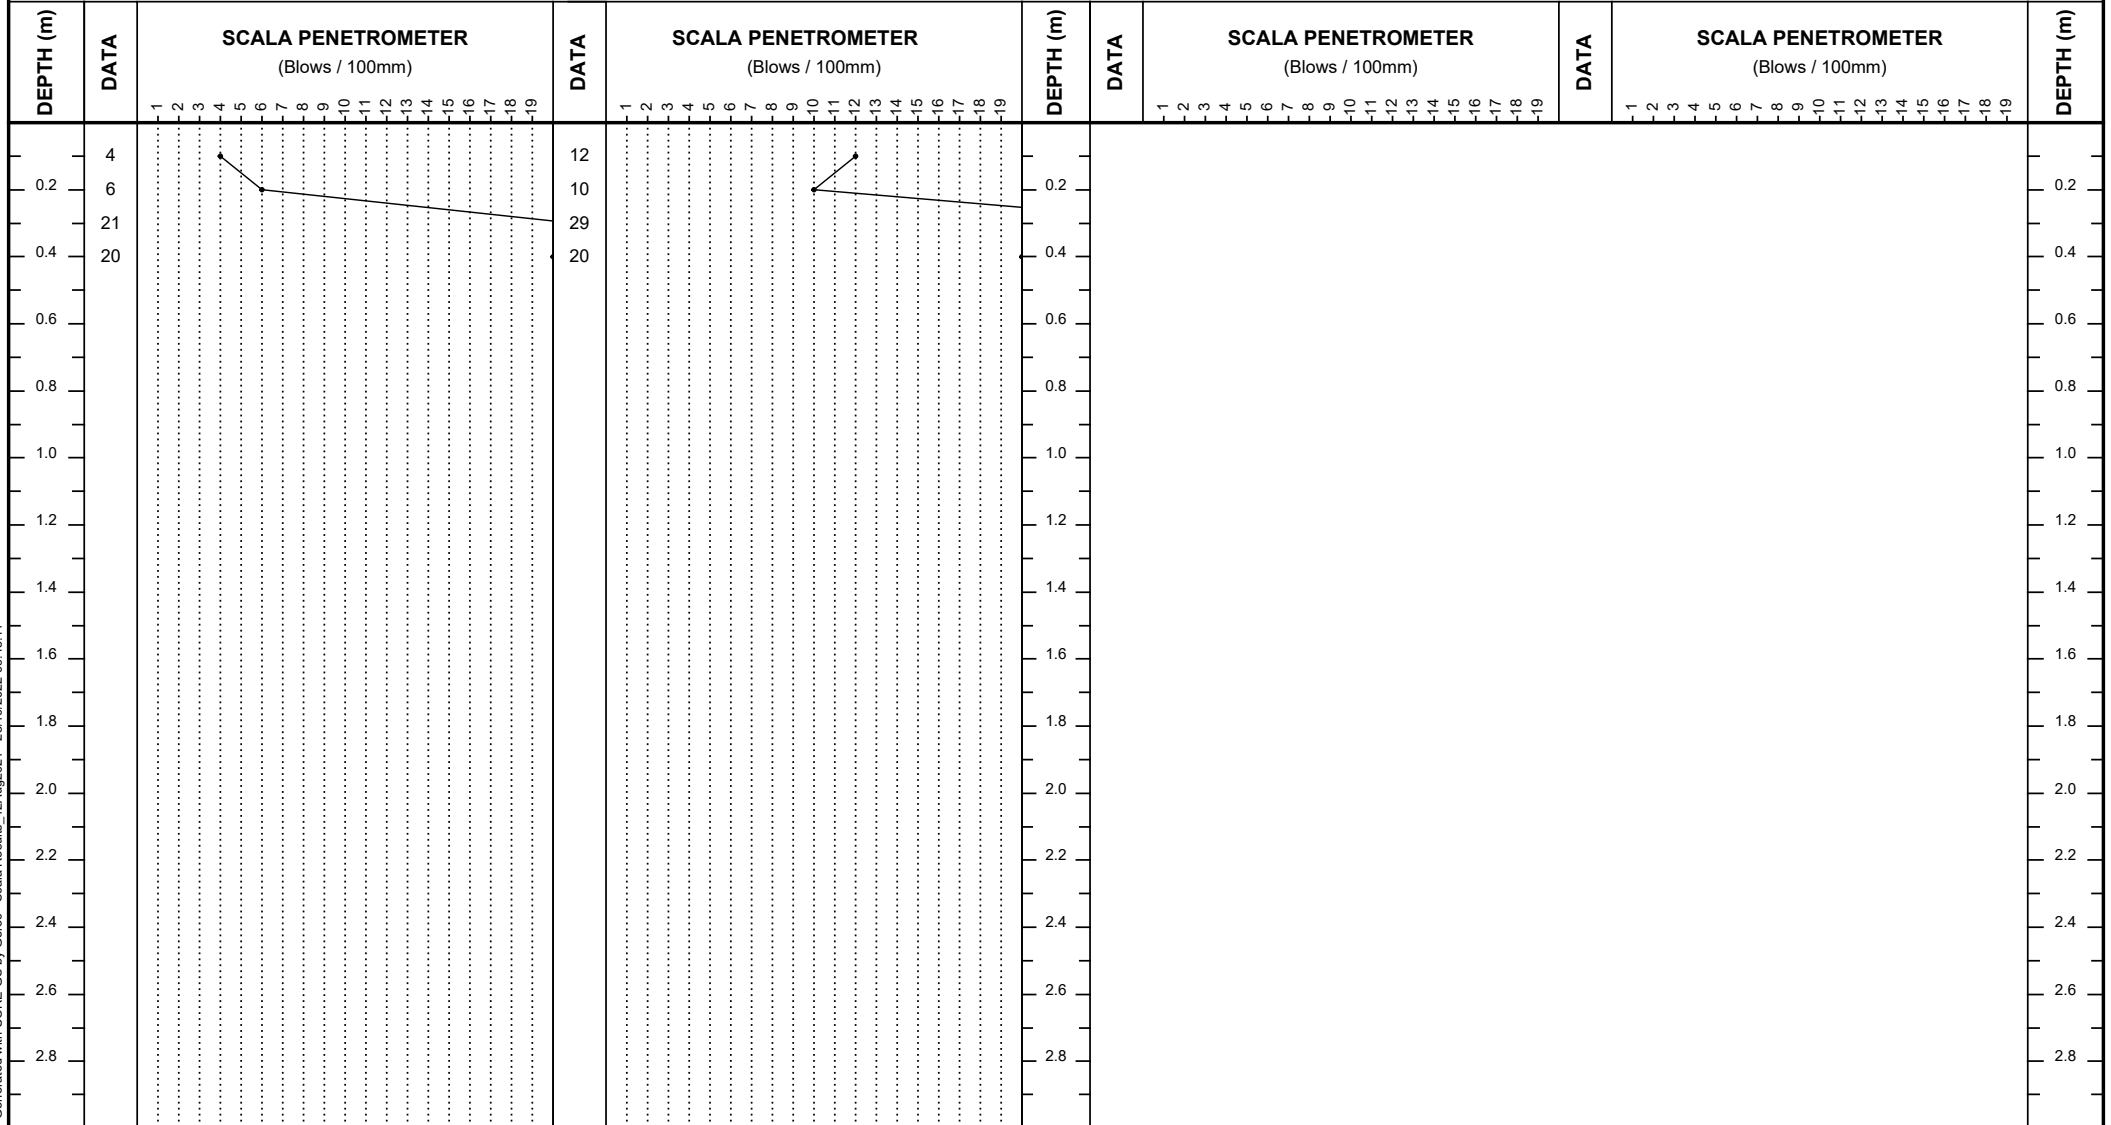
Lot 211 - SP01

The hand auger holes encountered topsoil/fill material from the ground surface to approximately 0.1m depths, underlain by inferred natural gravel. Groundwater was not encountered during testing. Scala Penetrometer testing at each of the four locations returned results between 4 and 40+ blows per 100mm penetration at the test positions, encountering refusal at 0.4m below present ground level.
