Project No: LTC22215

**RE: SHALLOW SOIL TEST REPORT  
LOT 140, 138 DUNNS CROSSING ROAD**

**Test Location Plan**  
 Lot 140, 138 Dunns Crossing Road  
 ROLLESTON

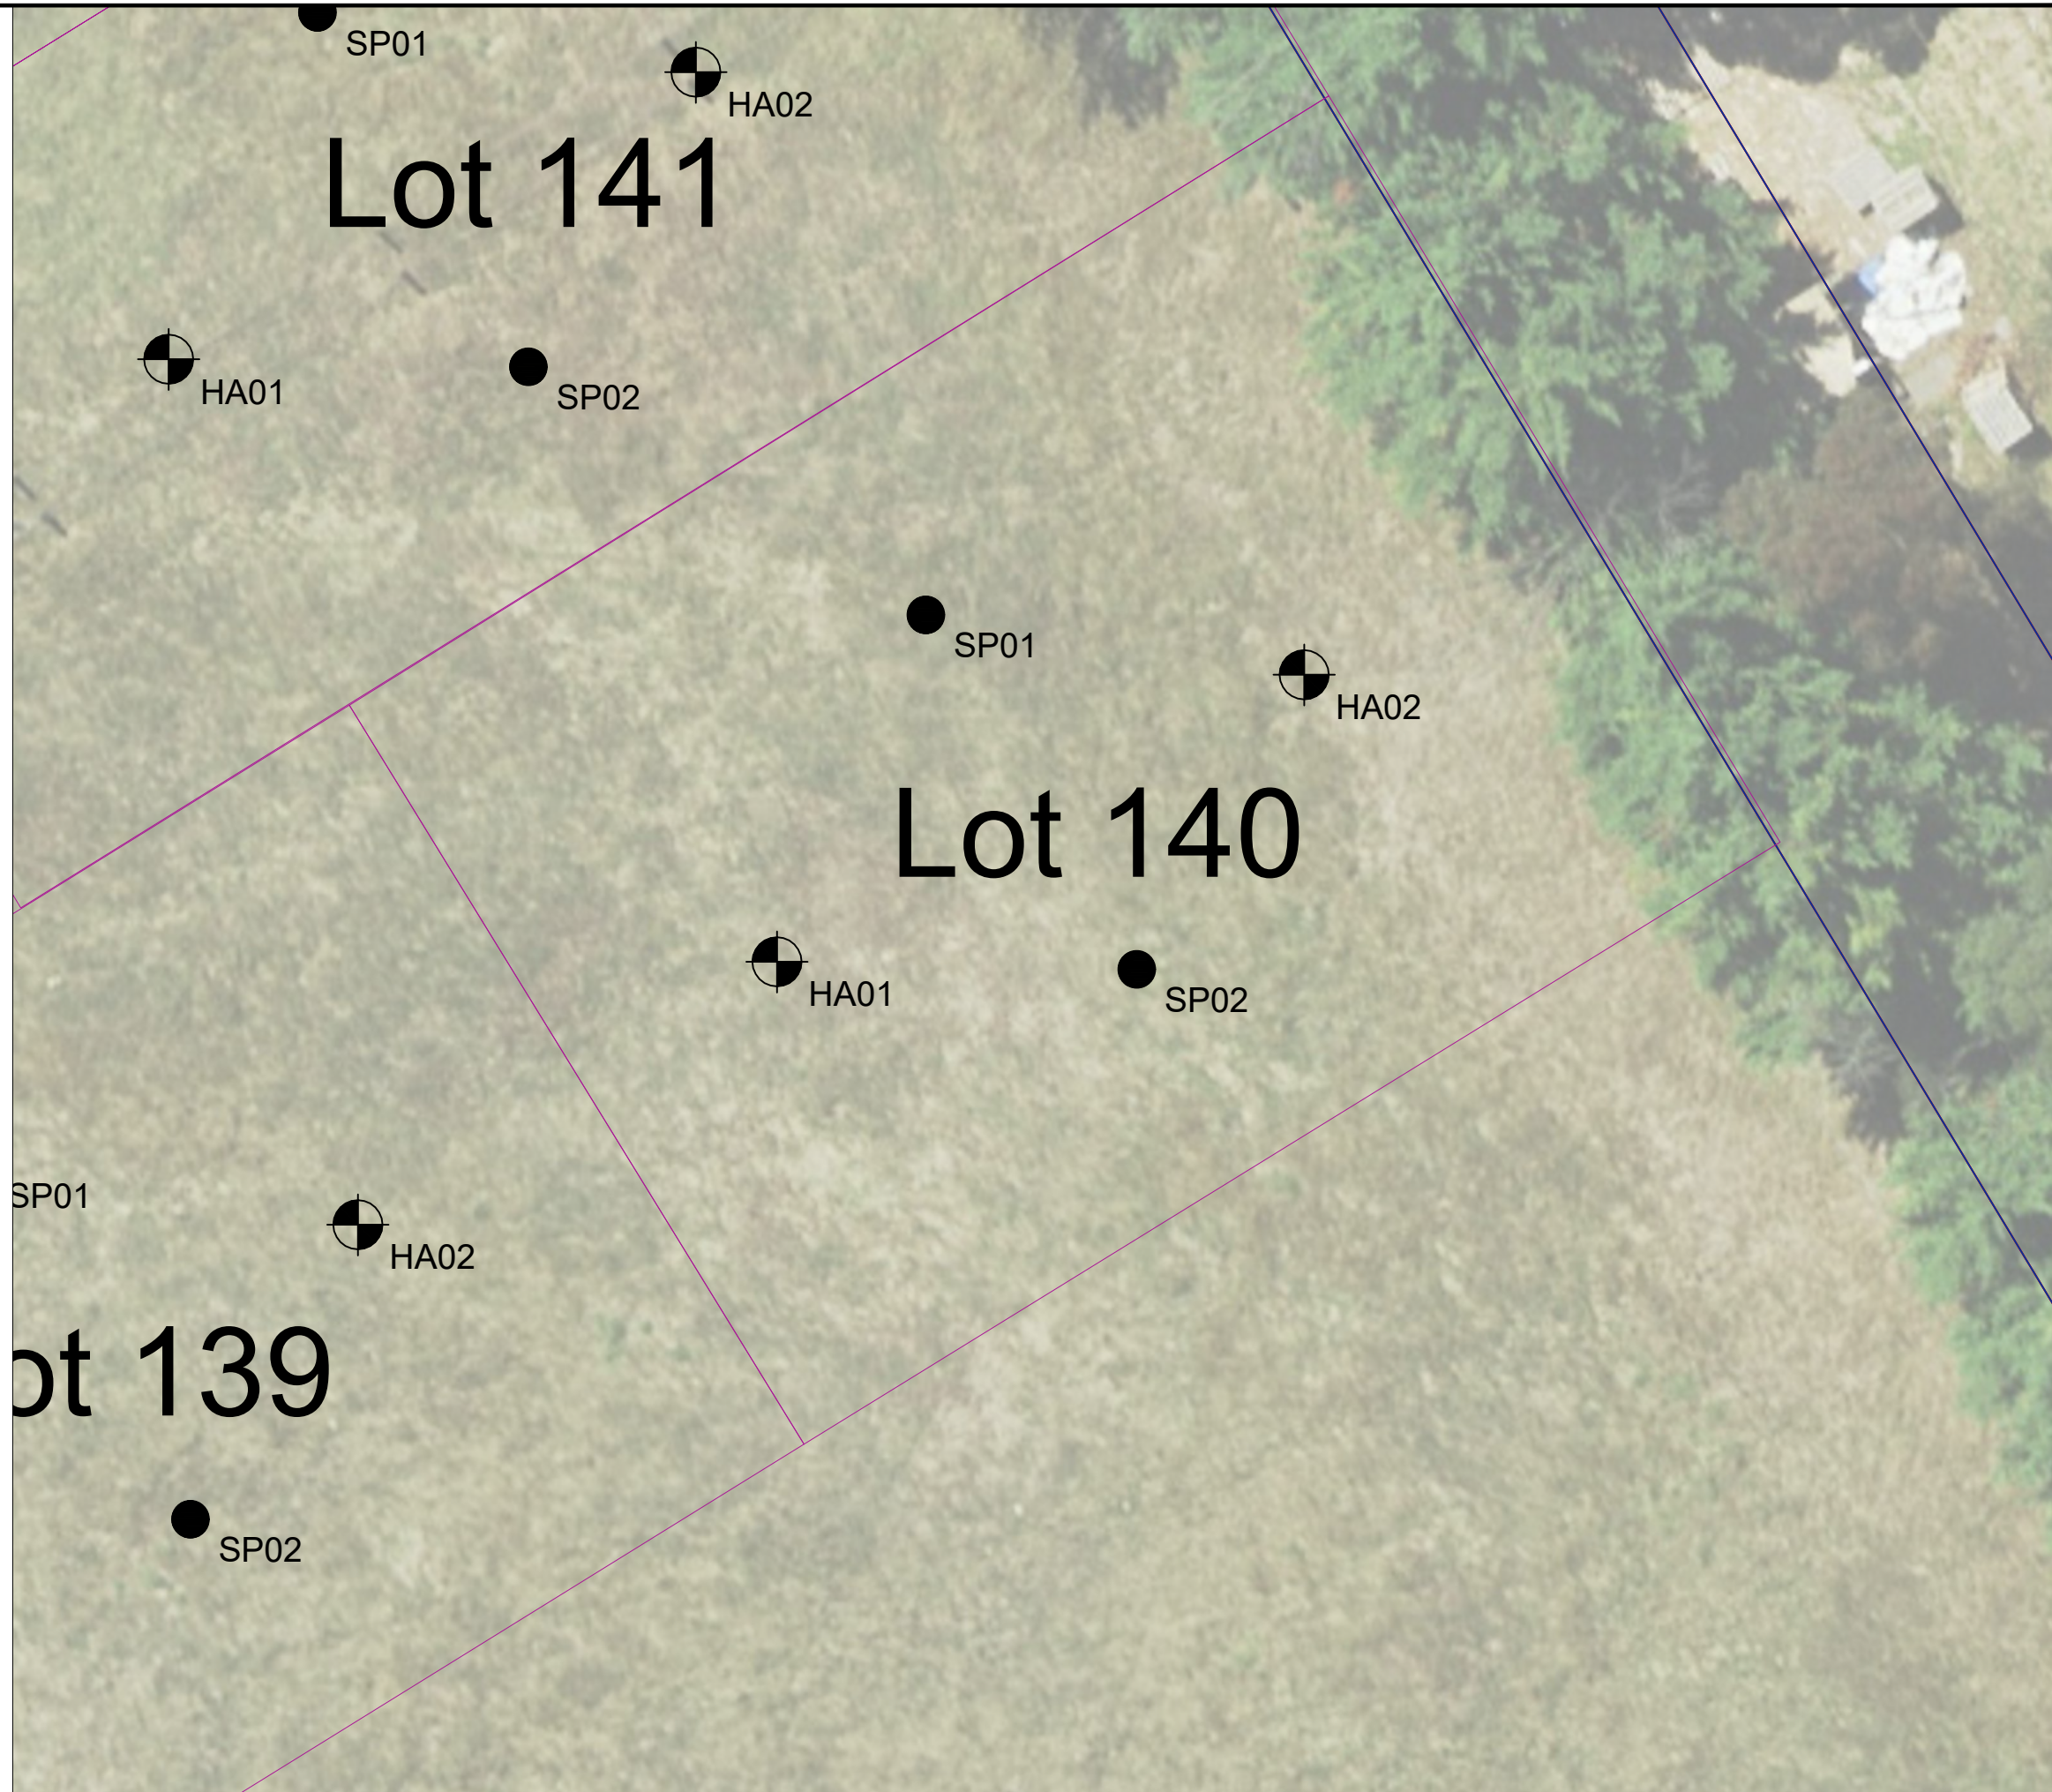
Drawing No: Lot 140/TLP	Drawn by: KB	Date: 15 September 2022
Scale: 1: 150(A3)	Checked by: DW	Revision: A
Filename: LTC22215 - Masterplan 138-144.dwg

LandTech investigated the site on 16 September 2022, comprising two hand auger holes with corresponding Scala Penetrometer tests and two additional Scala Penetrometer tests. The test locations were measured from lot boundaries and/or surveyed centre pegs and are approximate only. The test locations are shown on the LandTech *Test Location Plan*, Drawing No. Lot 140/ TLP attached to this report.

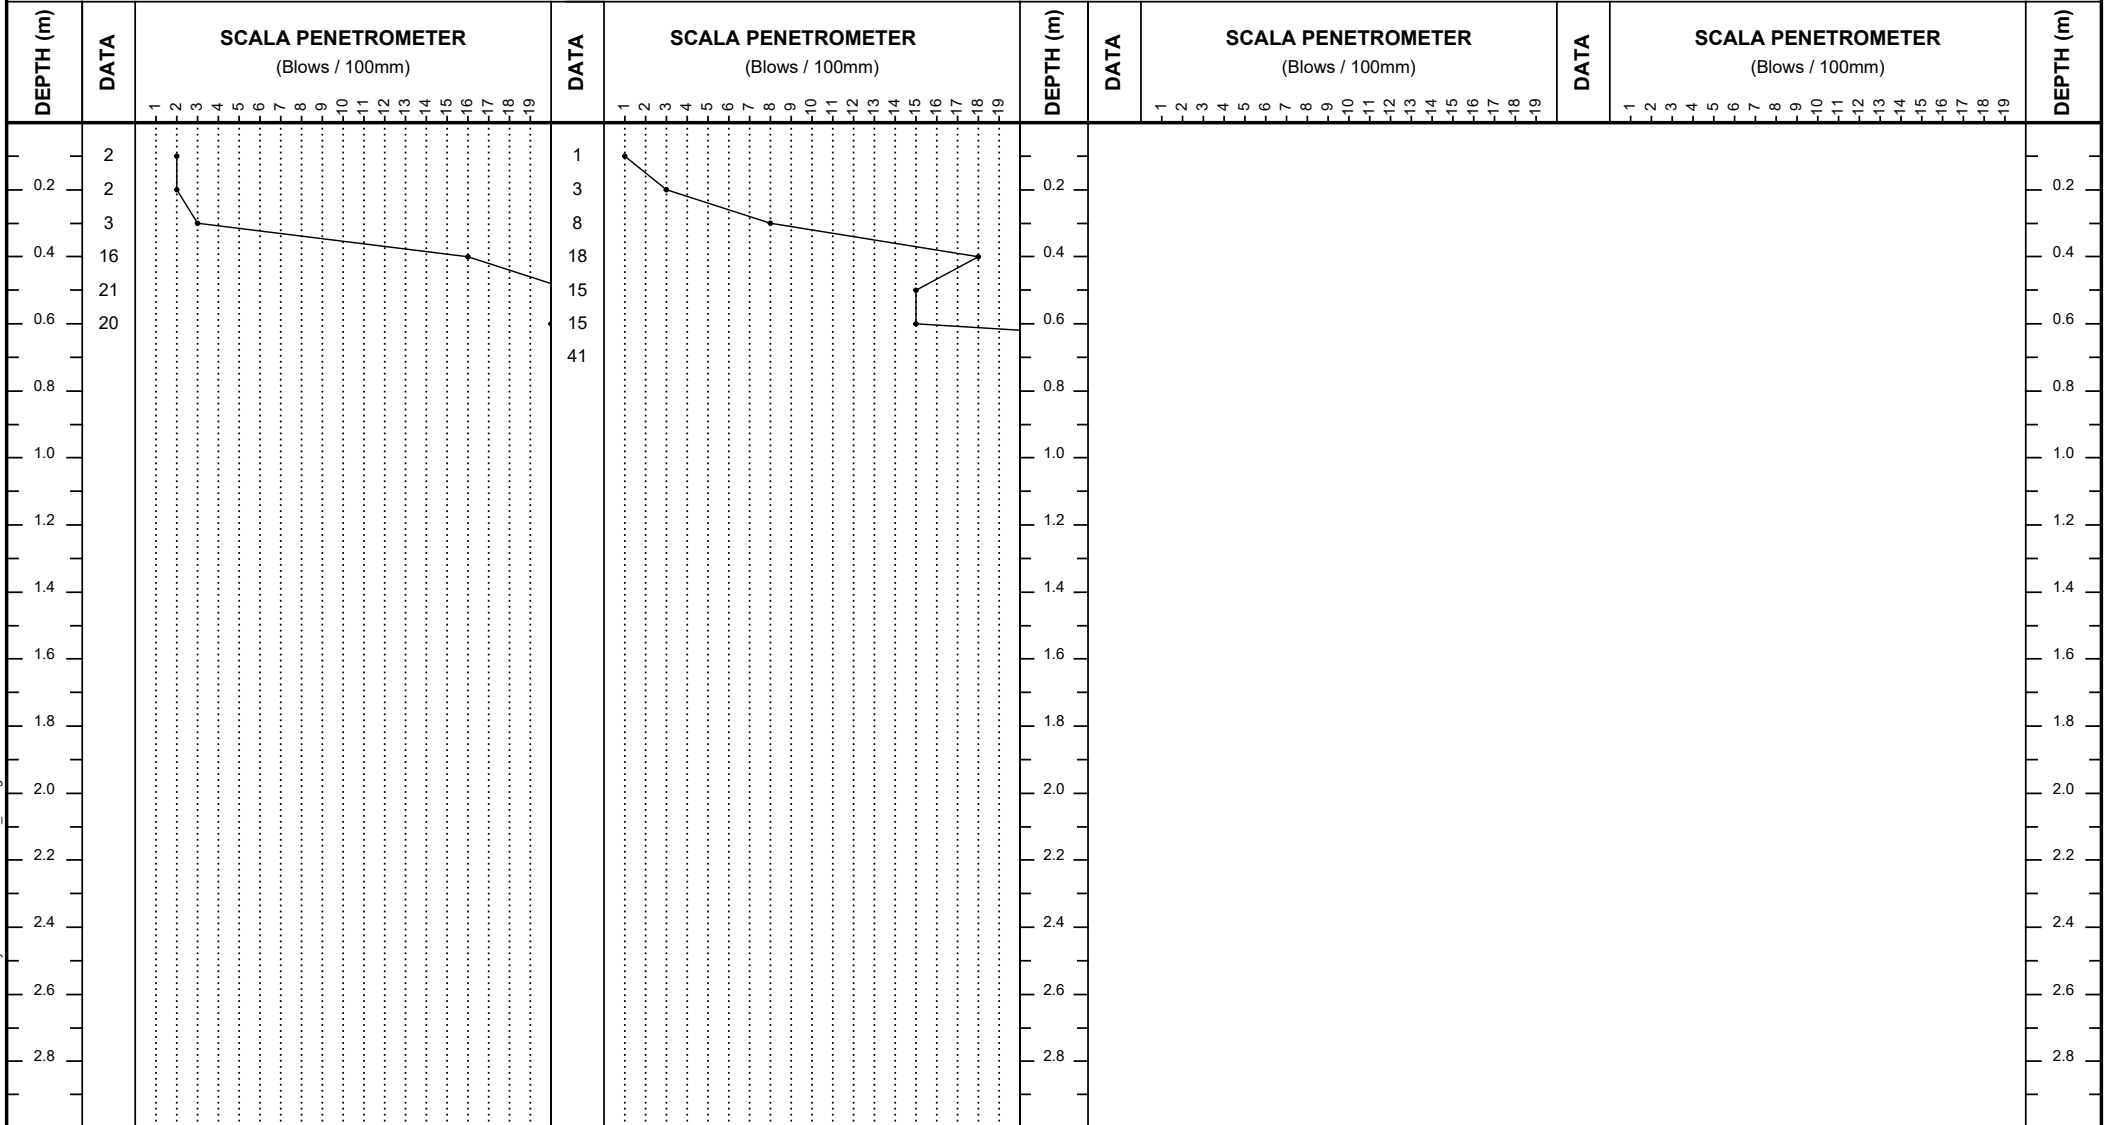
**Lot 140 - SP01**

The hand auger holes encountered topsoil/fill material from the ground surface to approximately 0.2m depths, underlain by inferred natural gravel. Groundwater was not encountered during testing. Scala Penetrometer testing at each of the four locations returned results between 1 and 40+ blows per 100mm penetration at the test positions, encountering refusal at depths between 0.5m and 0.7m below present ground level.
