28 October 2022

Project No: LTC22215

Gould Developments Limited

**RE: SHALLOW SOIL TEST REPORT  
LOT 215, 138 & 5/144 DUNNS CROSSING ROAD**

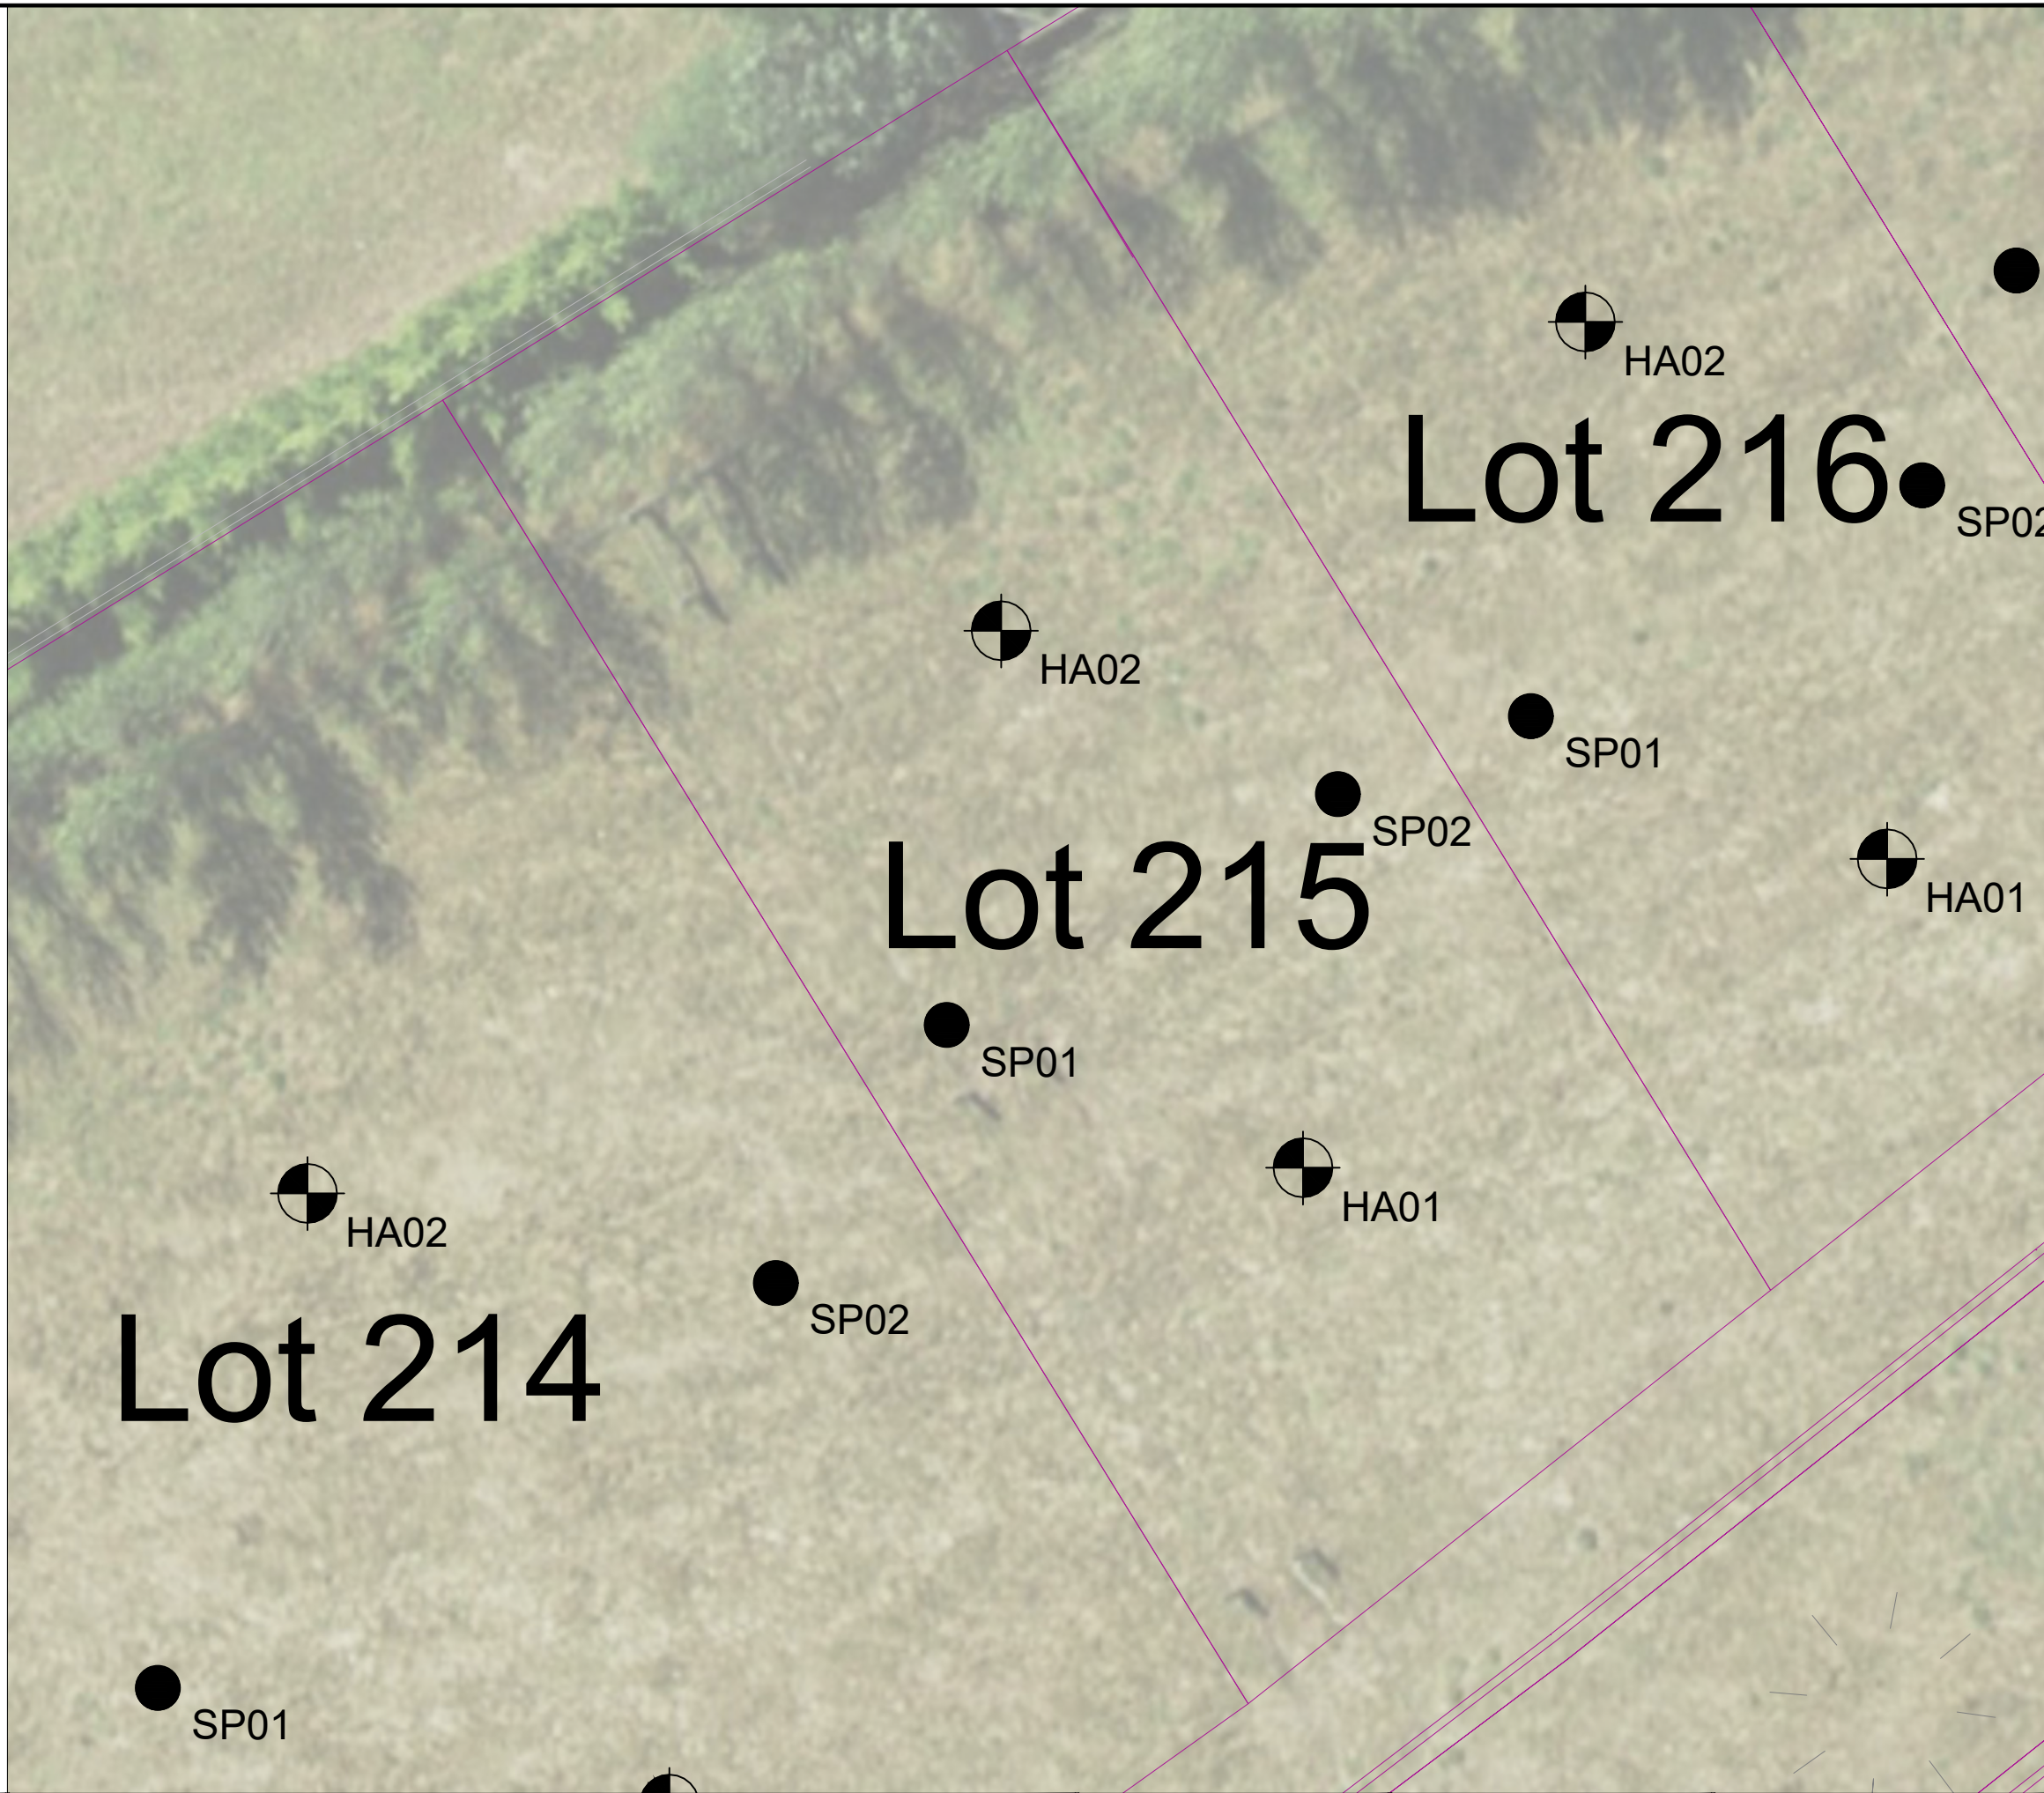
Test Location Plan  
 Lot 215, 138 Dunns Crossing Road  
 ROLLESTON

LandTech investigated the site on 26 October 2022, comprising two hand auger holes with corresponding Scala Penetrometer tests and two additional Scala Penetrometer tests. The test locations were measured from lot boundaries and/or surveyed centre pegs and are approximate only. The test locations are shown on the LandTech *Test Location Plan*, Drawing No. Lot 215/ TLP attached to this report.

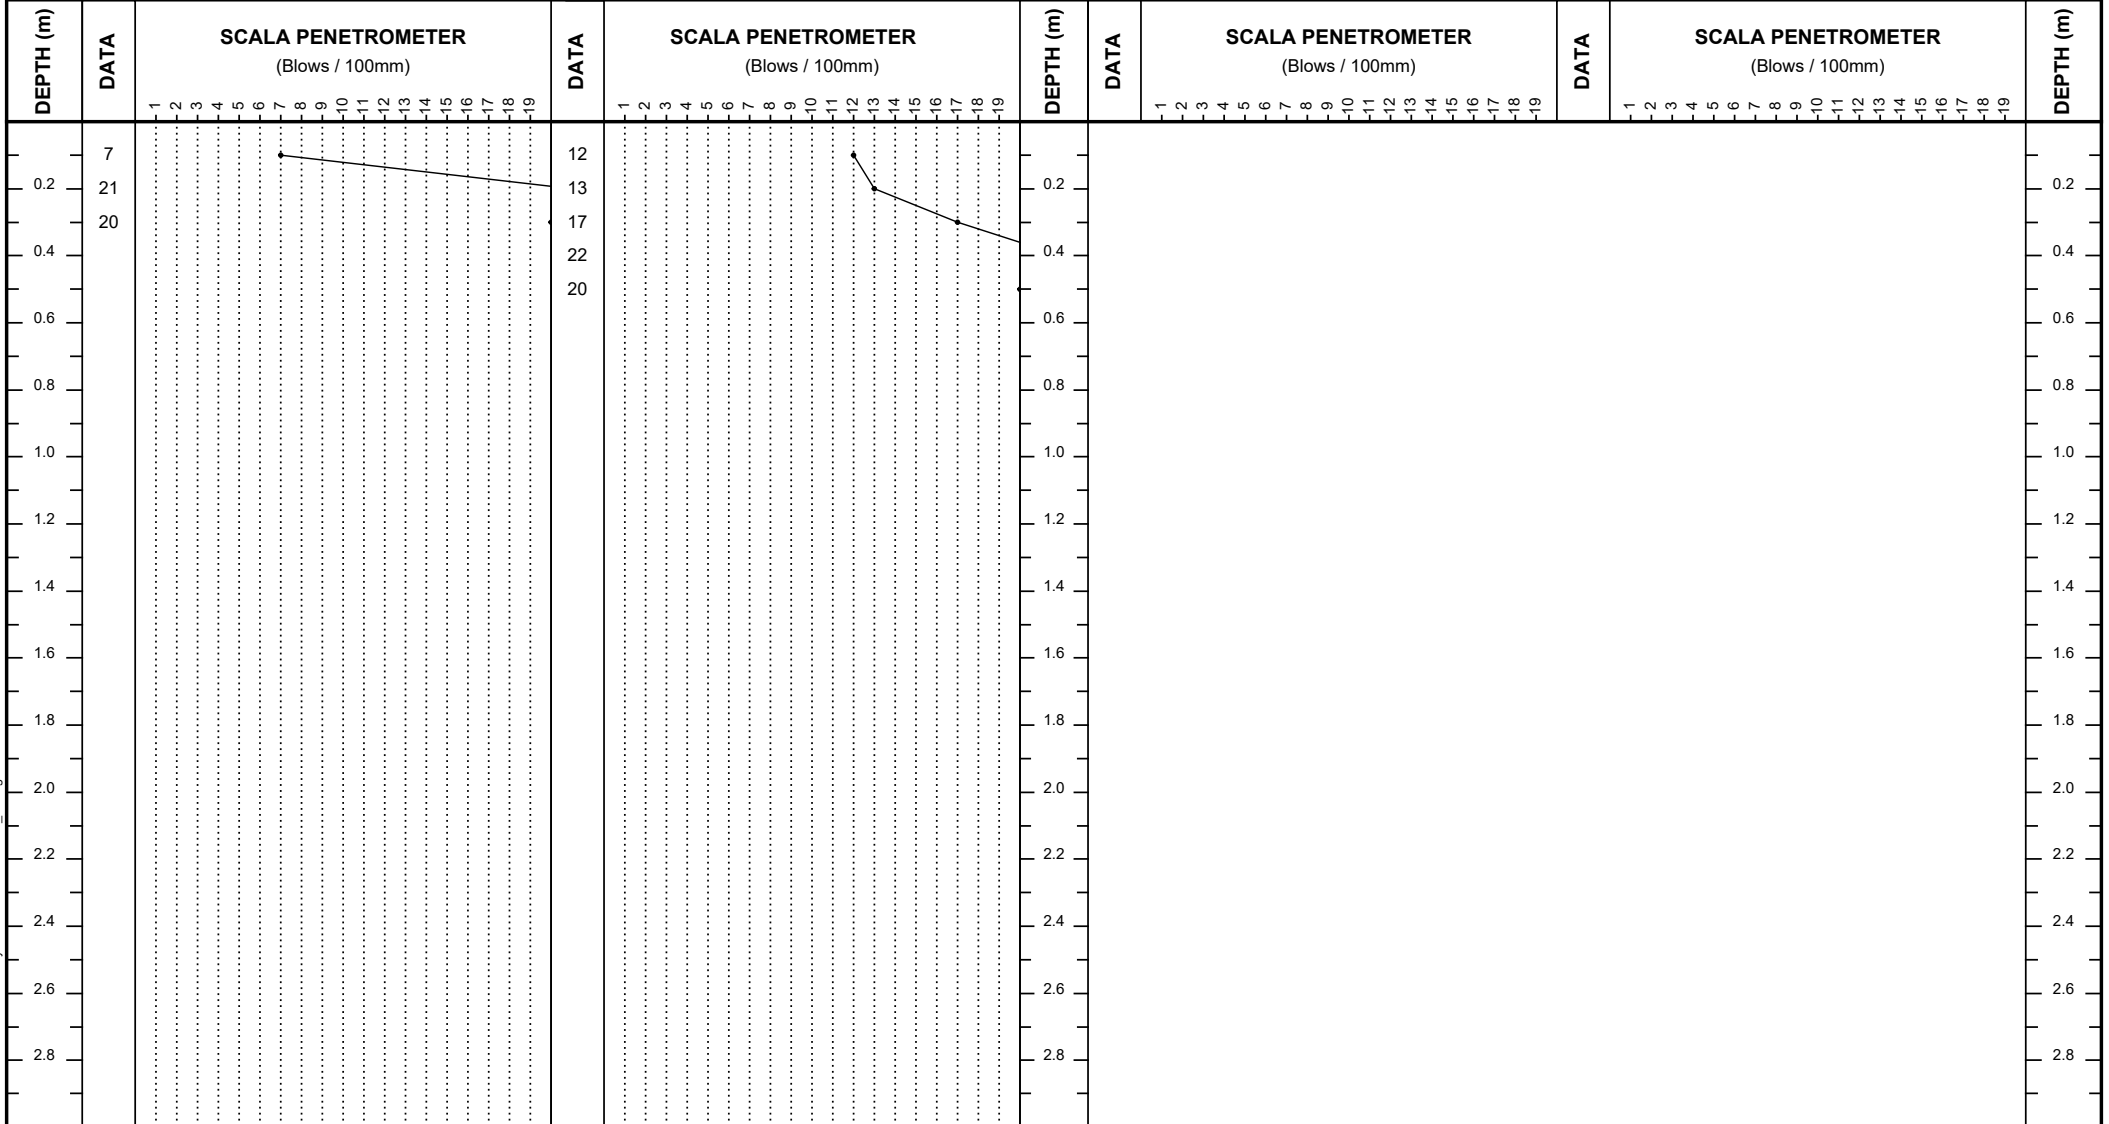
The hand auger holes encountered topsoil/fill material from the ground surface to approximately 0.1m depths, underlain by inferred natural gravel. Groundwater was not encountered during testing. Scala Penetrometer testing at each of the four locations returned results between 7 and 40+ blows per 100mm penetration at the test positions, encountering refusal at depths between 0.3m and 0.5m below present ground level.
