28 October 2022

Project No: LTC22215

**RE: SHALLOW SOIL TEST REPORT  
LOT 195, 138 & 5/144 DUNNS CROSSING ROAD**

**Test Location Plan**  
 Lot 195, 138 Dunns Crossing Road  
 ROLLESTON

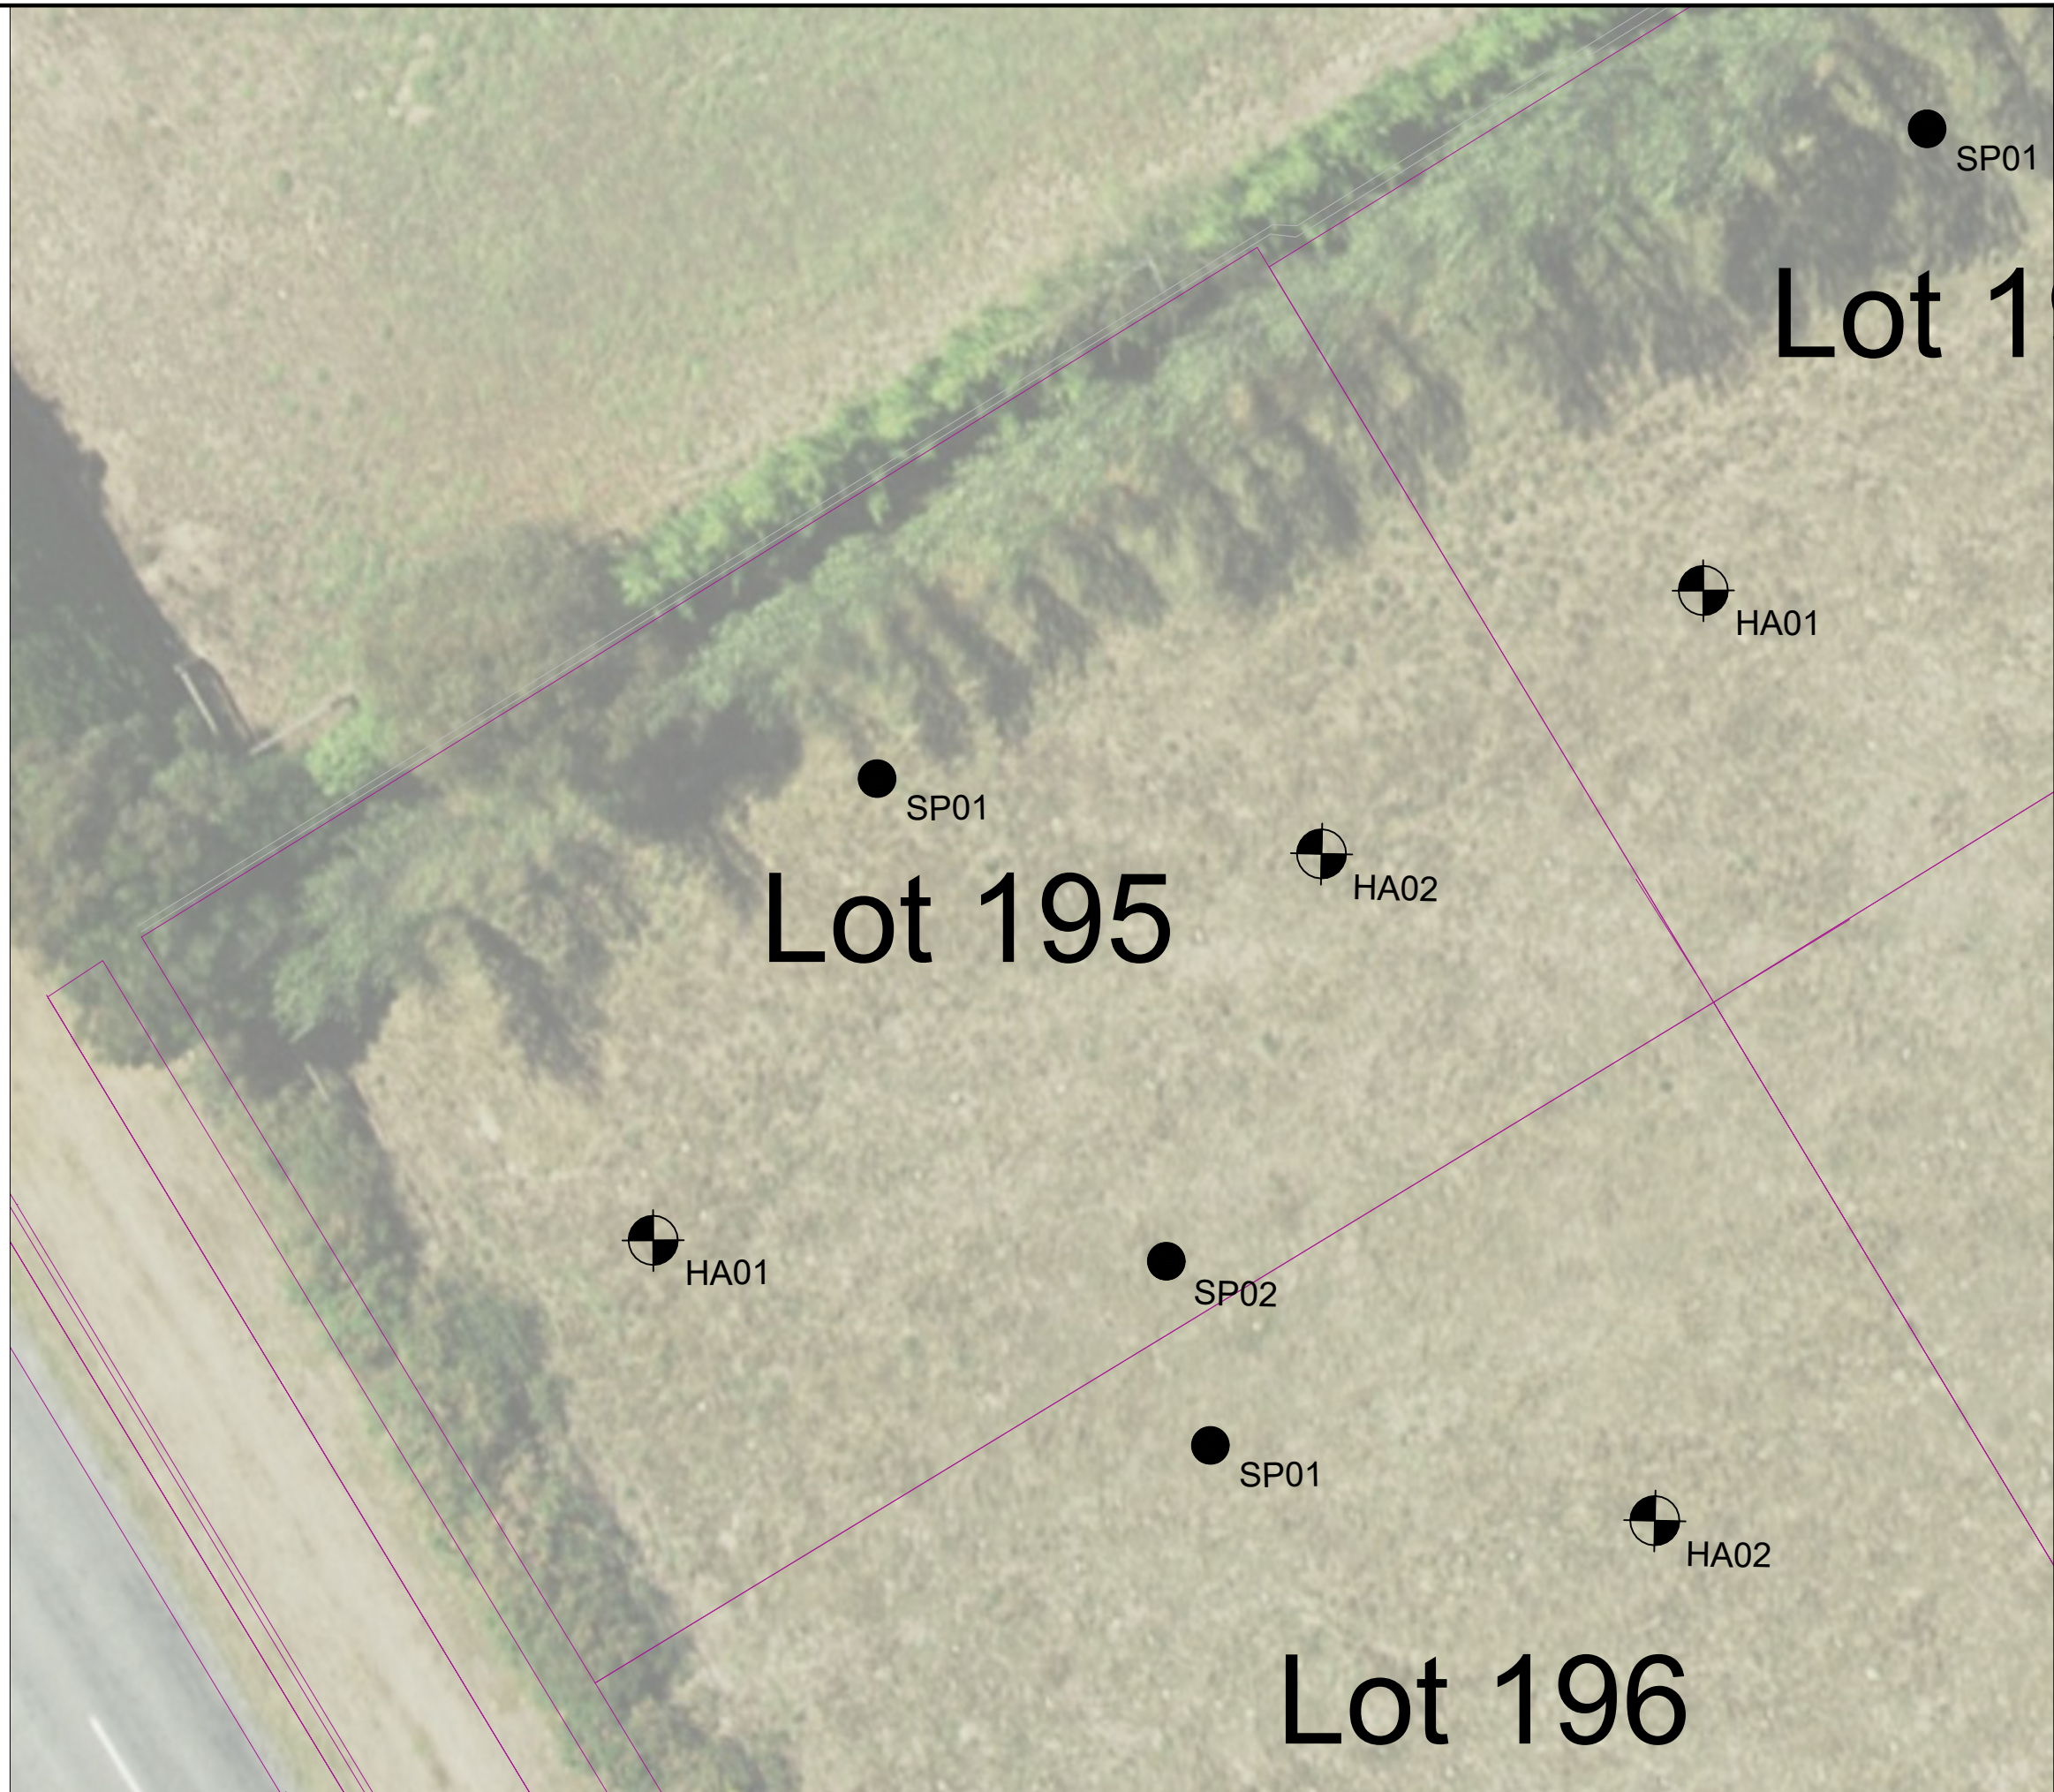
LandTech investigated the site on 26 October 2022, comprising two hand auger holes with corresponding Scala Penetrometer tests and two additional Scala Penetrometer tests. The test locations were measured from lot boundaries and/or surveyed centre pegs and are approximate only. The test locations are shown on the LandTech *Test Location Plan*, Drawing No. Lot 195/ TLP attached to this report.

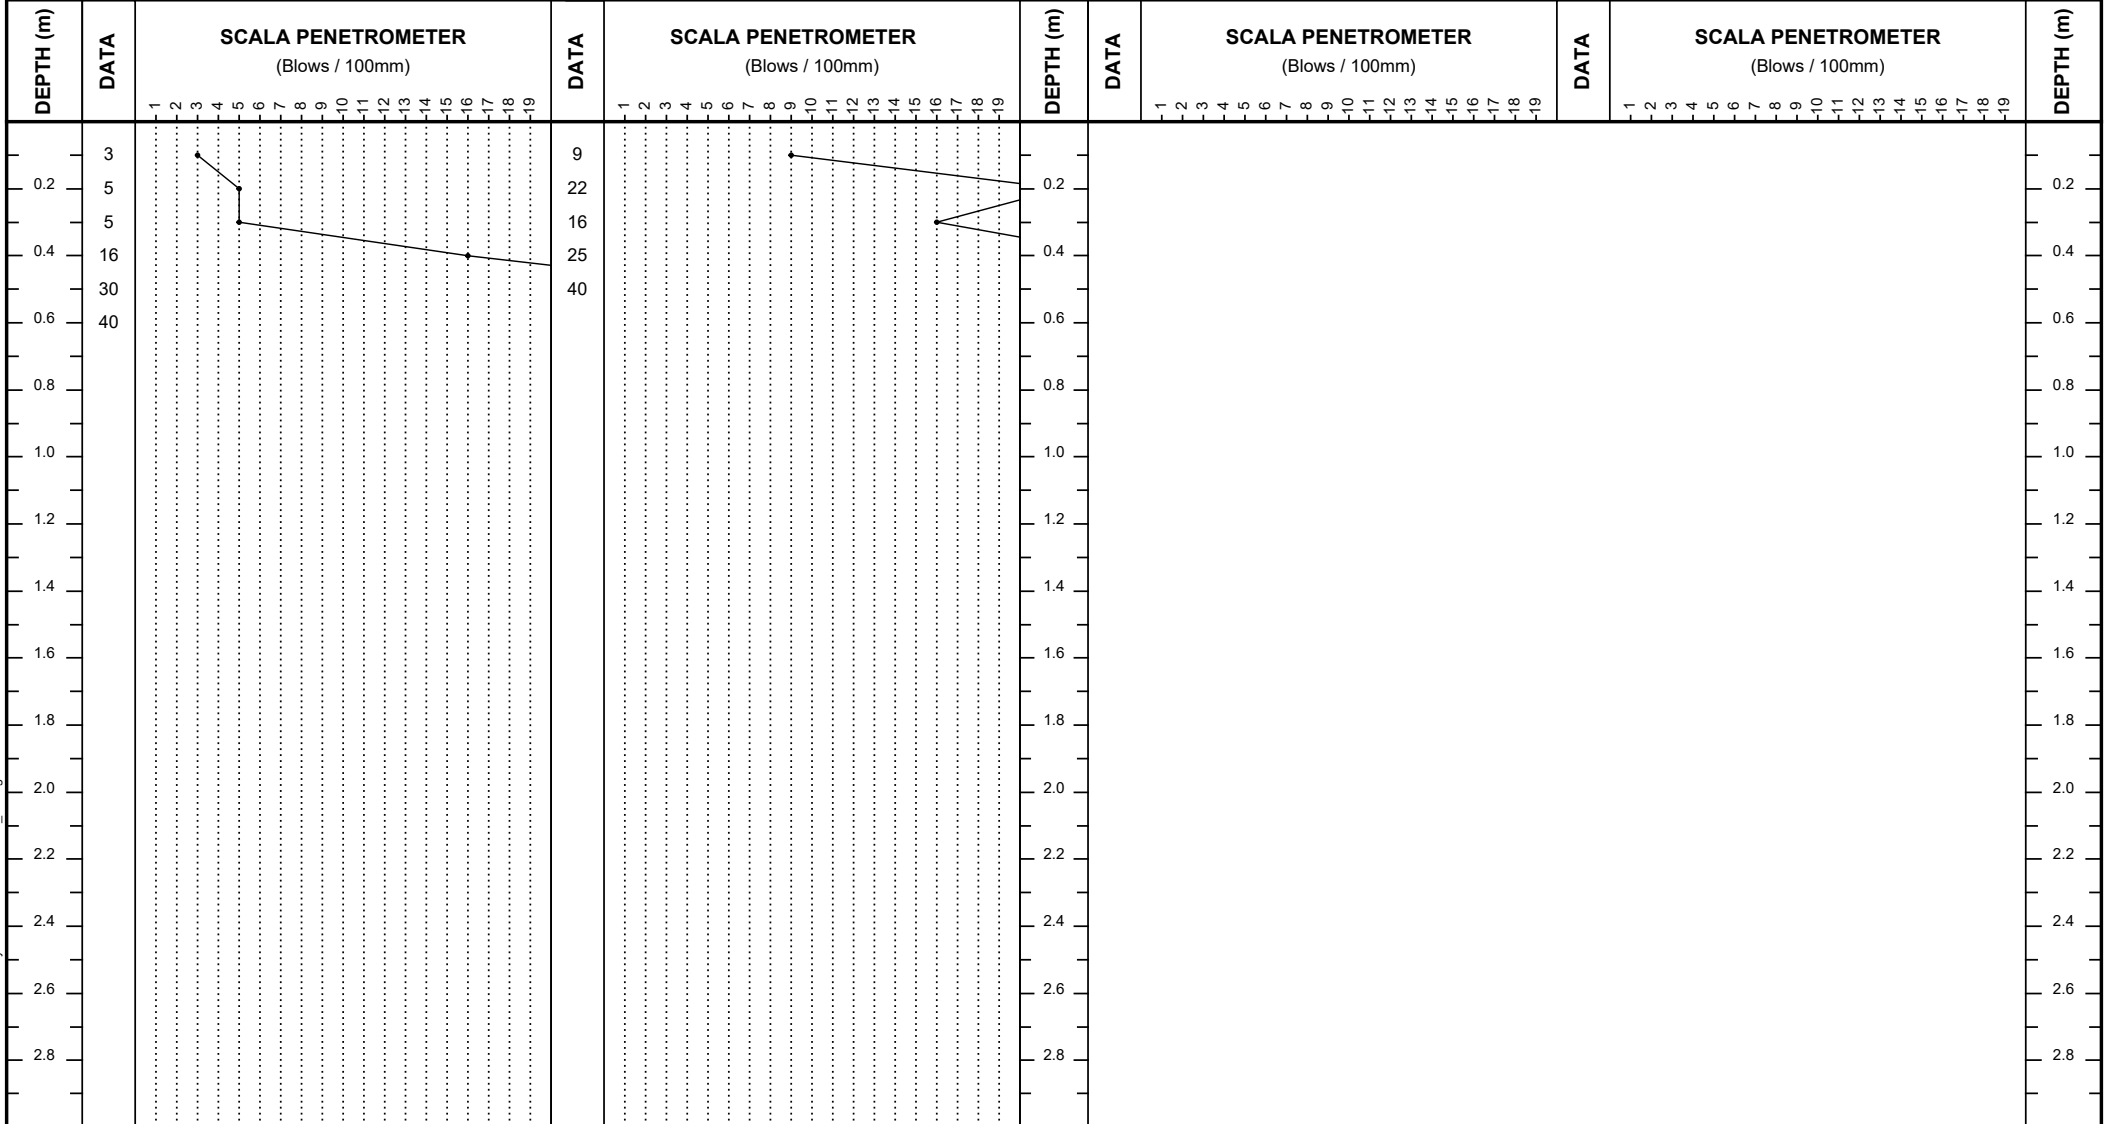
The hand auger holes encountered topsoil/fill material from the ground surface to approximately 0.2m depths, underlain by inferred natural gravel. Groundwater was not encountered during testing. Scala Penetrometer testing at each of the four locations returned results between 3 and 40+ blows per 100mm penetration at the test positions, encountering refusal at depths between 0.5m and 0.6m below present ground level.
