28 October 2022

Project No: LTC22215

Gould Developments Limited

**RE: SHALLOW SOIL TEST REPORT  
LOT 209, 138 & 5/144 DUNNS CROSSING ROAD**

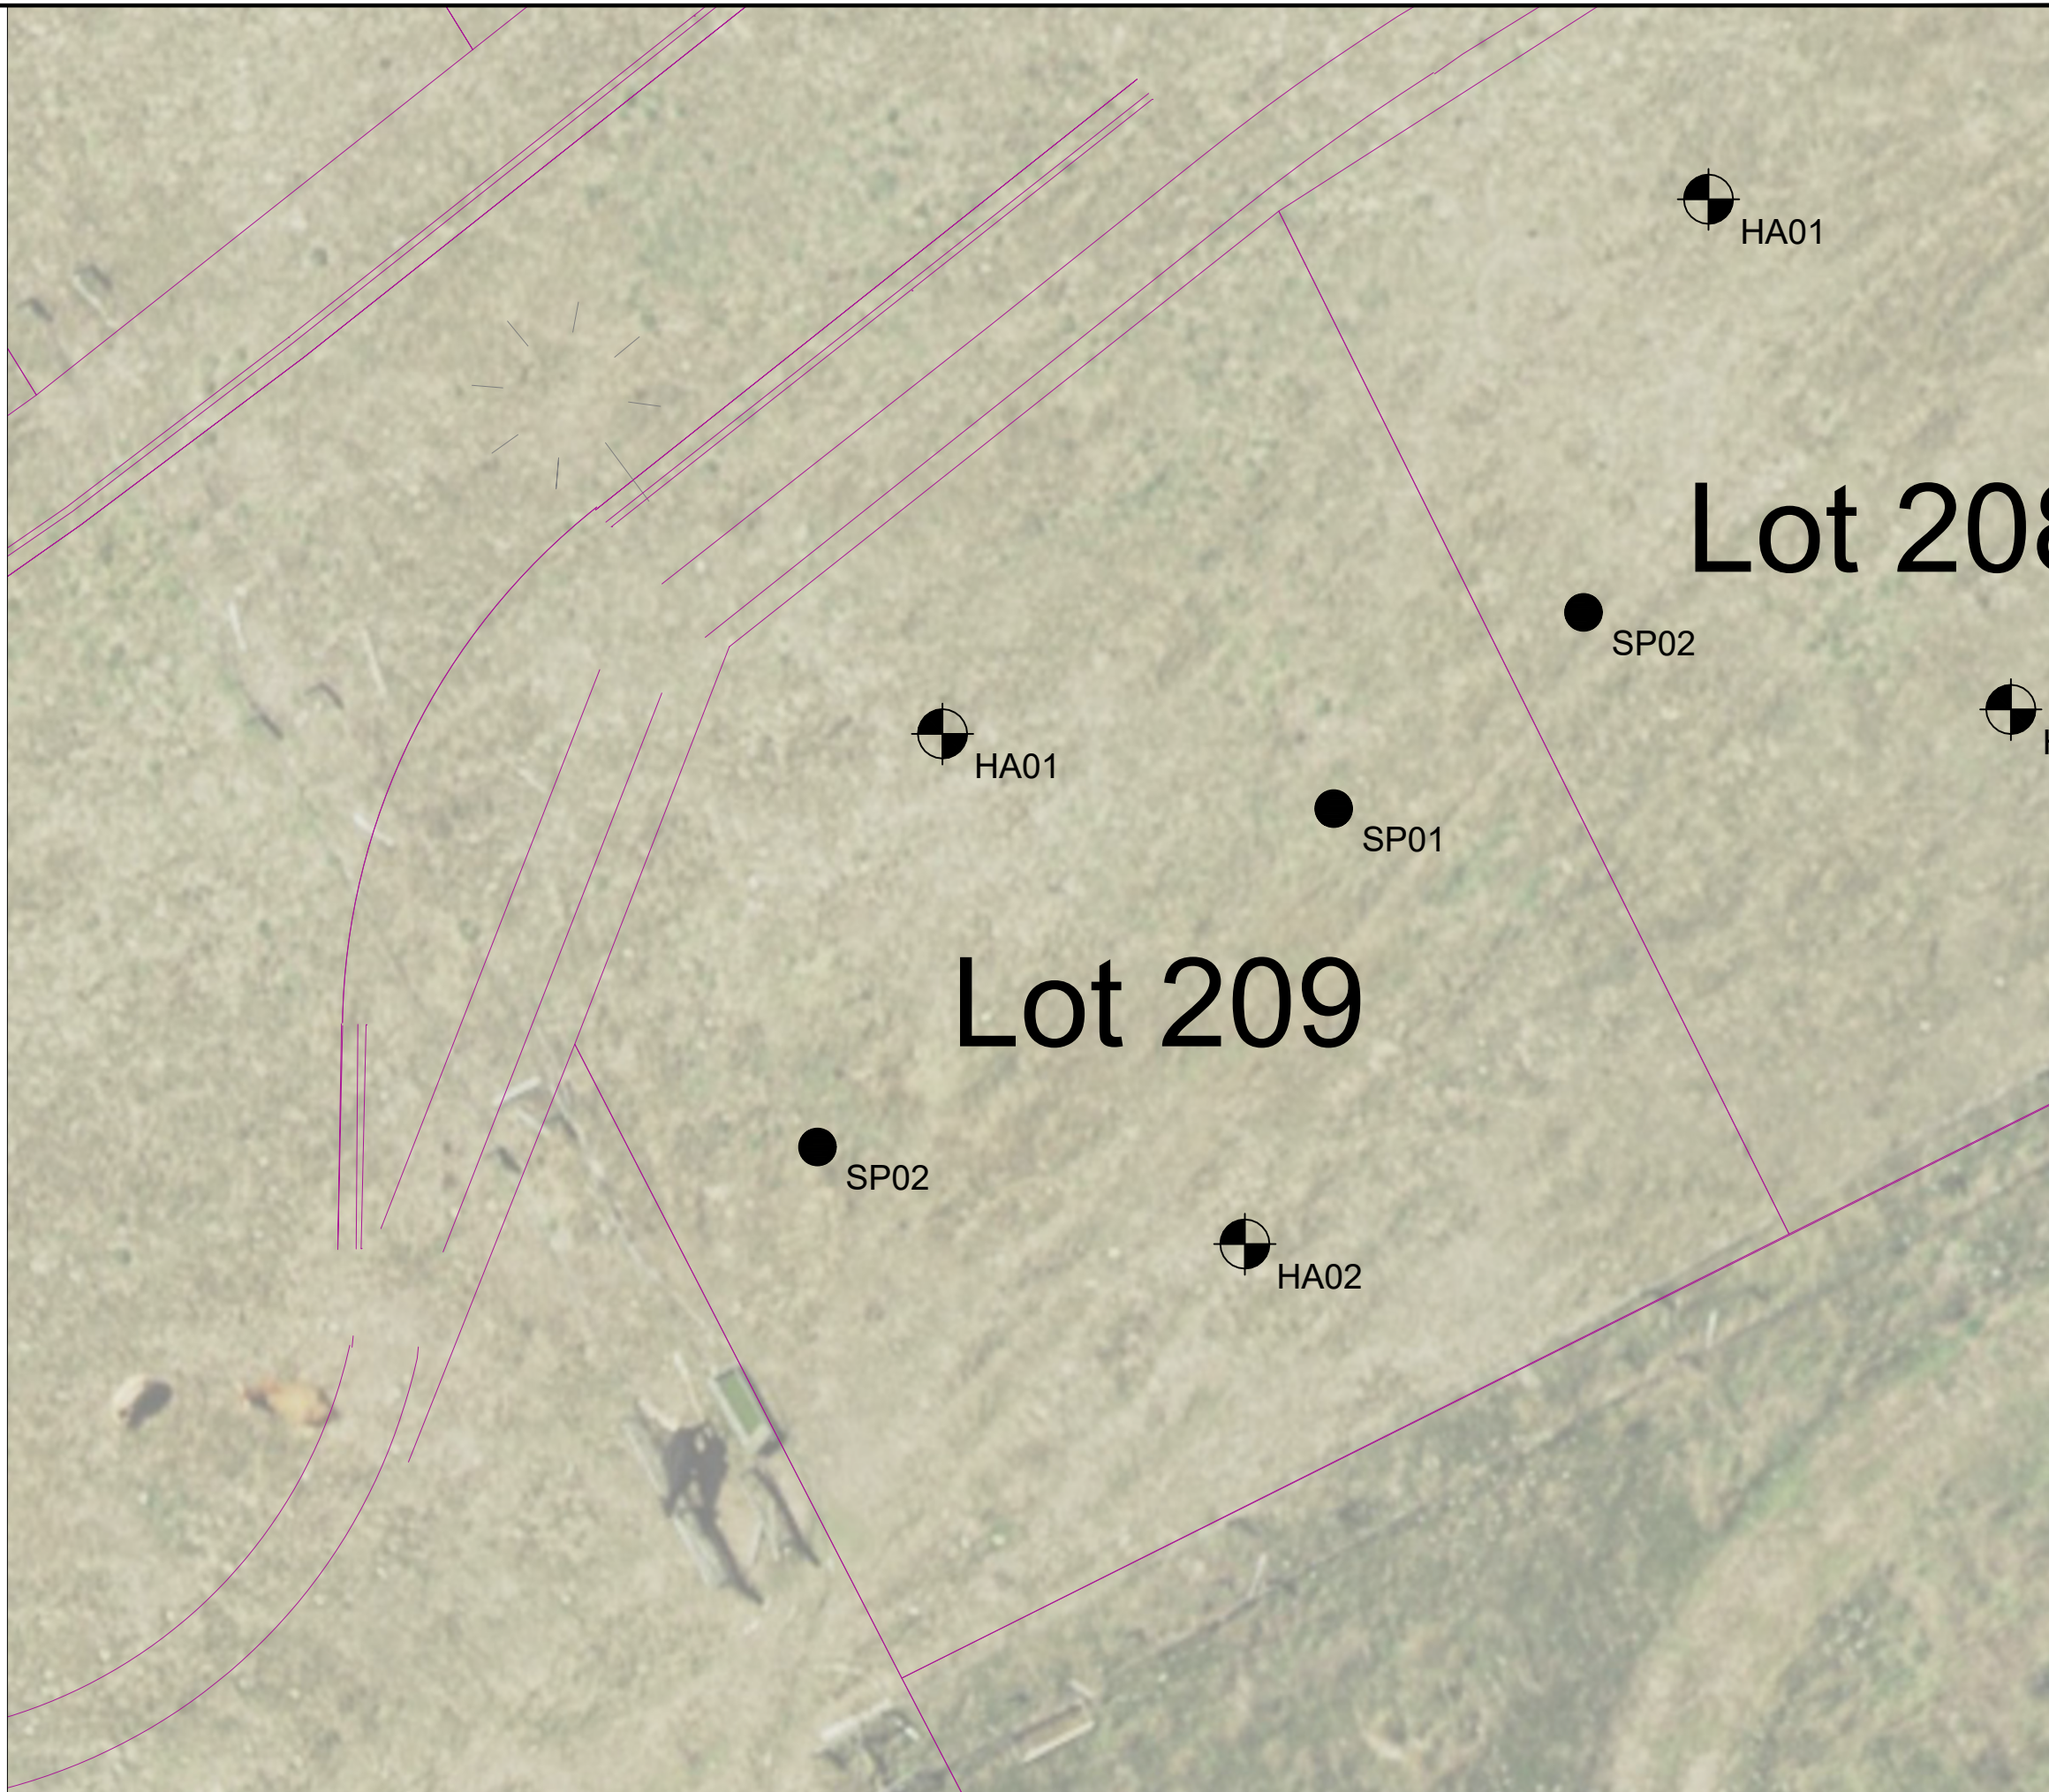
**Test Location Plan**

LandTech investigated the site on 26 October 2022, comprising two hand auger holes with corresponding Scala Penetrometer tests and two additional Scala Penetrometer tests. The test locations were measured from lot boundaries and/or surveyed centre pegs and are approximate only. The test locations are shown on the LandTech *Test Location Plan*, Drawing No. Lot 209/ TLP attached to this report.
