28 October 2022

Project No: LTC22215

Gould Developments Limited

**RE: SHALLOW SOIL TEST REPORT  
LOT 196, 138 & 5/144 DUNNS CROSSING ROAD**

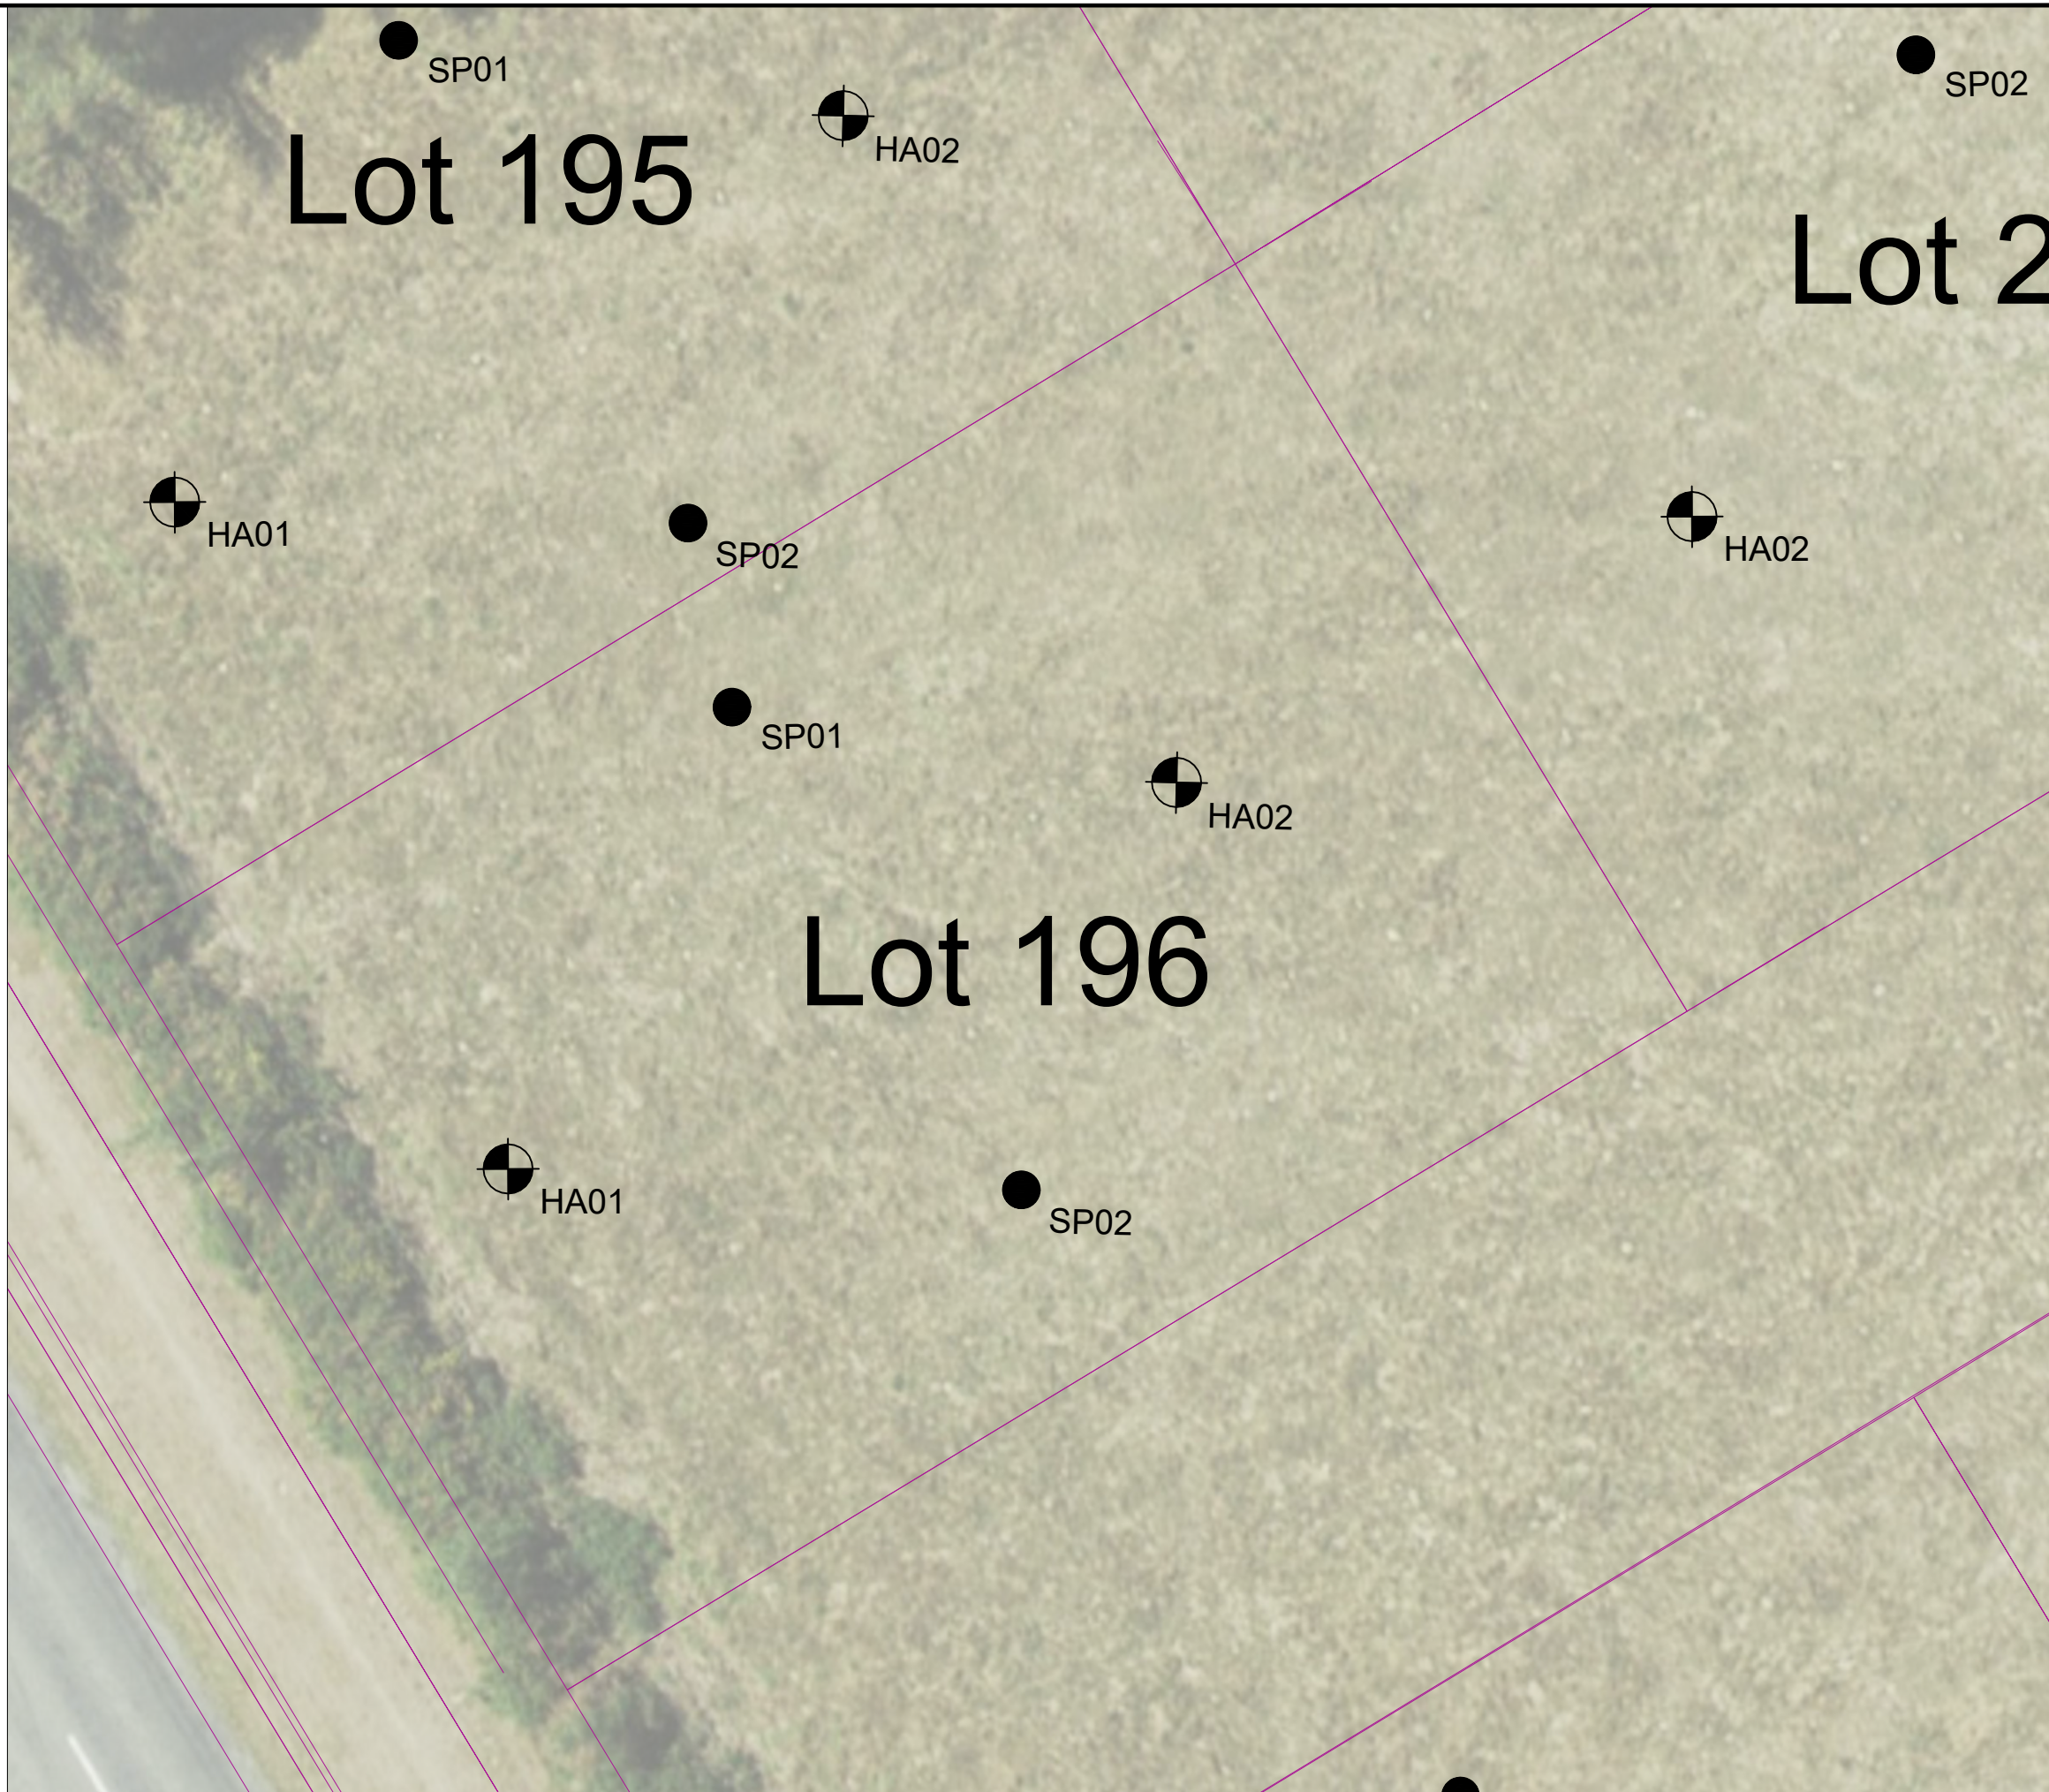
**Test Location Plan**  
 Lot 196, 138 Dunns Crossing Road  
 ROLLESTON

LandTech investigated the site on 26 October 2022, comprising two hand auger holes with corresponding Scala Penetrometer tests and two additional Scala Penetrometer tests. The test locations were measured from lot boundaries and/or surveyed centre pegs and are approximate only. The test locations are shown on the LandTech *Test Location Plan*, Drawing No. Lot 196/ TLP attached to this report.

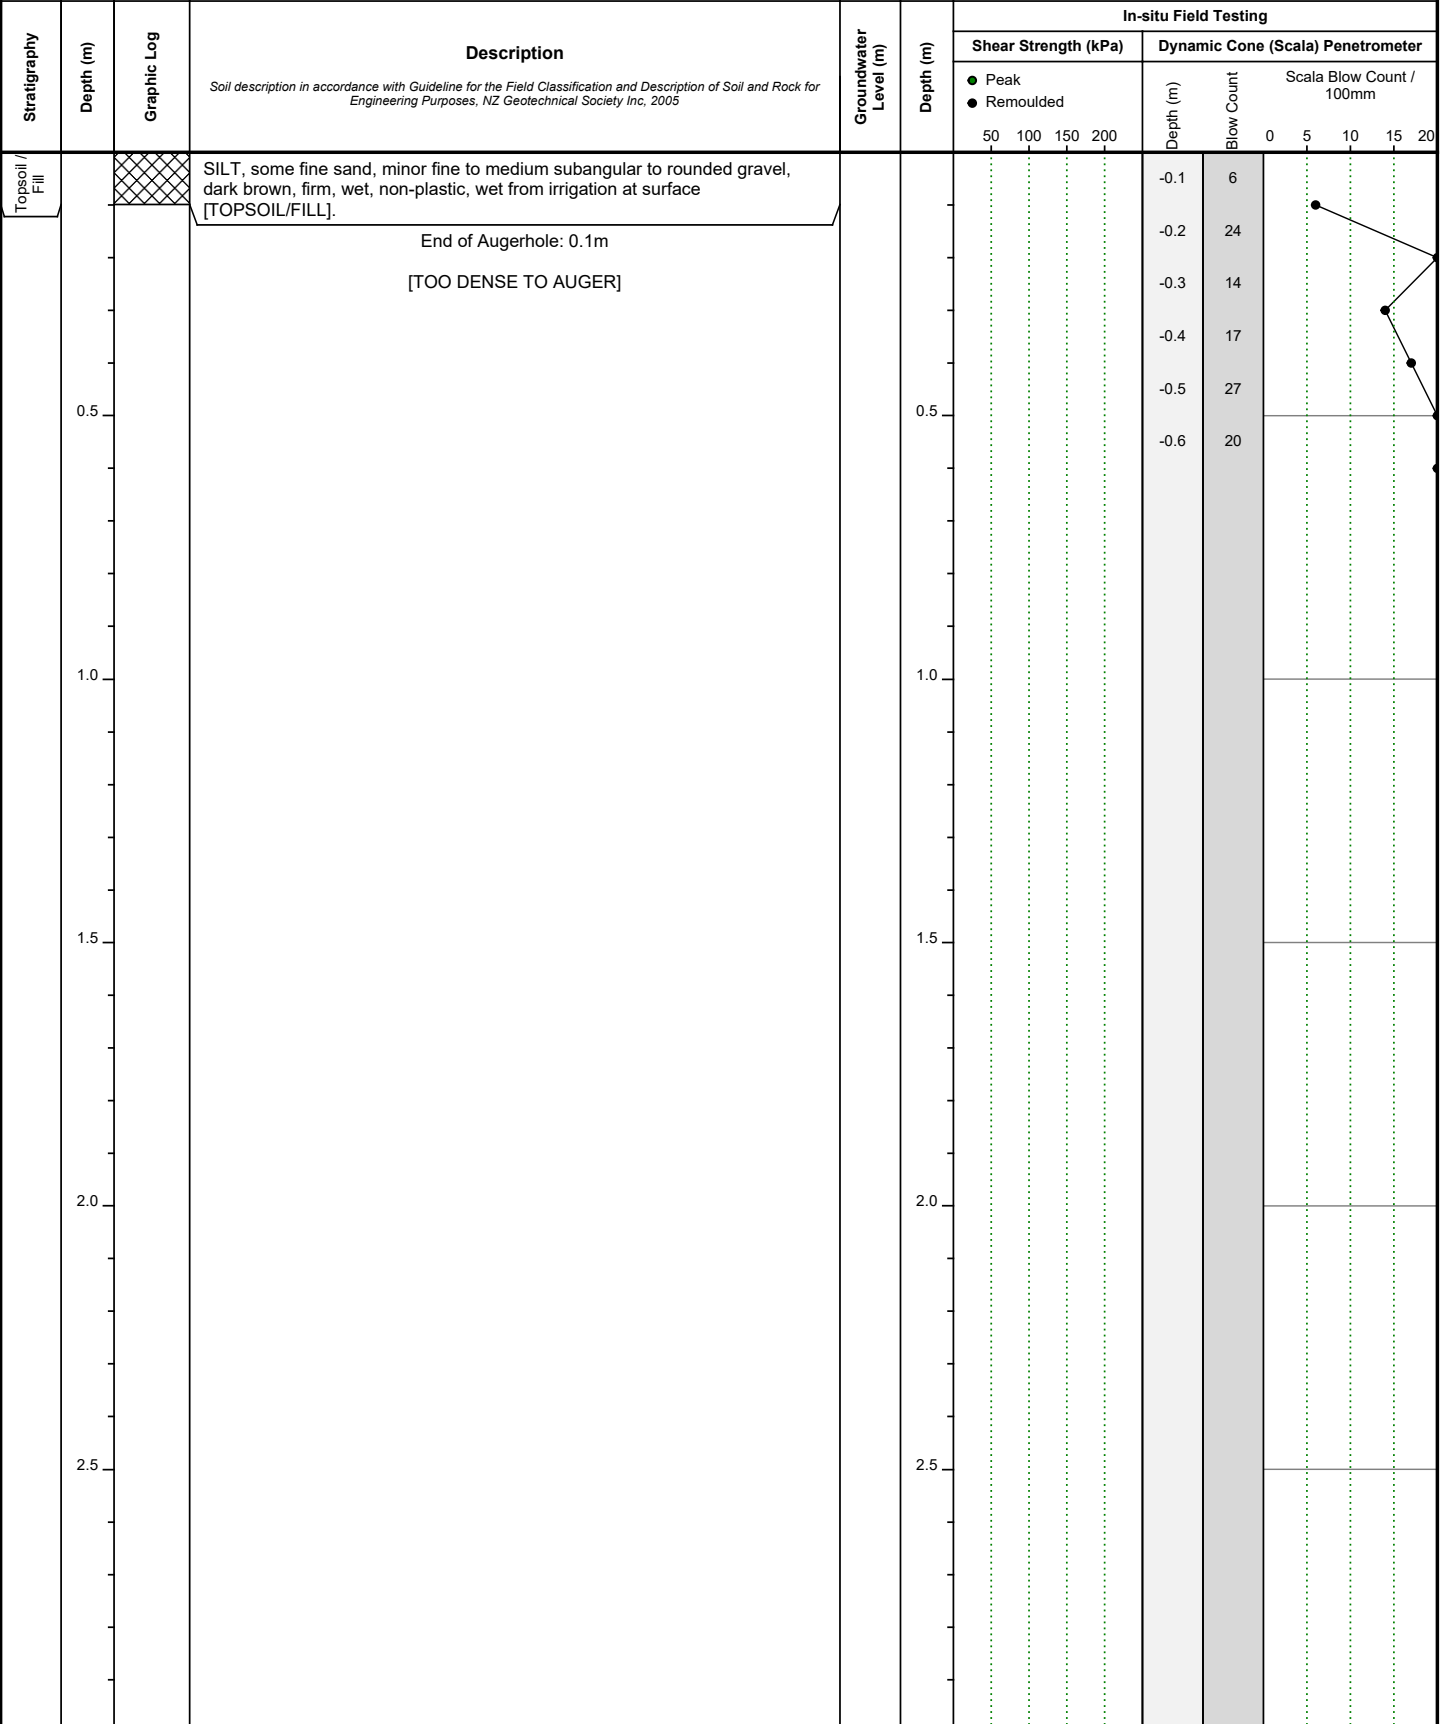
**Augerhole No.:** Lot 196 - HA01

Inferred gravels
