Project No: LTC22215

Gould Developments Limited

**RE: SHALLOW SOIL TEST REPORT  
LOT 121, 138 DUNNS CROSSING ROAD**

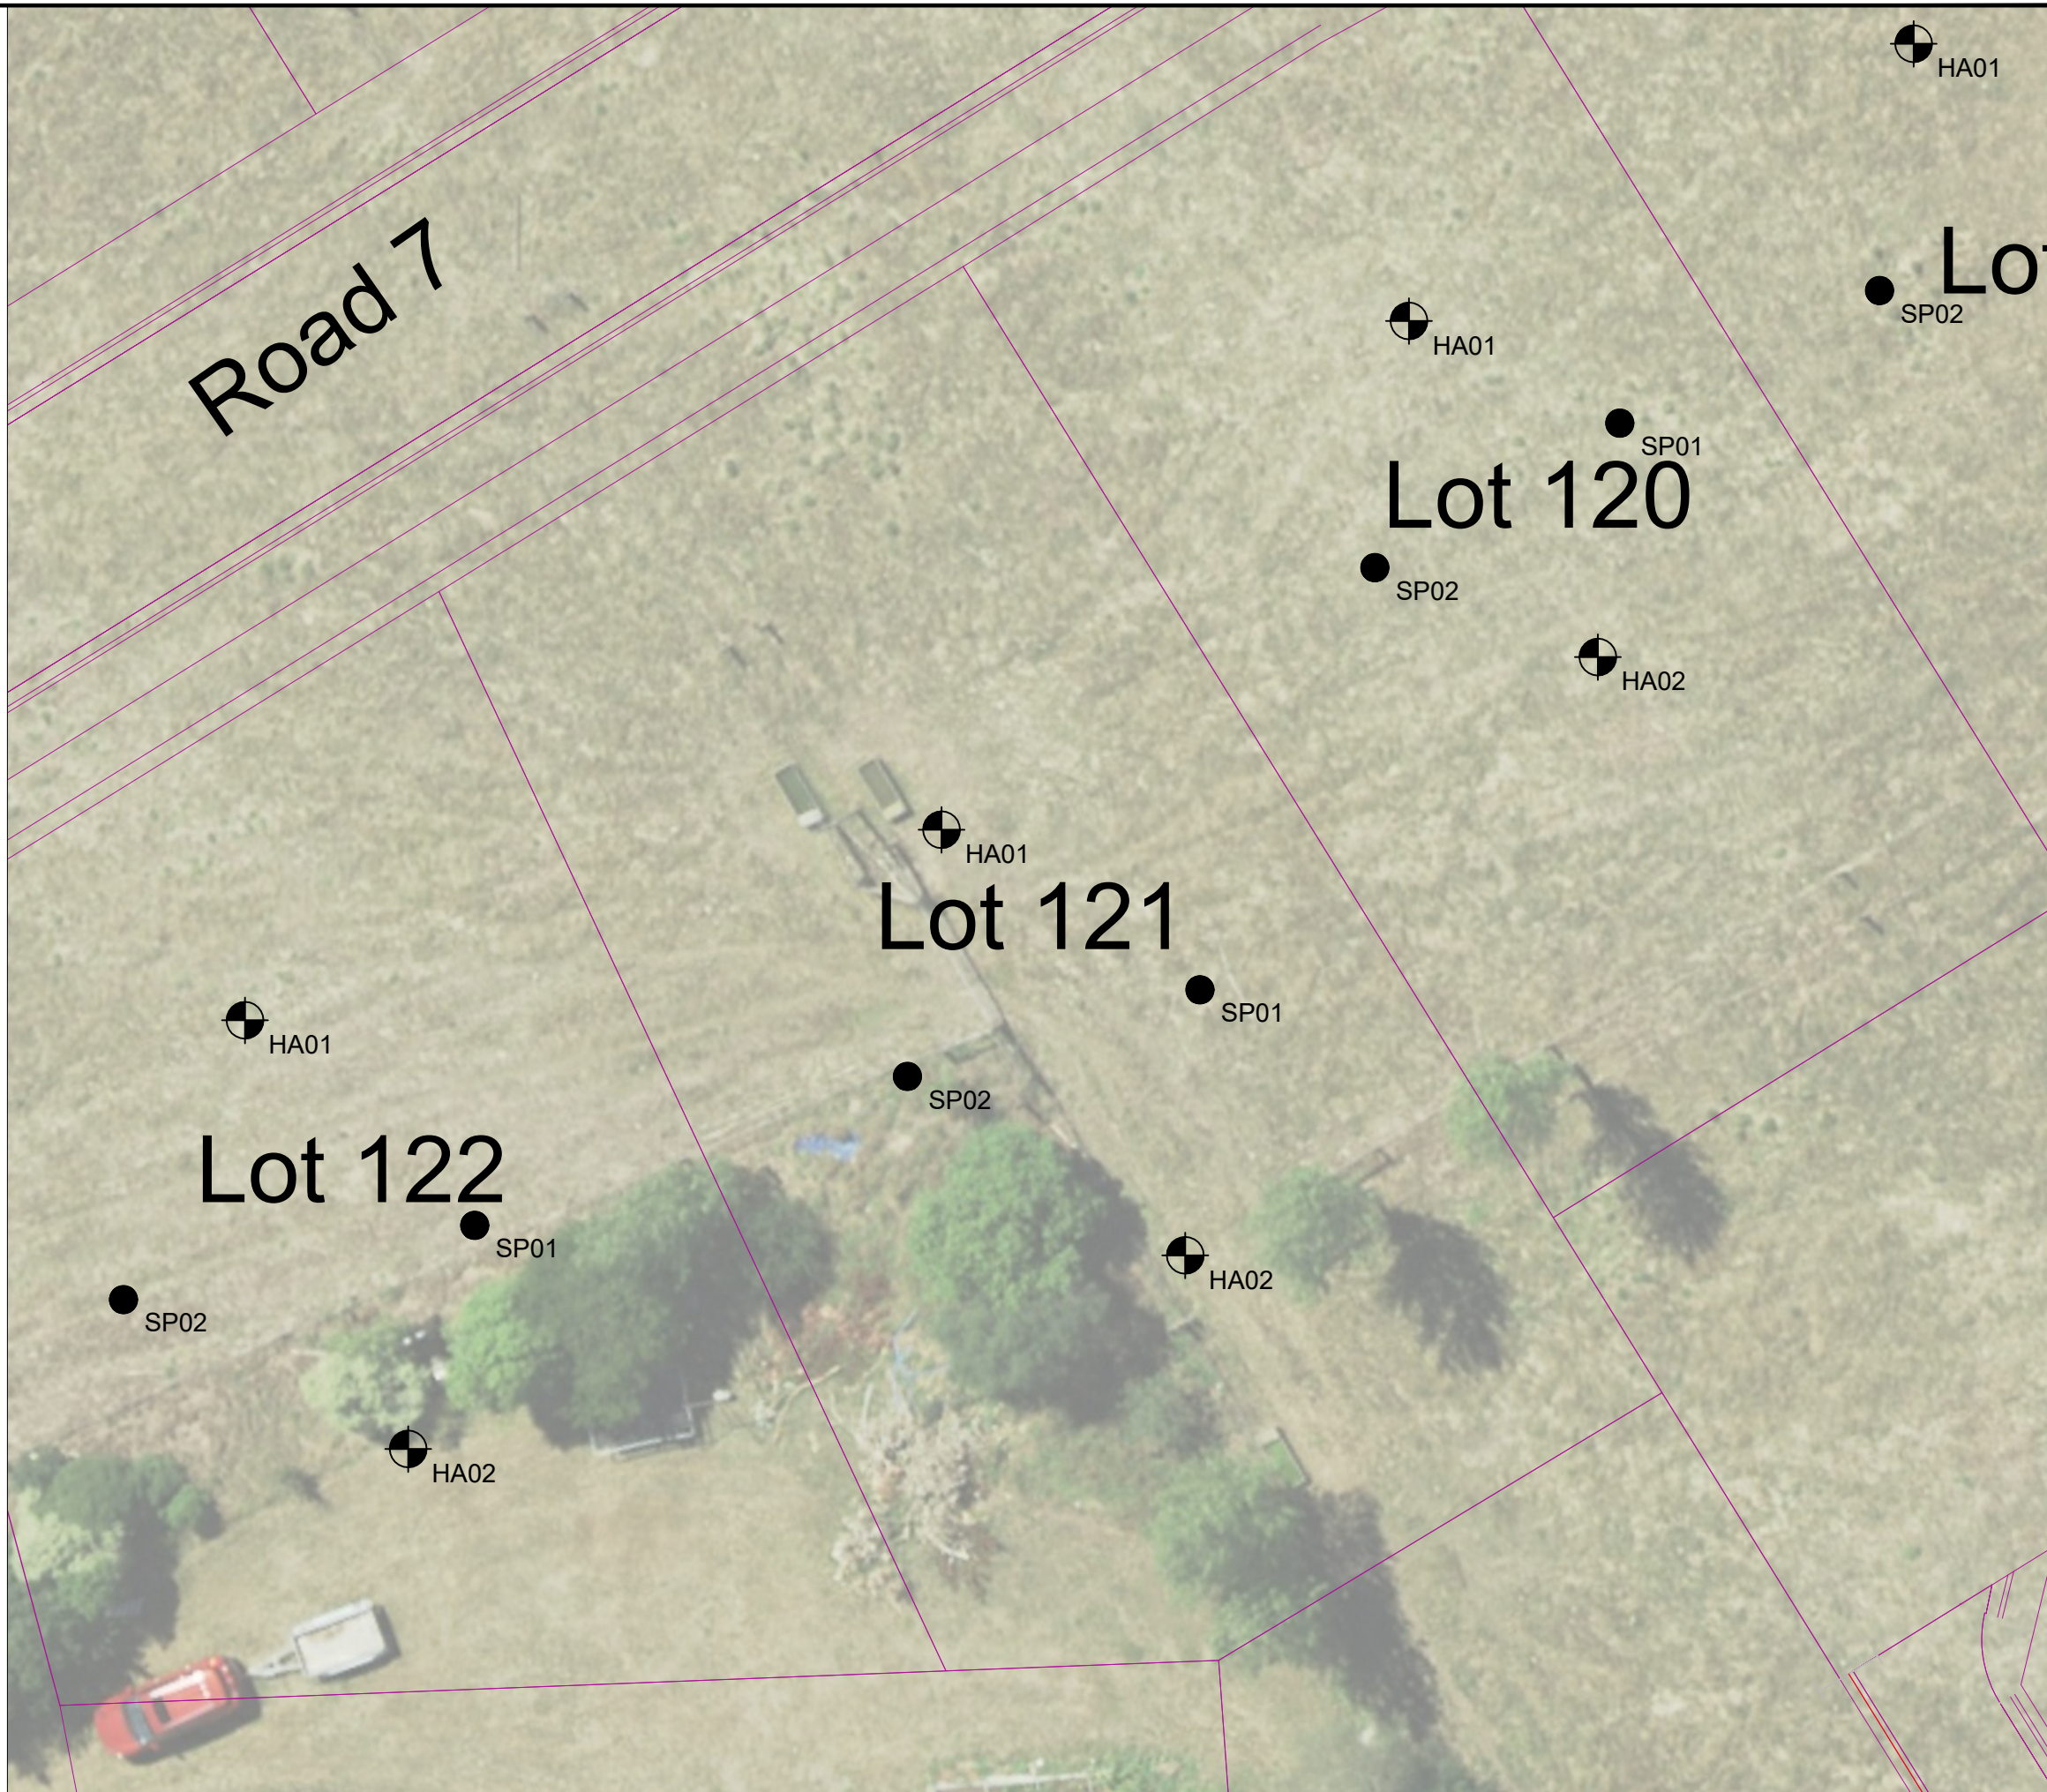
**Test Location Plan**  
 Lot 121, 138 Dunns Crossing Road  
 ROLLESTON

The hand auger holes encountered topsoil/fill material from the ground surface to approximately 0.1m depths, underlain by inferred natural gravel. Groundwater was not encountered during testing. Scala Penetrometer testing at each of the four locations returned results between 3 and 40+ blows per 100mm penetration at the test positions, encountering refusal at depths between 0.5m and 0.6m below present ground level.
