28 October 2022

Project No: LTC22215

**RE: SHALLOW SOIL TEST REPORT  
LOT 208, 138 & 5/144 DUNNS CROSSING ROAD**

Lot 208, 138 Dunns Crossing Road  
ROLLESTON

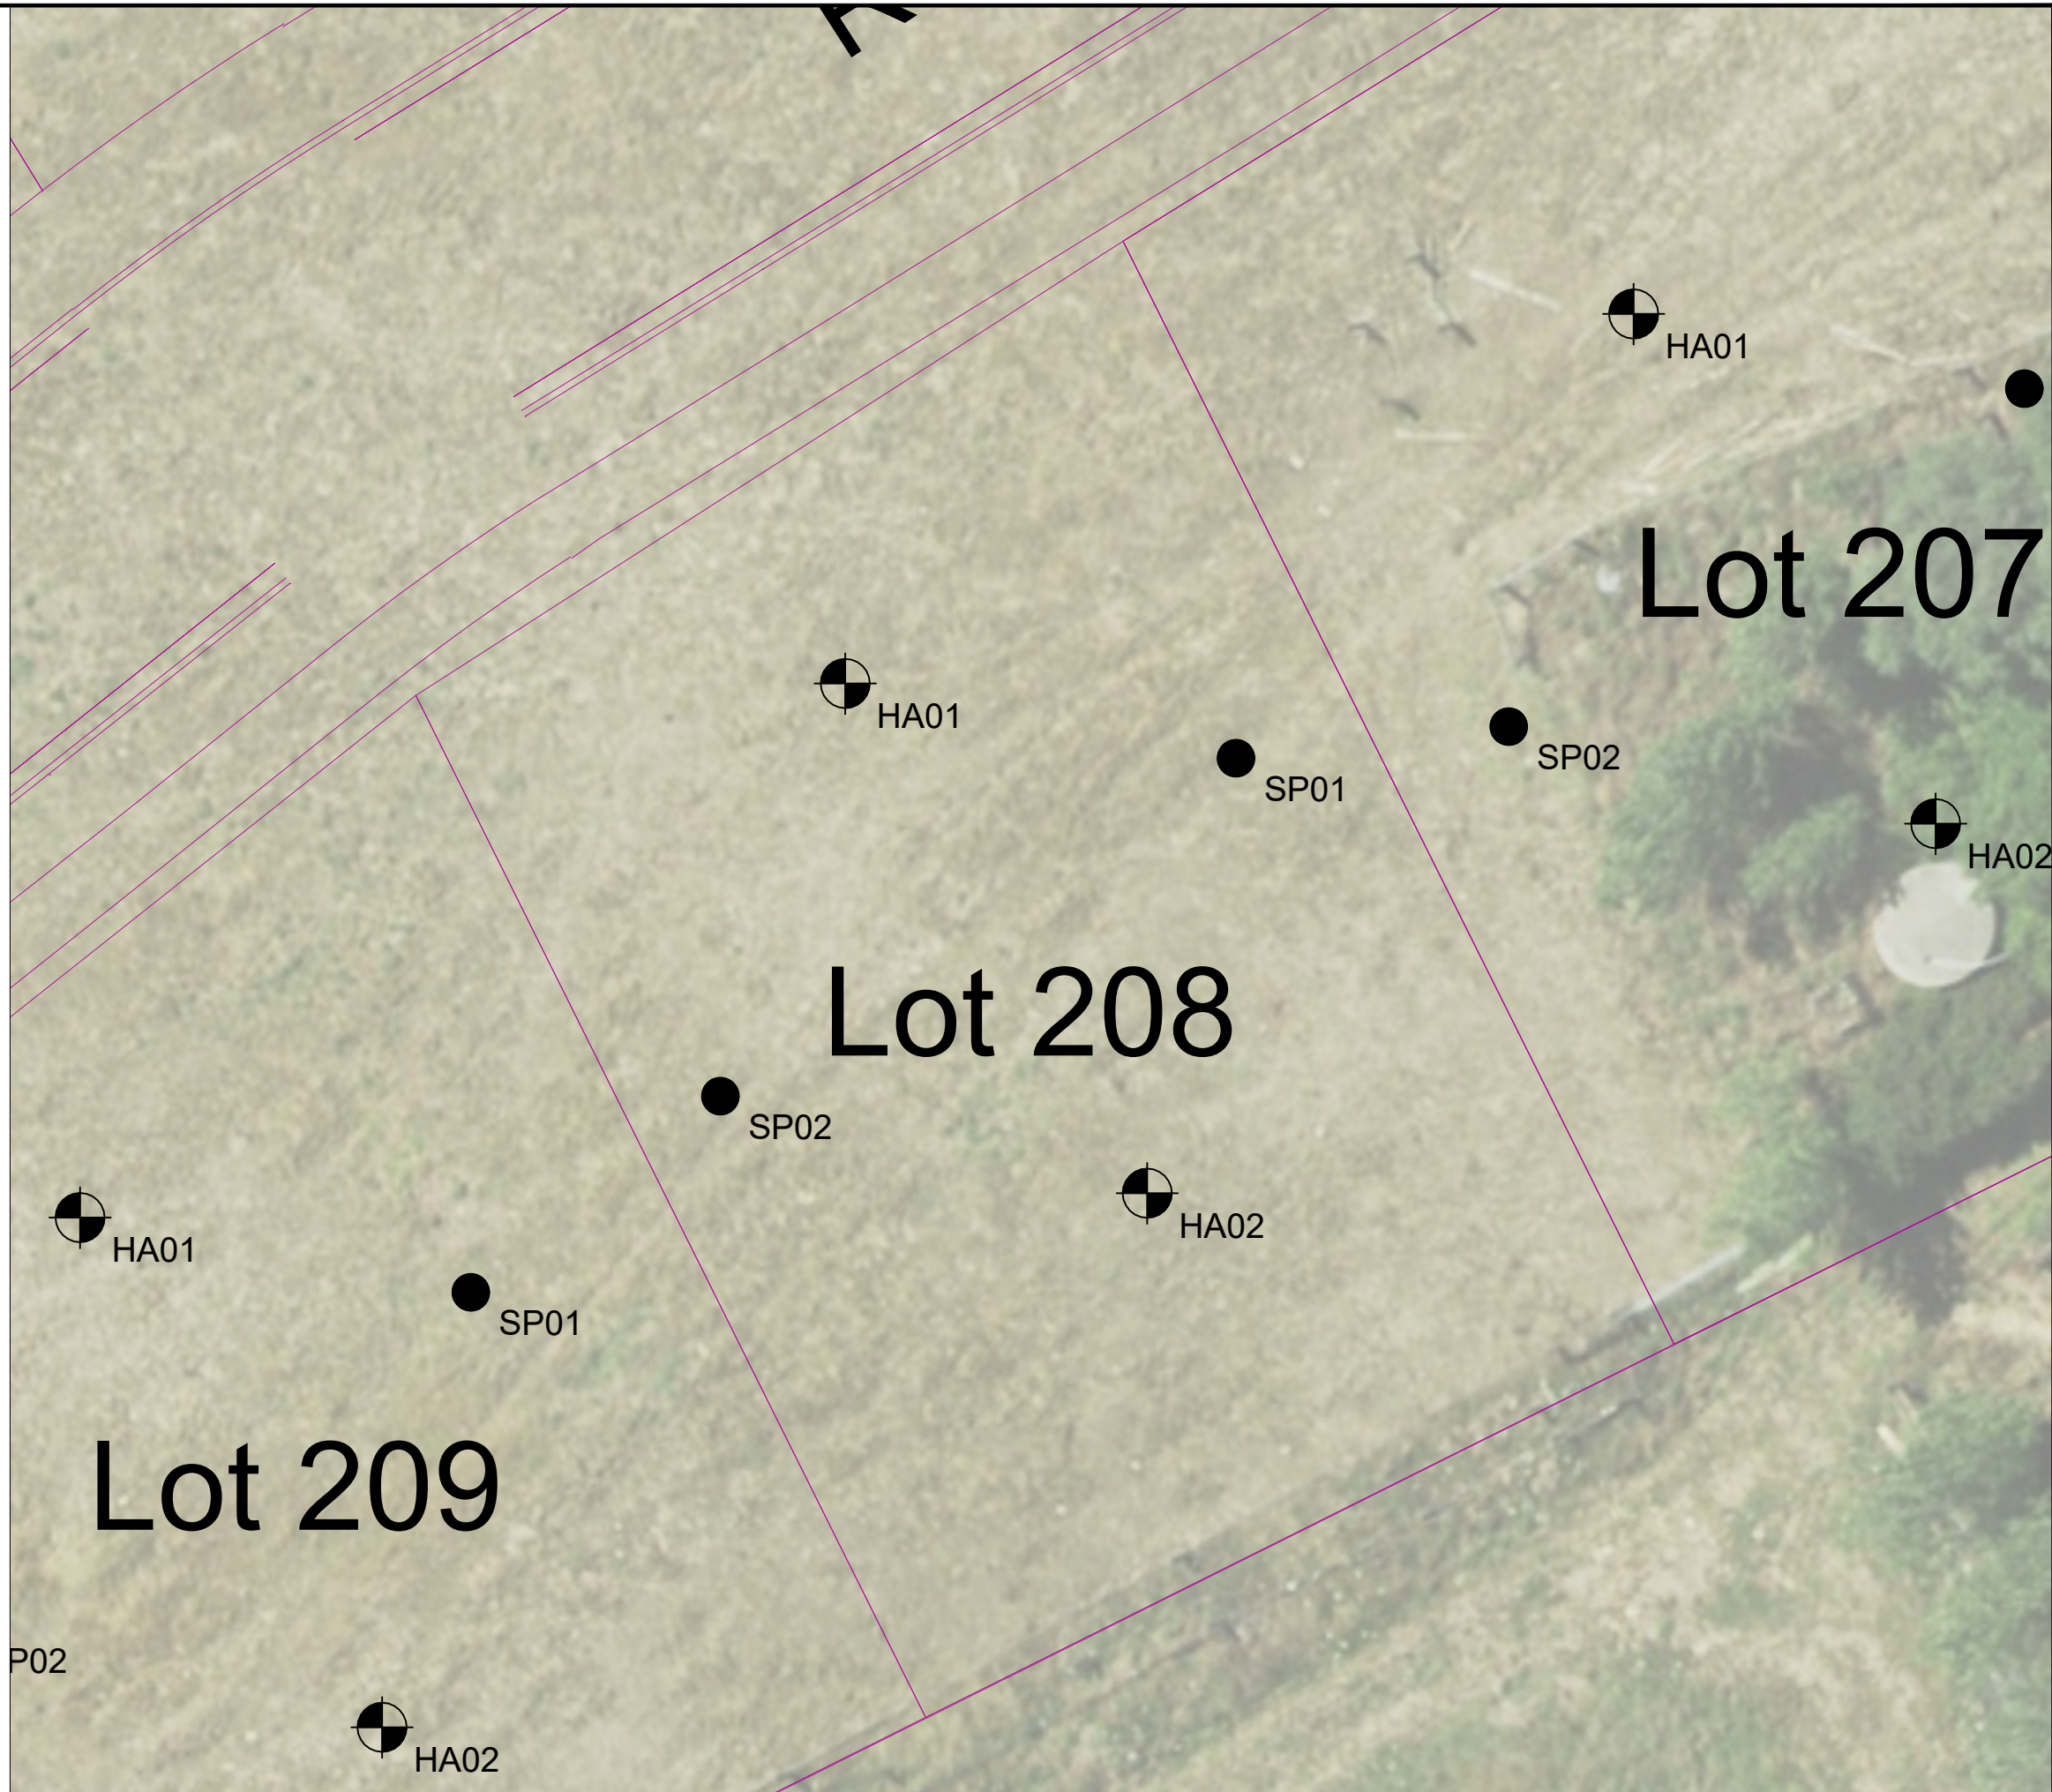
**Test Location Plan**

LandTech investigated the site on 26 October 2022, comprising two hand auger holes with corresponding Scala Penetrometer tests and two additional Scala Penetrometer tests. The test locations were measured from lot boundaries and/or surveyed centre pegs and are approximate only. The test locations are shown on the LandTech *Test Location Plan*, Drawing No. Lot 208/ TLP attached to this report.
