Project No: LTC22215

**RE: SHALLOW SOIL TEST REPORT  
LOT 112, 138 DUNNS CROSSING ROAD**

Lot 112, 138 Dunns Crossing Road  
 ROLLESTON

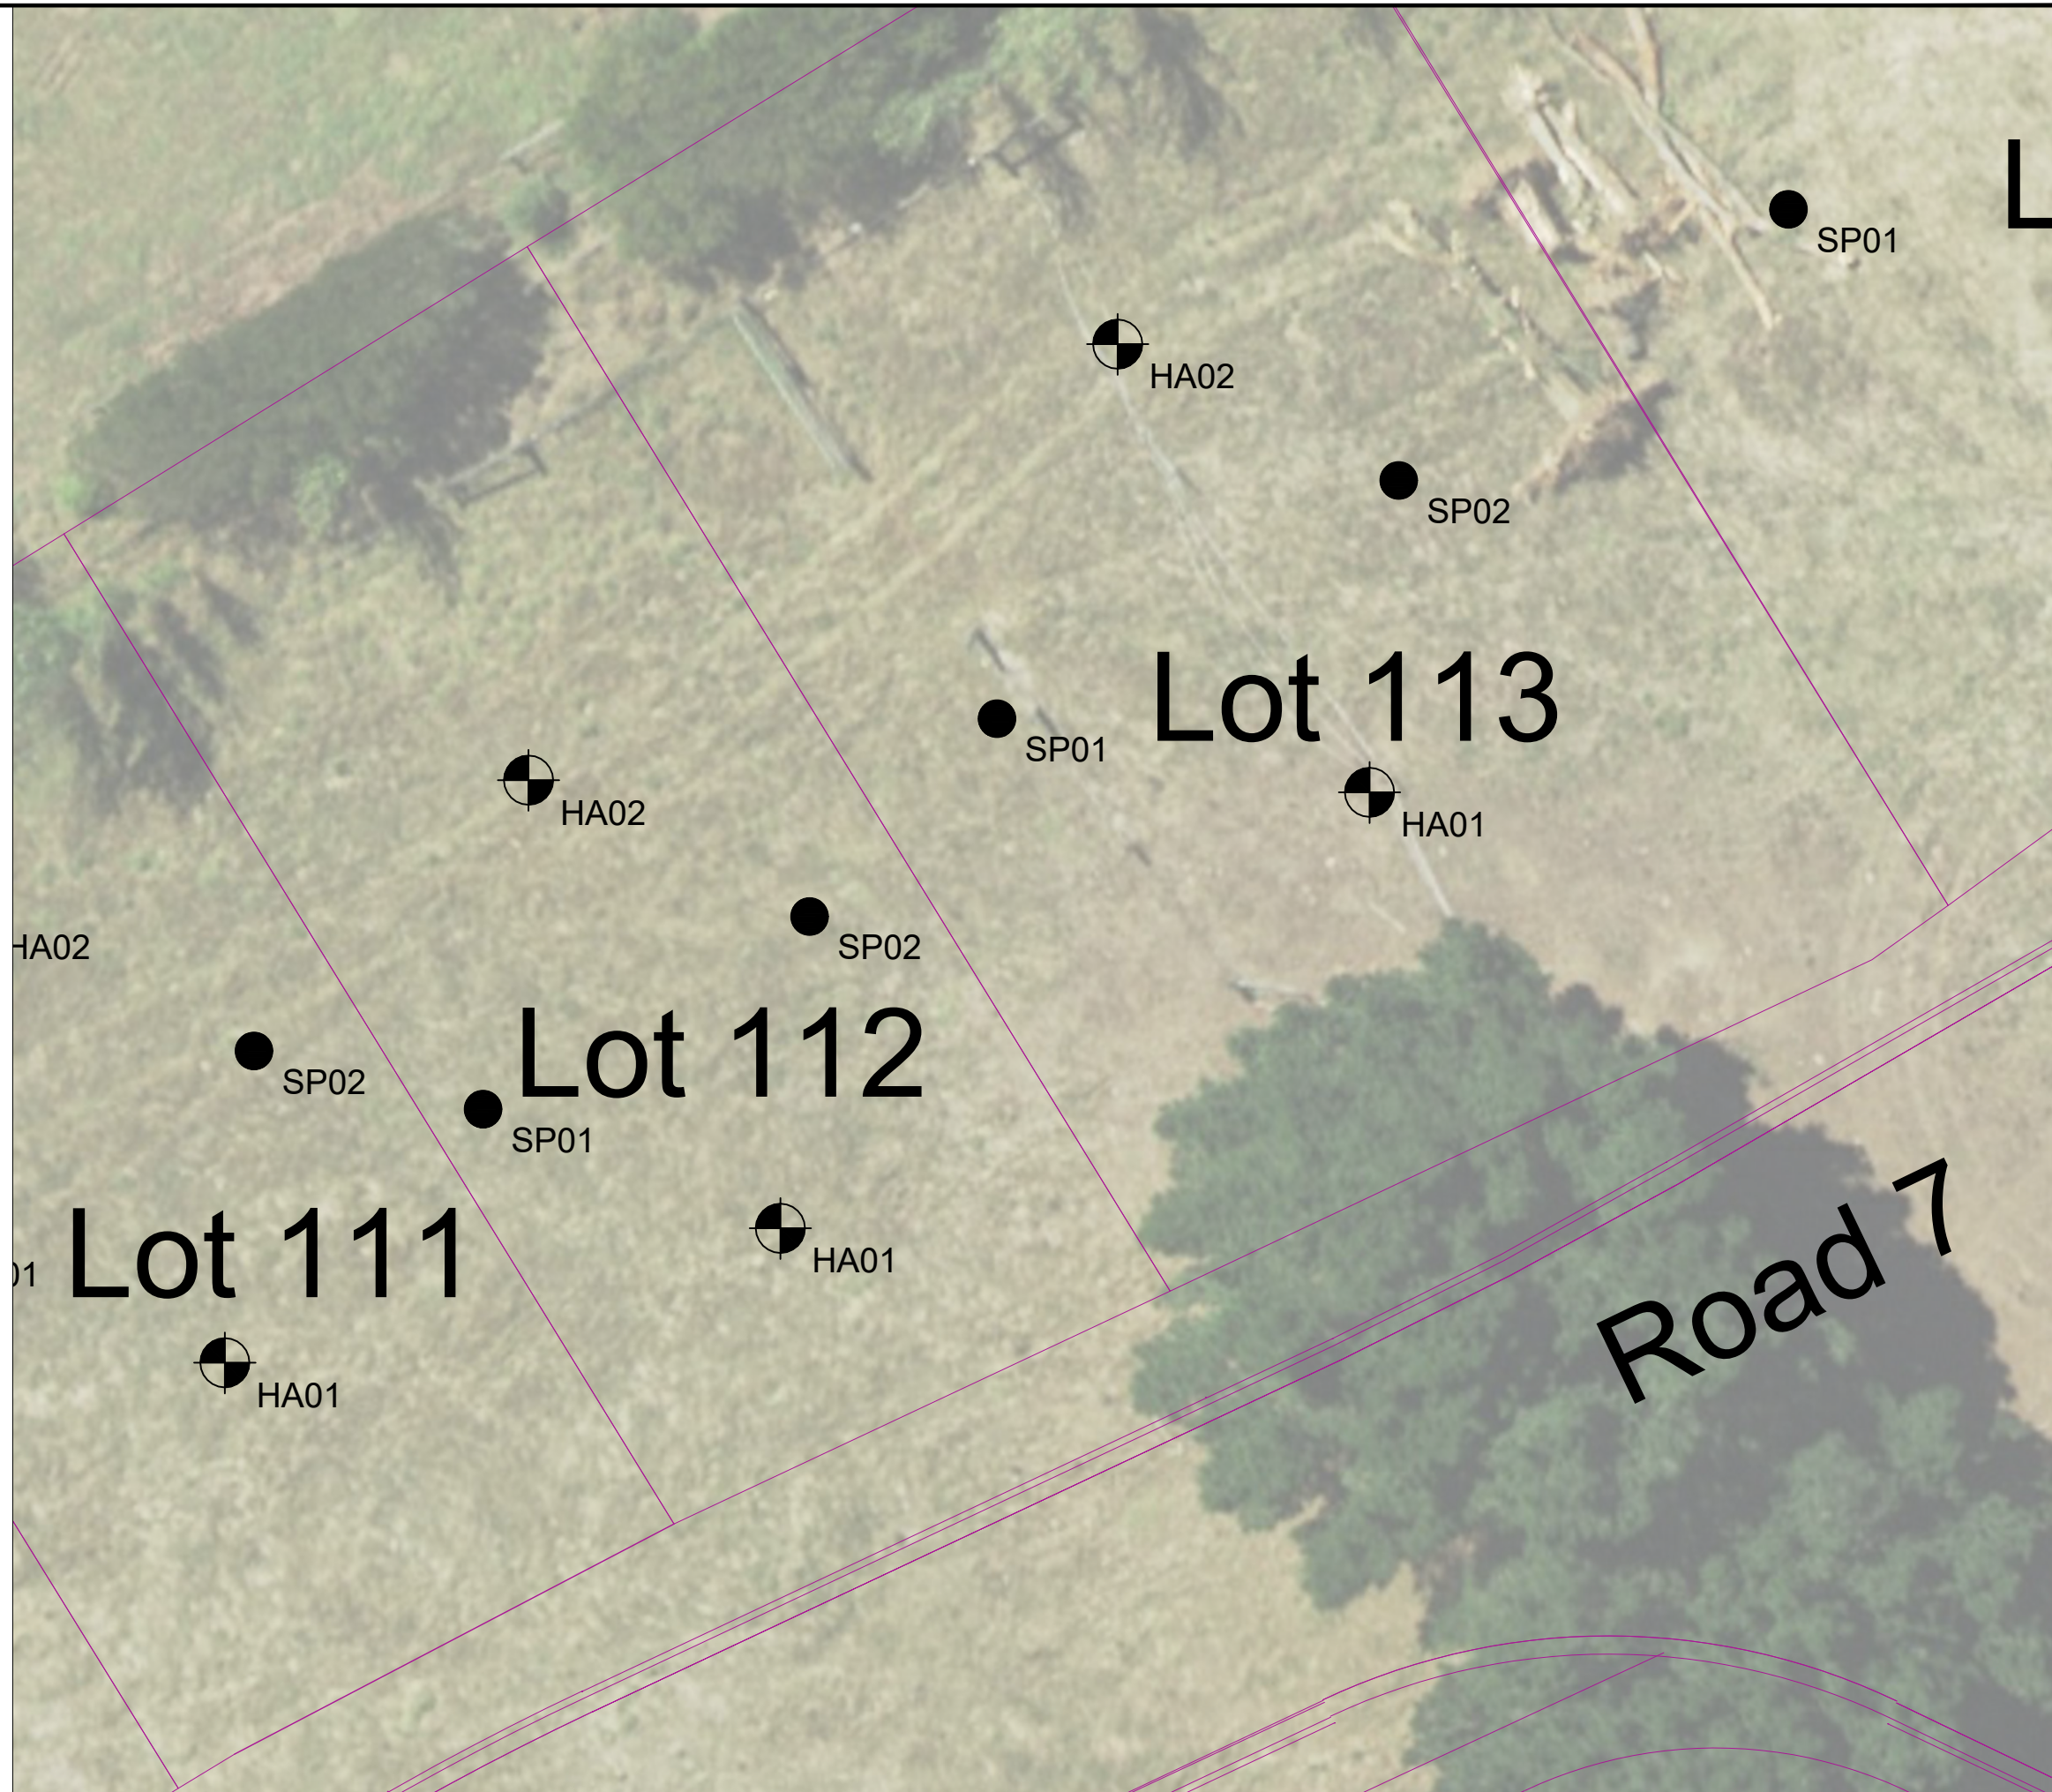
**Test Location Plan**

LandTech investigated the site on 16 September 2022, comprising two hand auger holes with corresponding Scala Penetrometer tests and two additional Scala Penetrometer tests. The test locations were measured from lot boundaries and/or surveyed centre pegs and are approximate only. The test locations are shown on the LandTech *Test Location Plan*, Drawing No. Lot 112/ TLP attached to this report.

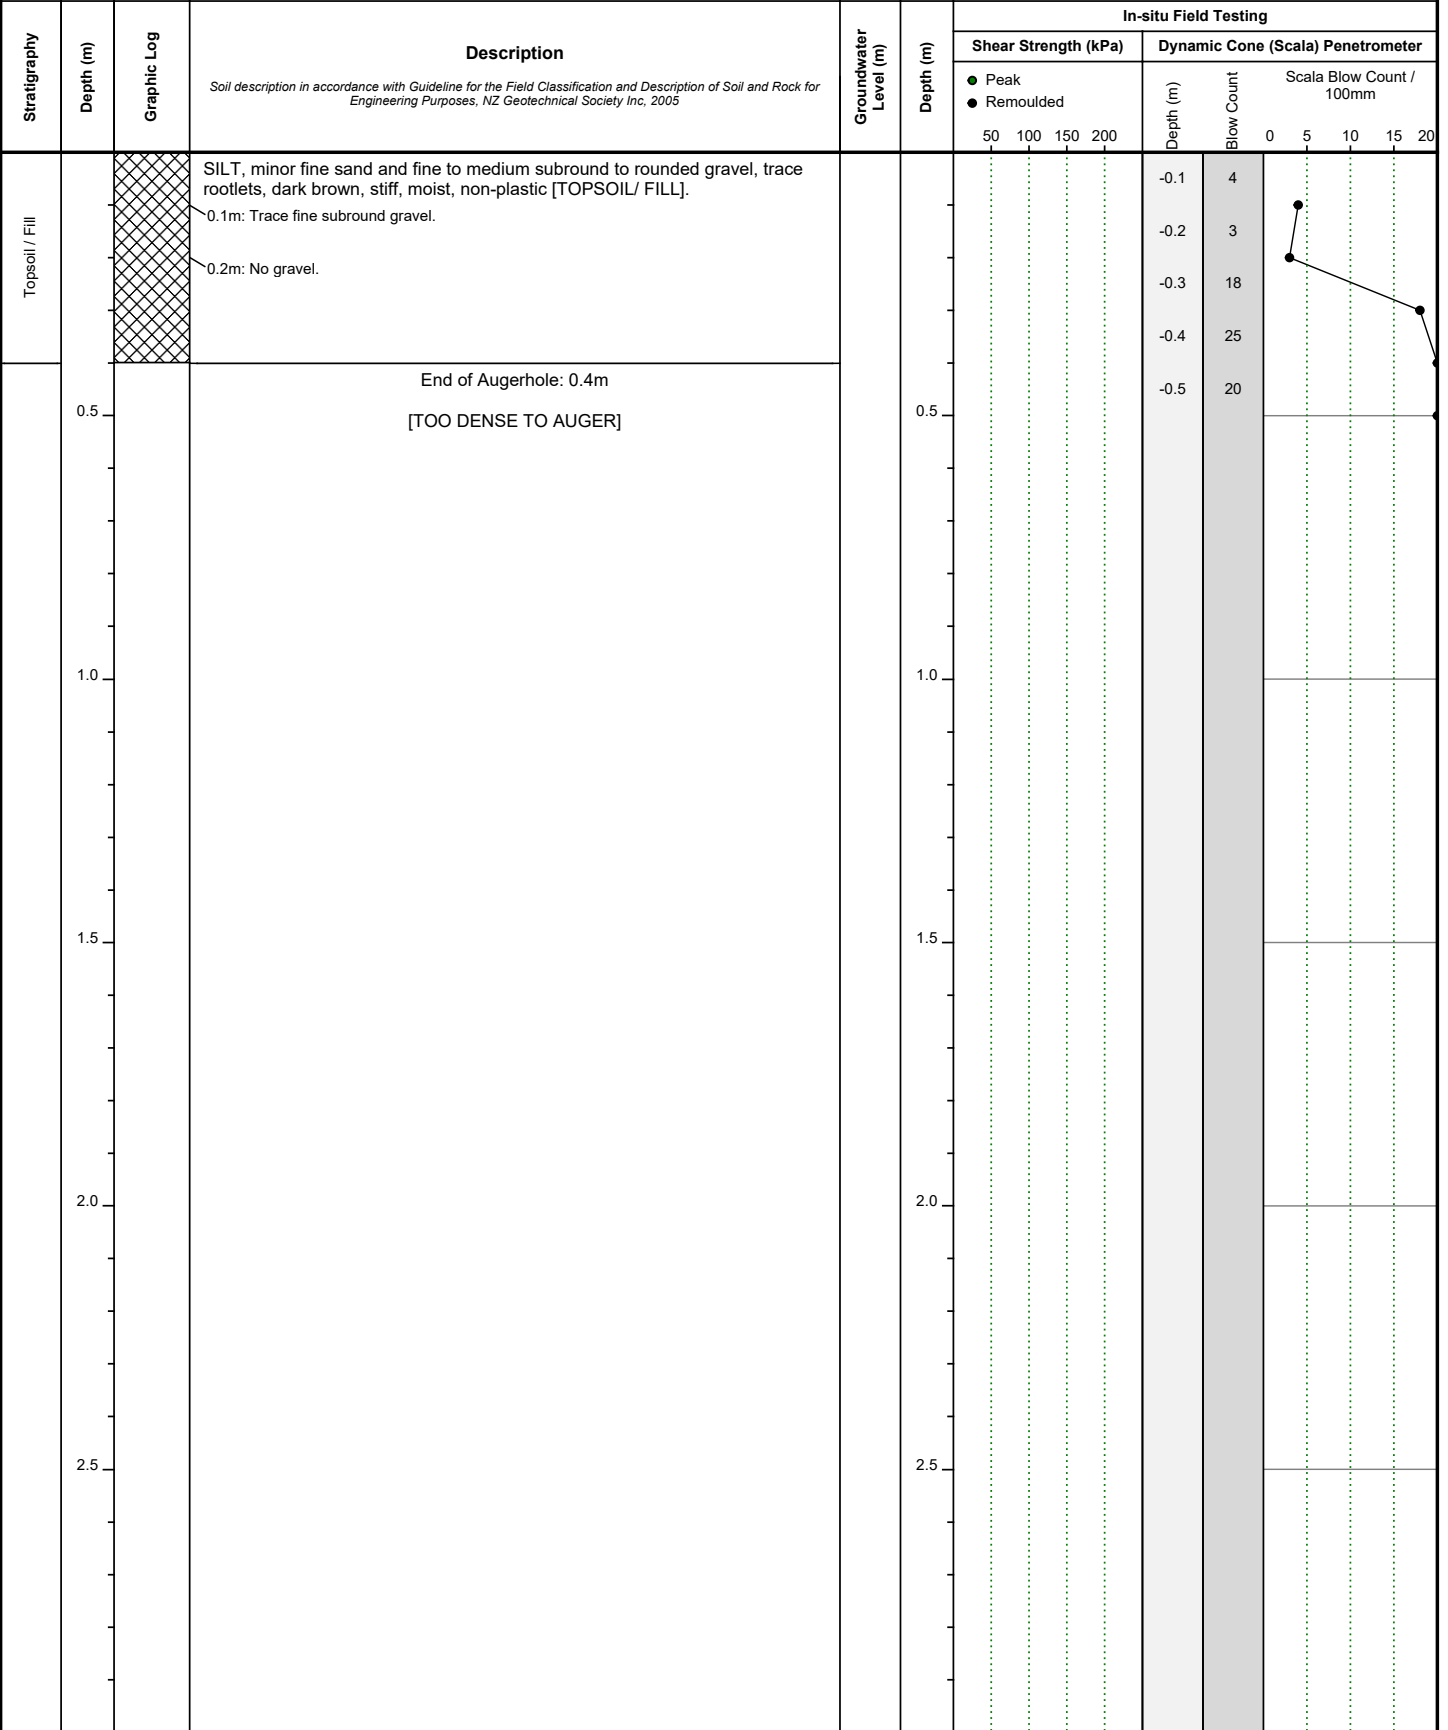
**Augerhole No.:** Lot 112 - HA02

Inferred gravels      In-situ testing in accordance with the following standards:  
 Scala Penetrometer Testing: NZS 4402:1988, Test 6.5.2, Dynamic Cone Penetrometer  
 Shear Vane Testing: Guideline for Hand Held Shear Vane Test, NZGS, August 2001

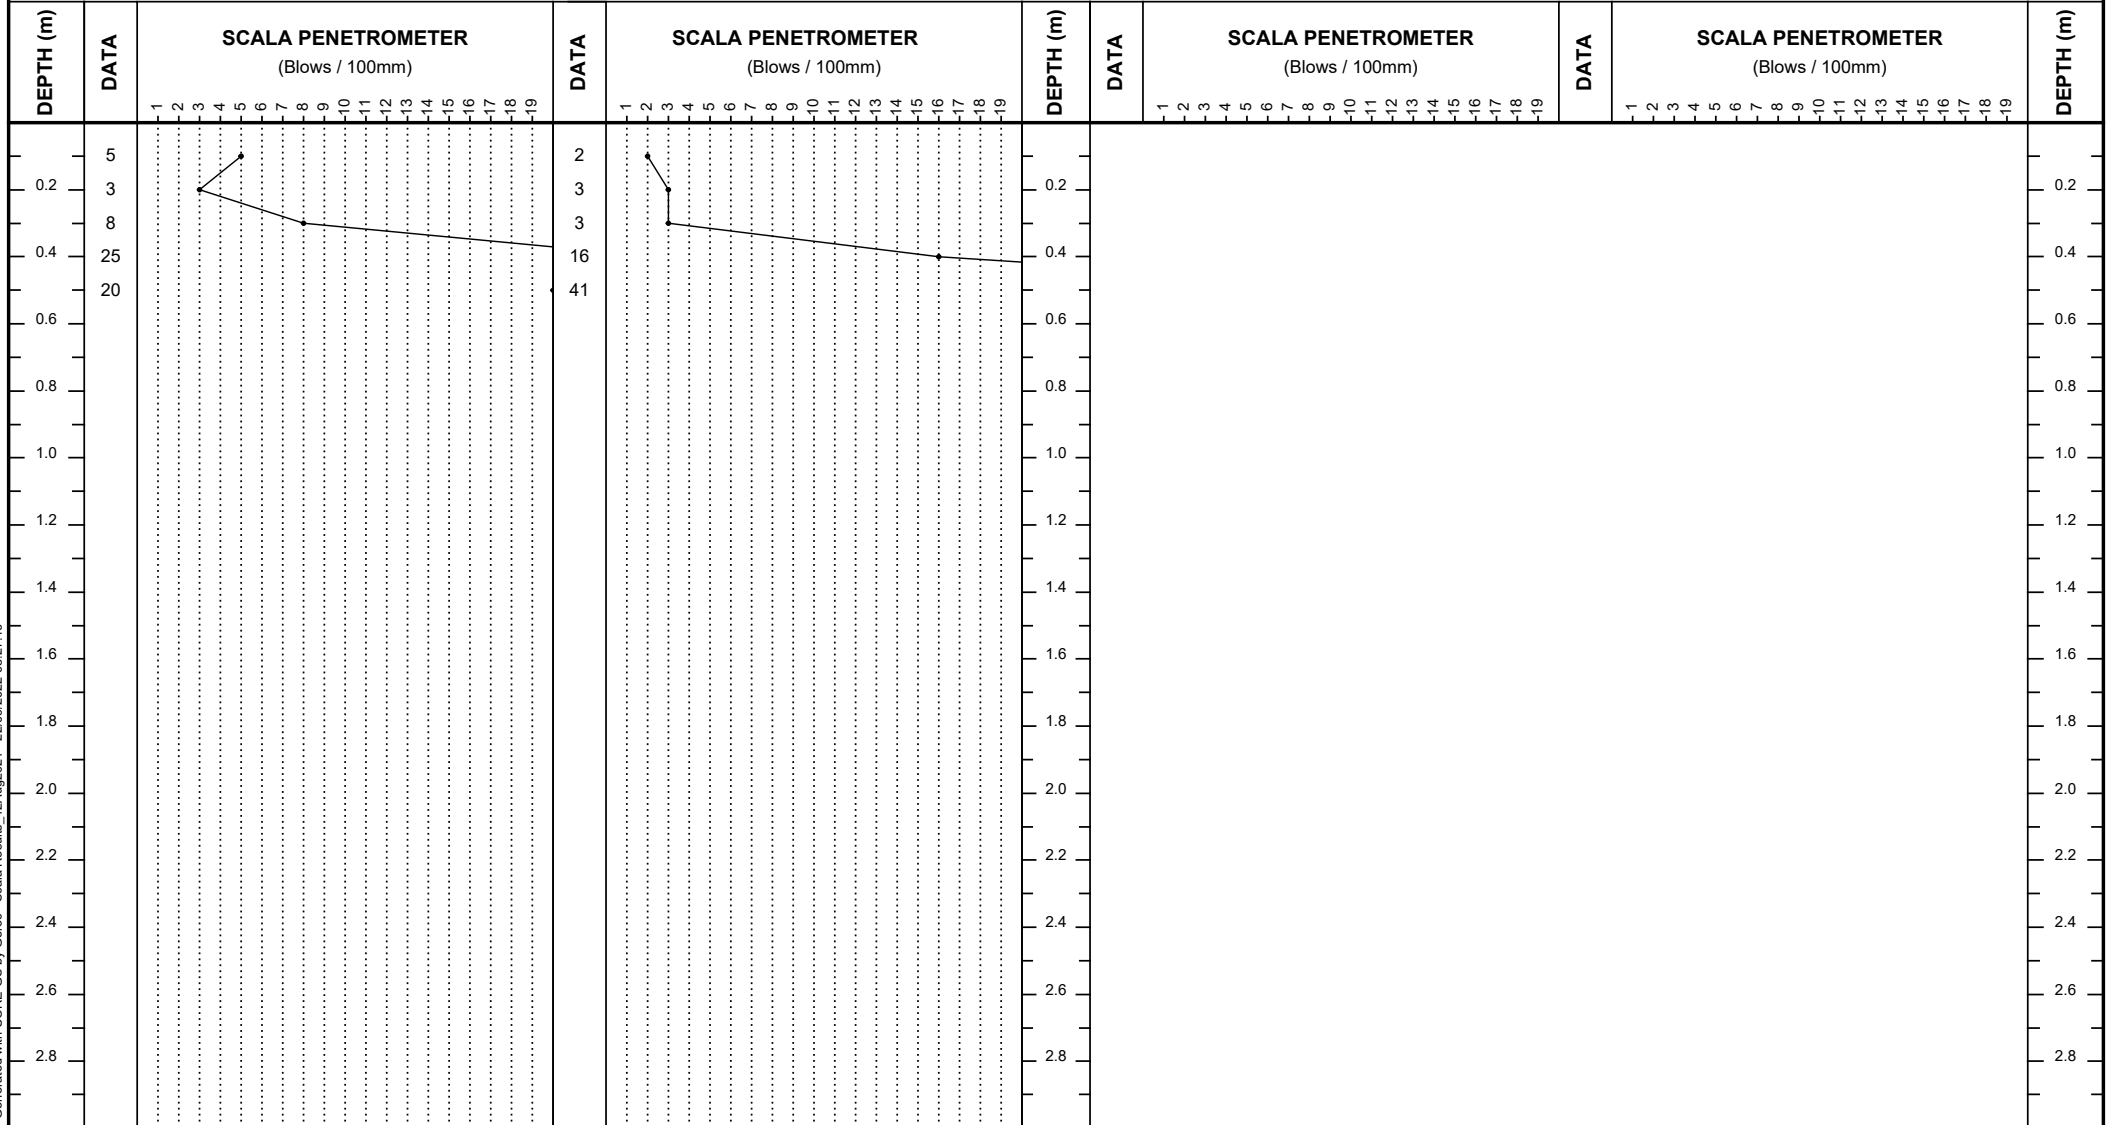
**Lot 112 - SP01**

The hand auger holes encountered topsoil/fill material from the ground surface to approximately 0.1m to 0.4m depths, underlain by inferred natural gravel. Groundwater was not encountered during testing. Scala Penetrometer testing at each of the four locations returned results between 3 and 40+ blows per 100mm penetration at the test positions, encountering refusal at depths between 0.5m and 0.6m below present ground level.
