Project No: LTC22215

**RE: SHALLOW SOIL TEST REPORT
LOT 110, 138 DUNNS CROSSING ROAD**

Test Location Plan
 Lot 110, 138 Dunns Crossing Road
 ROLLESTON

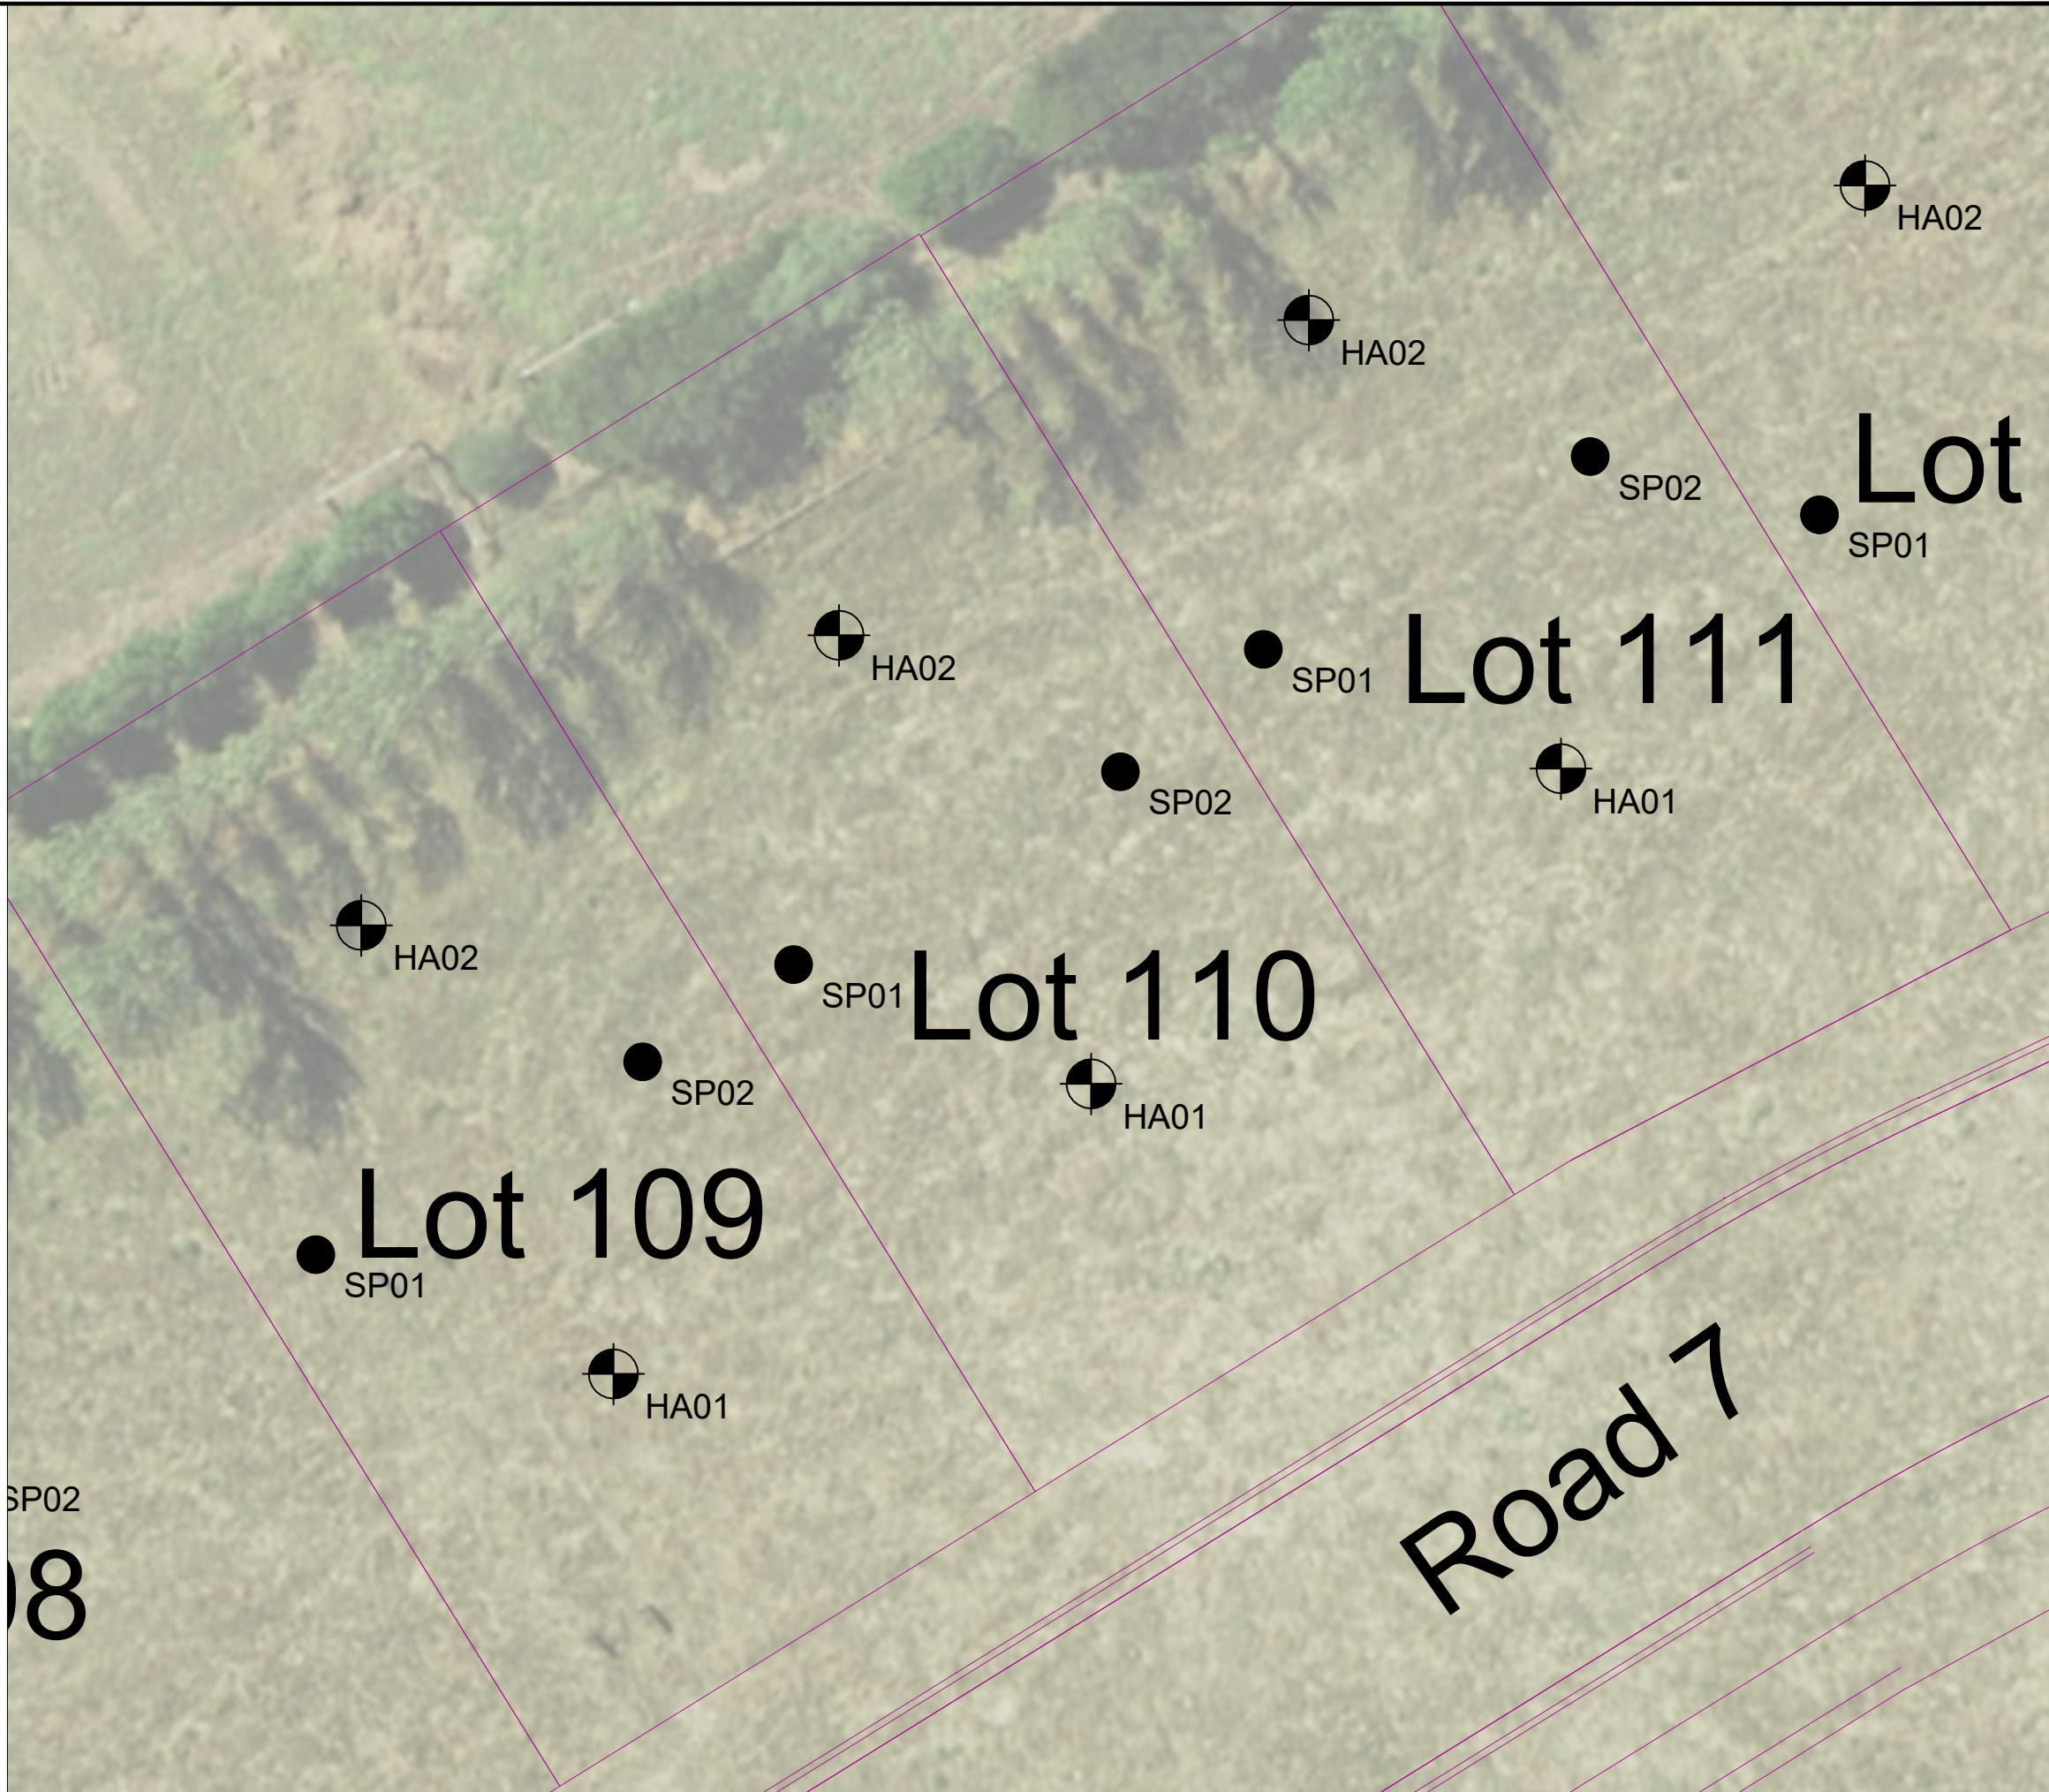
LandTech investigated the site on 16 September 2022, comprising two hand auger holes with corresponding Scala Penetrometer tests and two additional Scala Penetrometer tests. The test locations were measured from lot boundaries and/or surveyed centre pegs and are approximate only. The test locations are shown on the LandTech *Test Location Plan*, Drawing No. Lot 110/ TLP attached to this report.
