Project No: LTC22215

**RE: SHALLOW SOIL TEST REPORT
LOT 116, 138 DUNNS CROSSING ROAD**

Test Location Plan
 Lot 116, 138 Dunns Crossing Road
 ROLLESTON

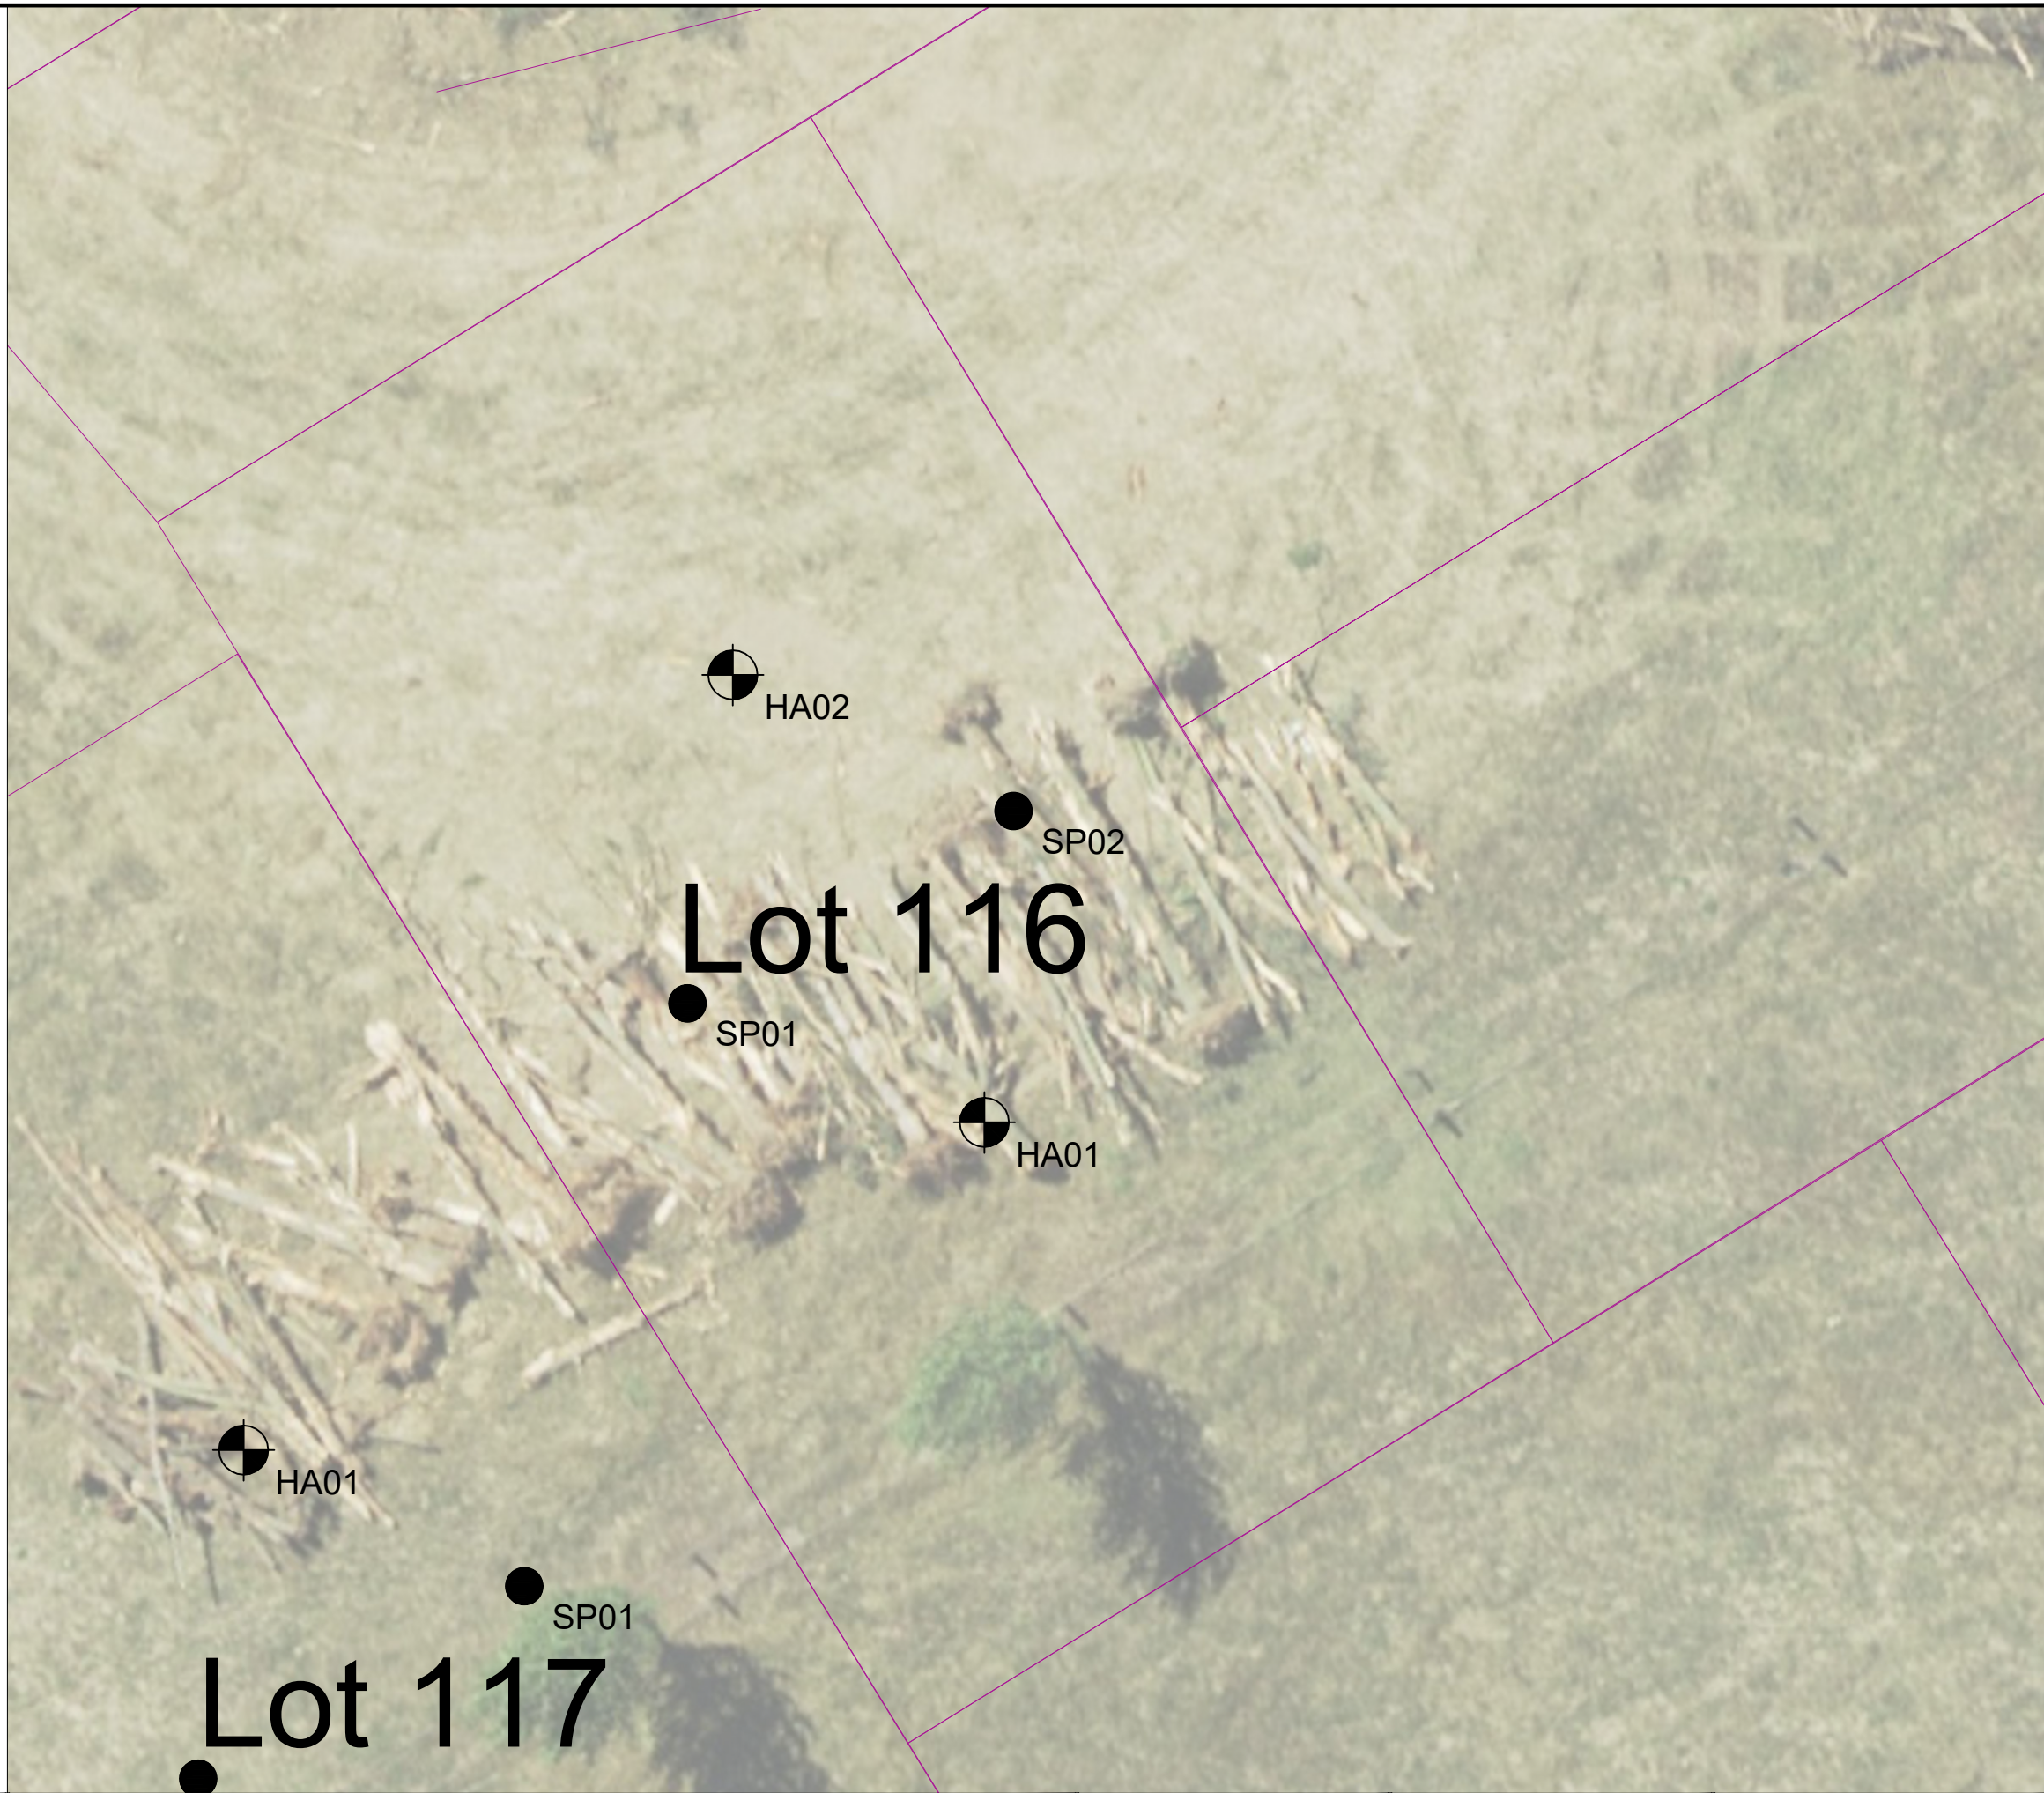
LandTech investigated the site on 16 September 2022, comprising two hand auger holes with corresponding Scala Penetrometer tests and two additional Scala Penetrometer tests. The test locations were measured from lot boundaries and/or surveyed centre pegs and are approximate only. The test locations are shown on the LandTech *Test Location Plan*, Drawing No. Lot 116/ TLP attached to this report.
