Project No: LTC22215

**RE: SHALLOW SOIL TEST REPORT
LOT 213, 138 & 5/144 DUNNS CROSSING ROAD**

Test Location Plan
 Lot 213, 138 Dunns Crossing Road
 ROLLESTON

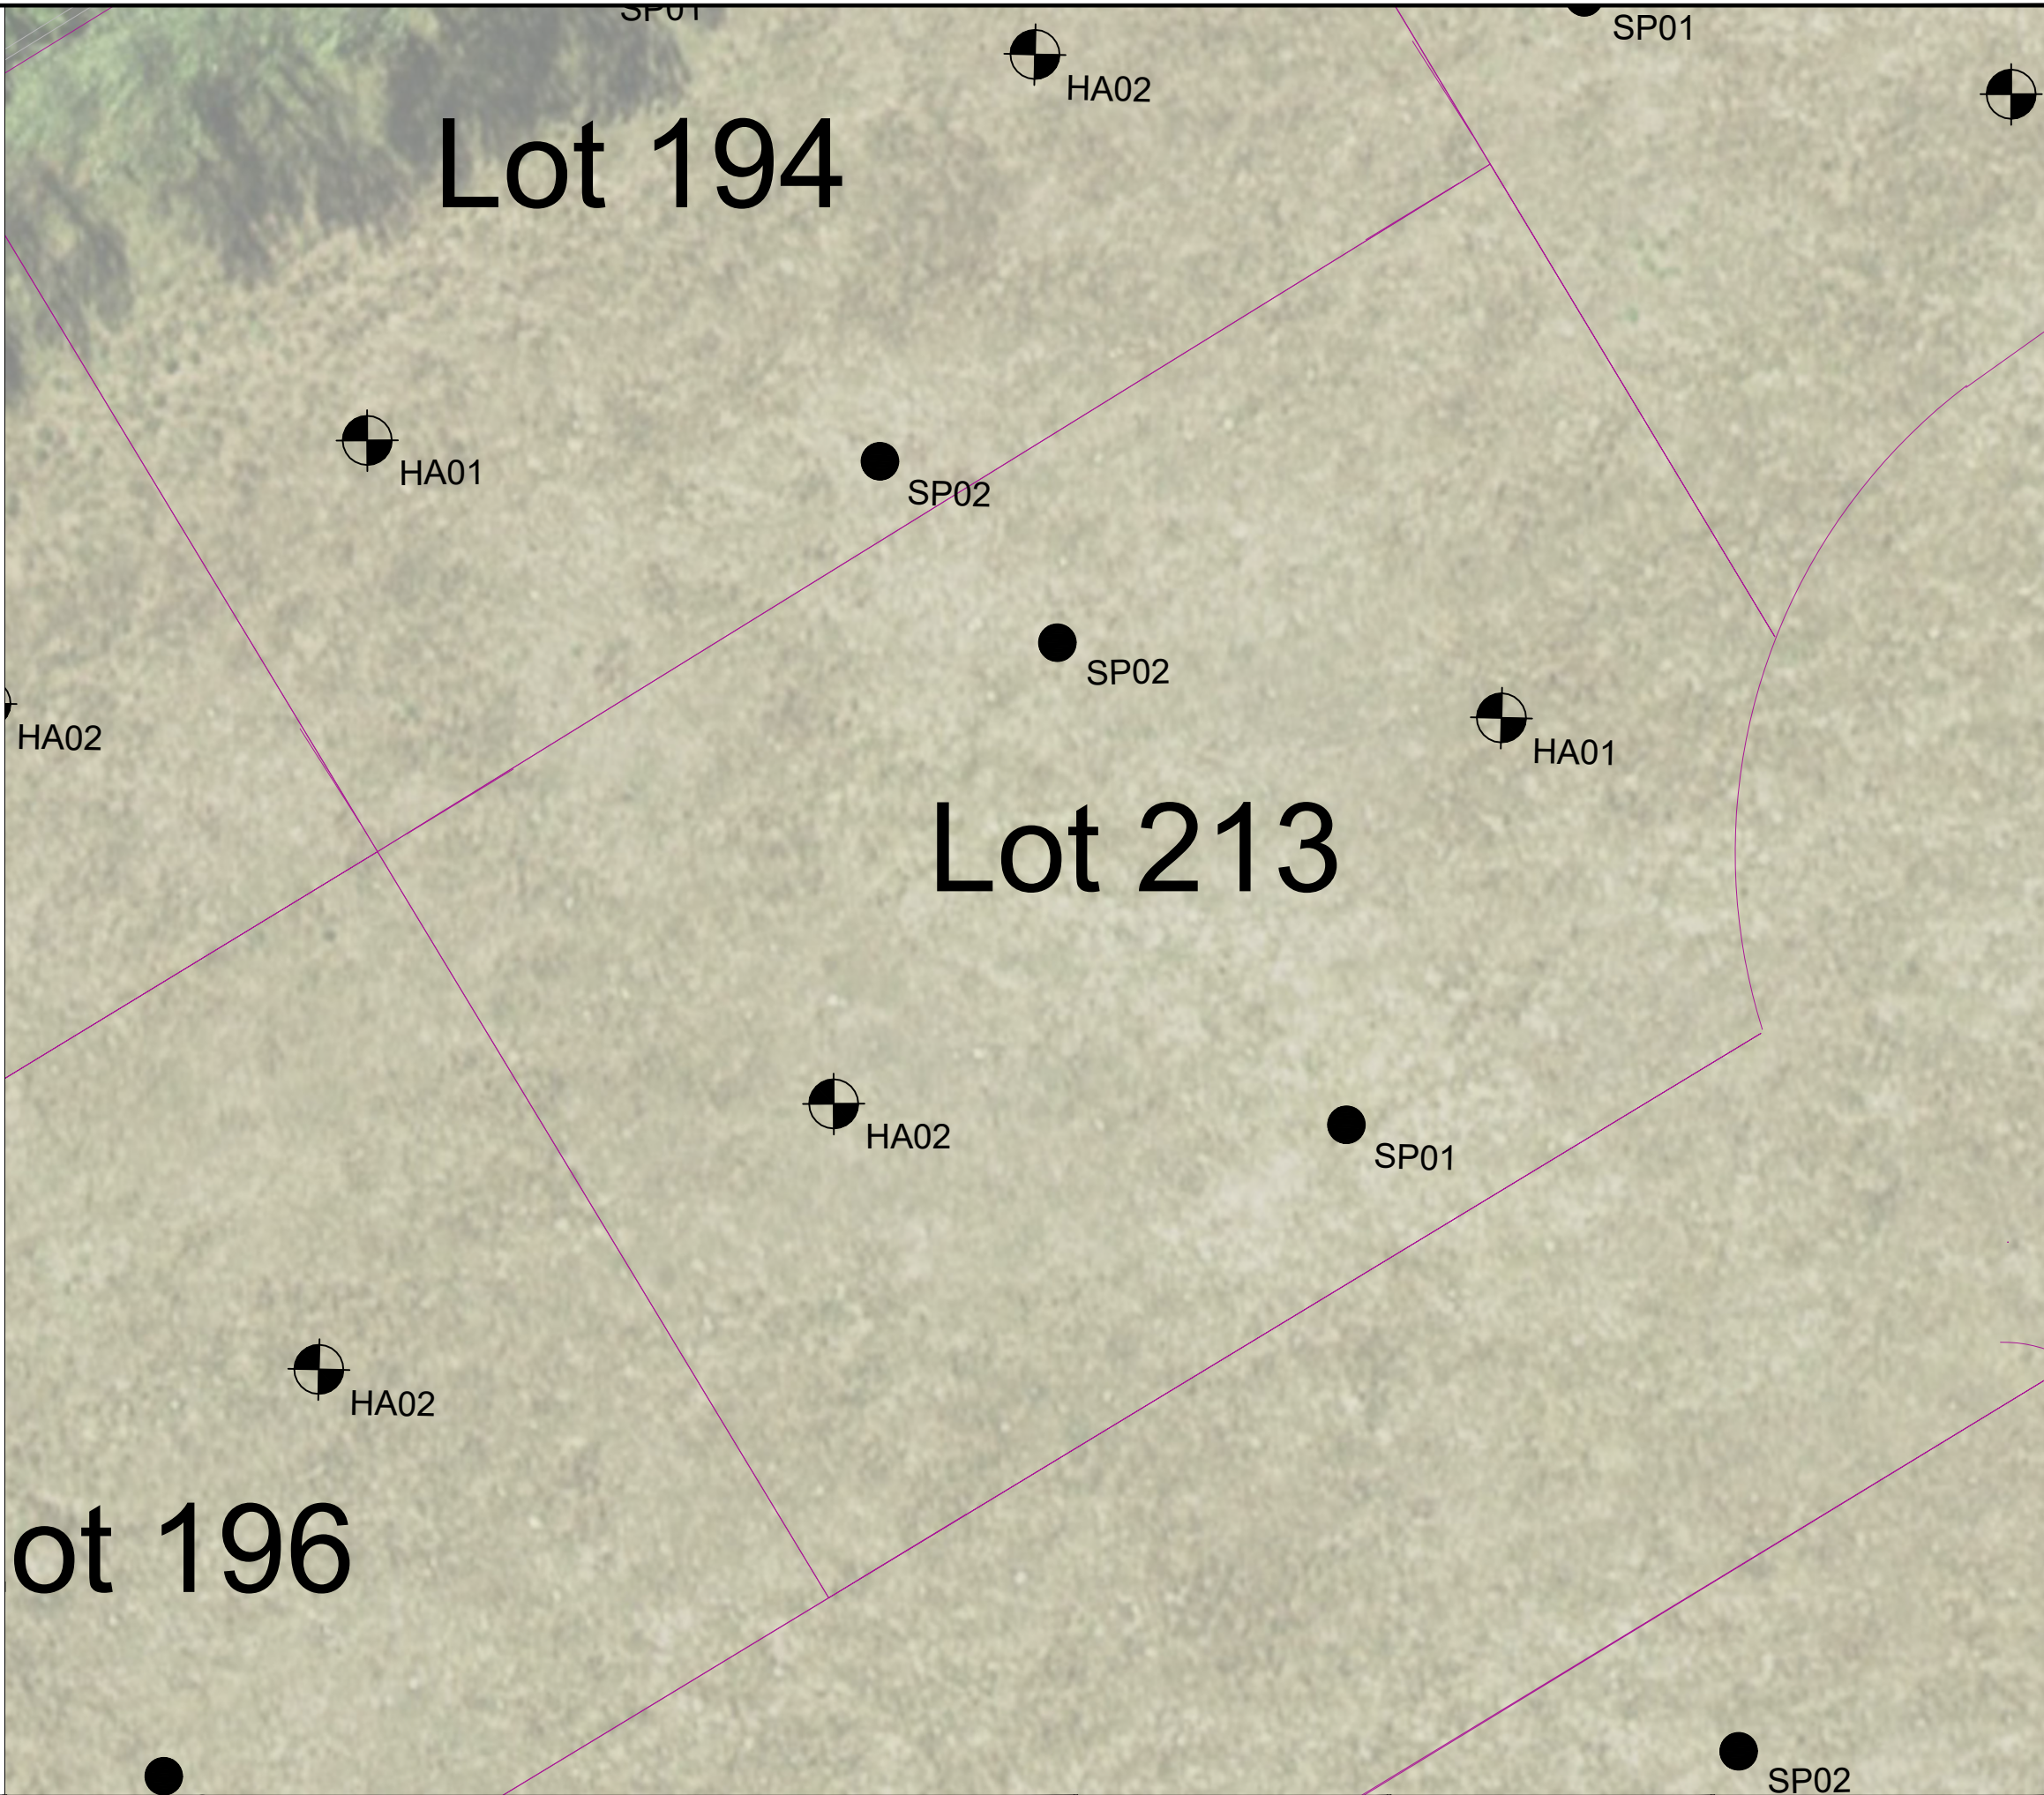
Drawing No: Lot 213/TLP	Drawn by: KB	Date: 26 October 2022
Scale: 1: 150 (A3)	Checked by: DW	Revision: A
Filename: LTC22215 - Master Plan Drawings.dwg

LandTech investigated the site on 26 October 2022, comprising two hand auger holes with corresponding Scala Penetrometer tests and two additional Scala Penetrometer tests. The test locations were measured from lot boundaries and/or surveyed centre pegs and are approximate only. The test locations are shown on the LandTech *Test Location Plan*, Drawing No. Lot 213/ TLP attached to this report.

The hand auger holes encountered topsoil/fill material from the ground surface to approximately 0.1m to 0.2m depths, underlain by inferred natural gravel. Groundwater was not encountered during testing. Scala Penetrometer testing at each of the four locations returned results between 3 and 40+ blows per 100mm penetration at the test positions, encountering refusal at depths between 0.3m and 0.6m below present ground level.

The two hand auger holes were carried out at either end of the lot; therefore, ground conditions could vary away from the test positions. Additionally, the tests refused within placed topsoil and inferred underlying natural ground. This bears the potential for greater depths of unsuitable topsoil and fill than those encountered within our hand augers, which should be considered during earthworks and foundation excavations.

From the lot-specific investigation for the site we conclude the site has “Good Ground”, and that dwelling foundations on this site can comprise NZS3604:2011 type foundations or codemark approved concrete slab foundations that are applicable for the site conditions (i.e. “good ground”). All foundations must be embedded to a minimum depth of 0.2m below ground level, into the underlying Natural Gravel or Engineered Fill. At these depths, either “Good Ground” or an Ultimate Bearing Capacity of 300kPa is available/inferred. If specific engineering design is being carried out a strength reduction factor of $\phi=0.5$ should be used. This depth has been supplied based on ground level at the time of testing. All topsoil and unsuitable materials should be removed below foundations and floor slab areas.

The subgrade should be inspected by a suitably qualified structural or geotechnical engineer or suitably experienced building inspector to confirm founding conditions meet the requirements of NZS3604:2011 “Good Ground”.
