Project No: LTC22215

**RE: SHALLOW SOIL TEST REPORT  
LOT 144, 138 DUNNS CROSSING ROAD**

Test Location Plan  
Lot 144, 138 Dunns Crossing Road  
ROLLESTON

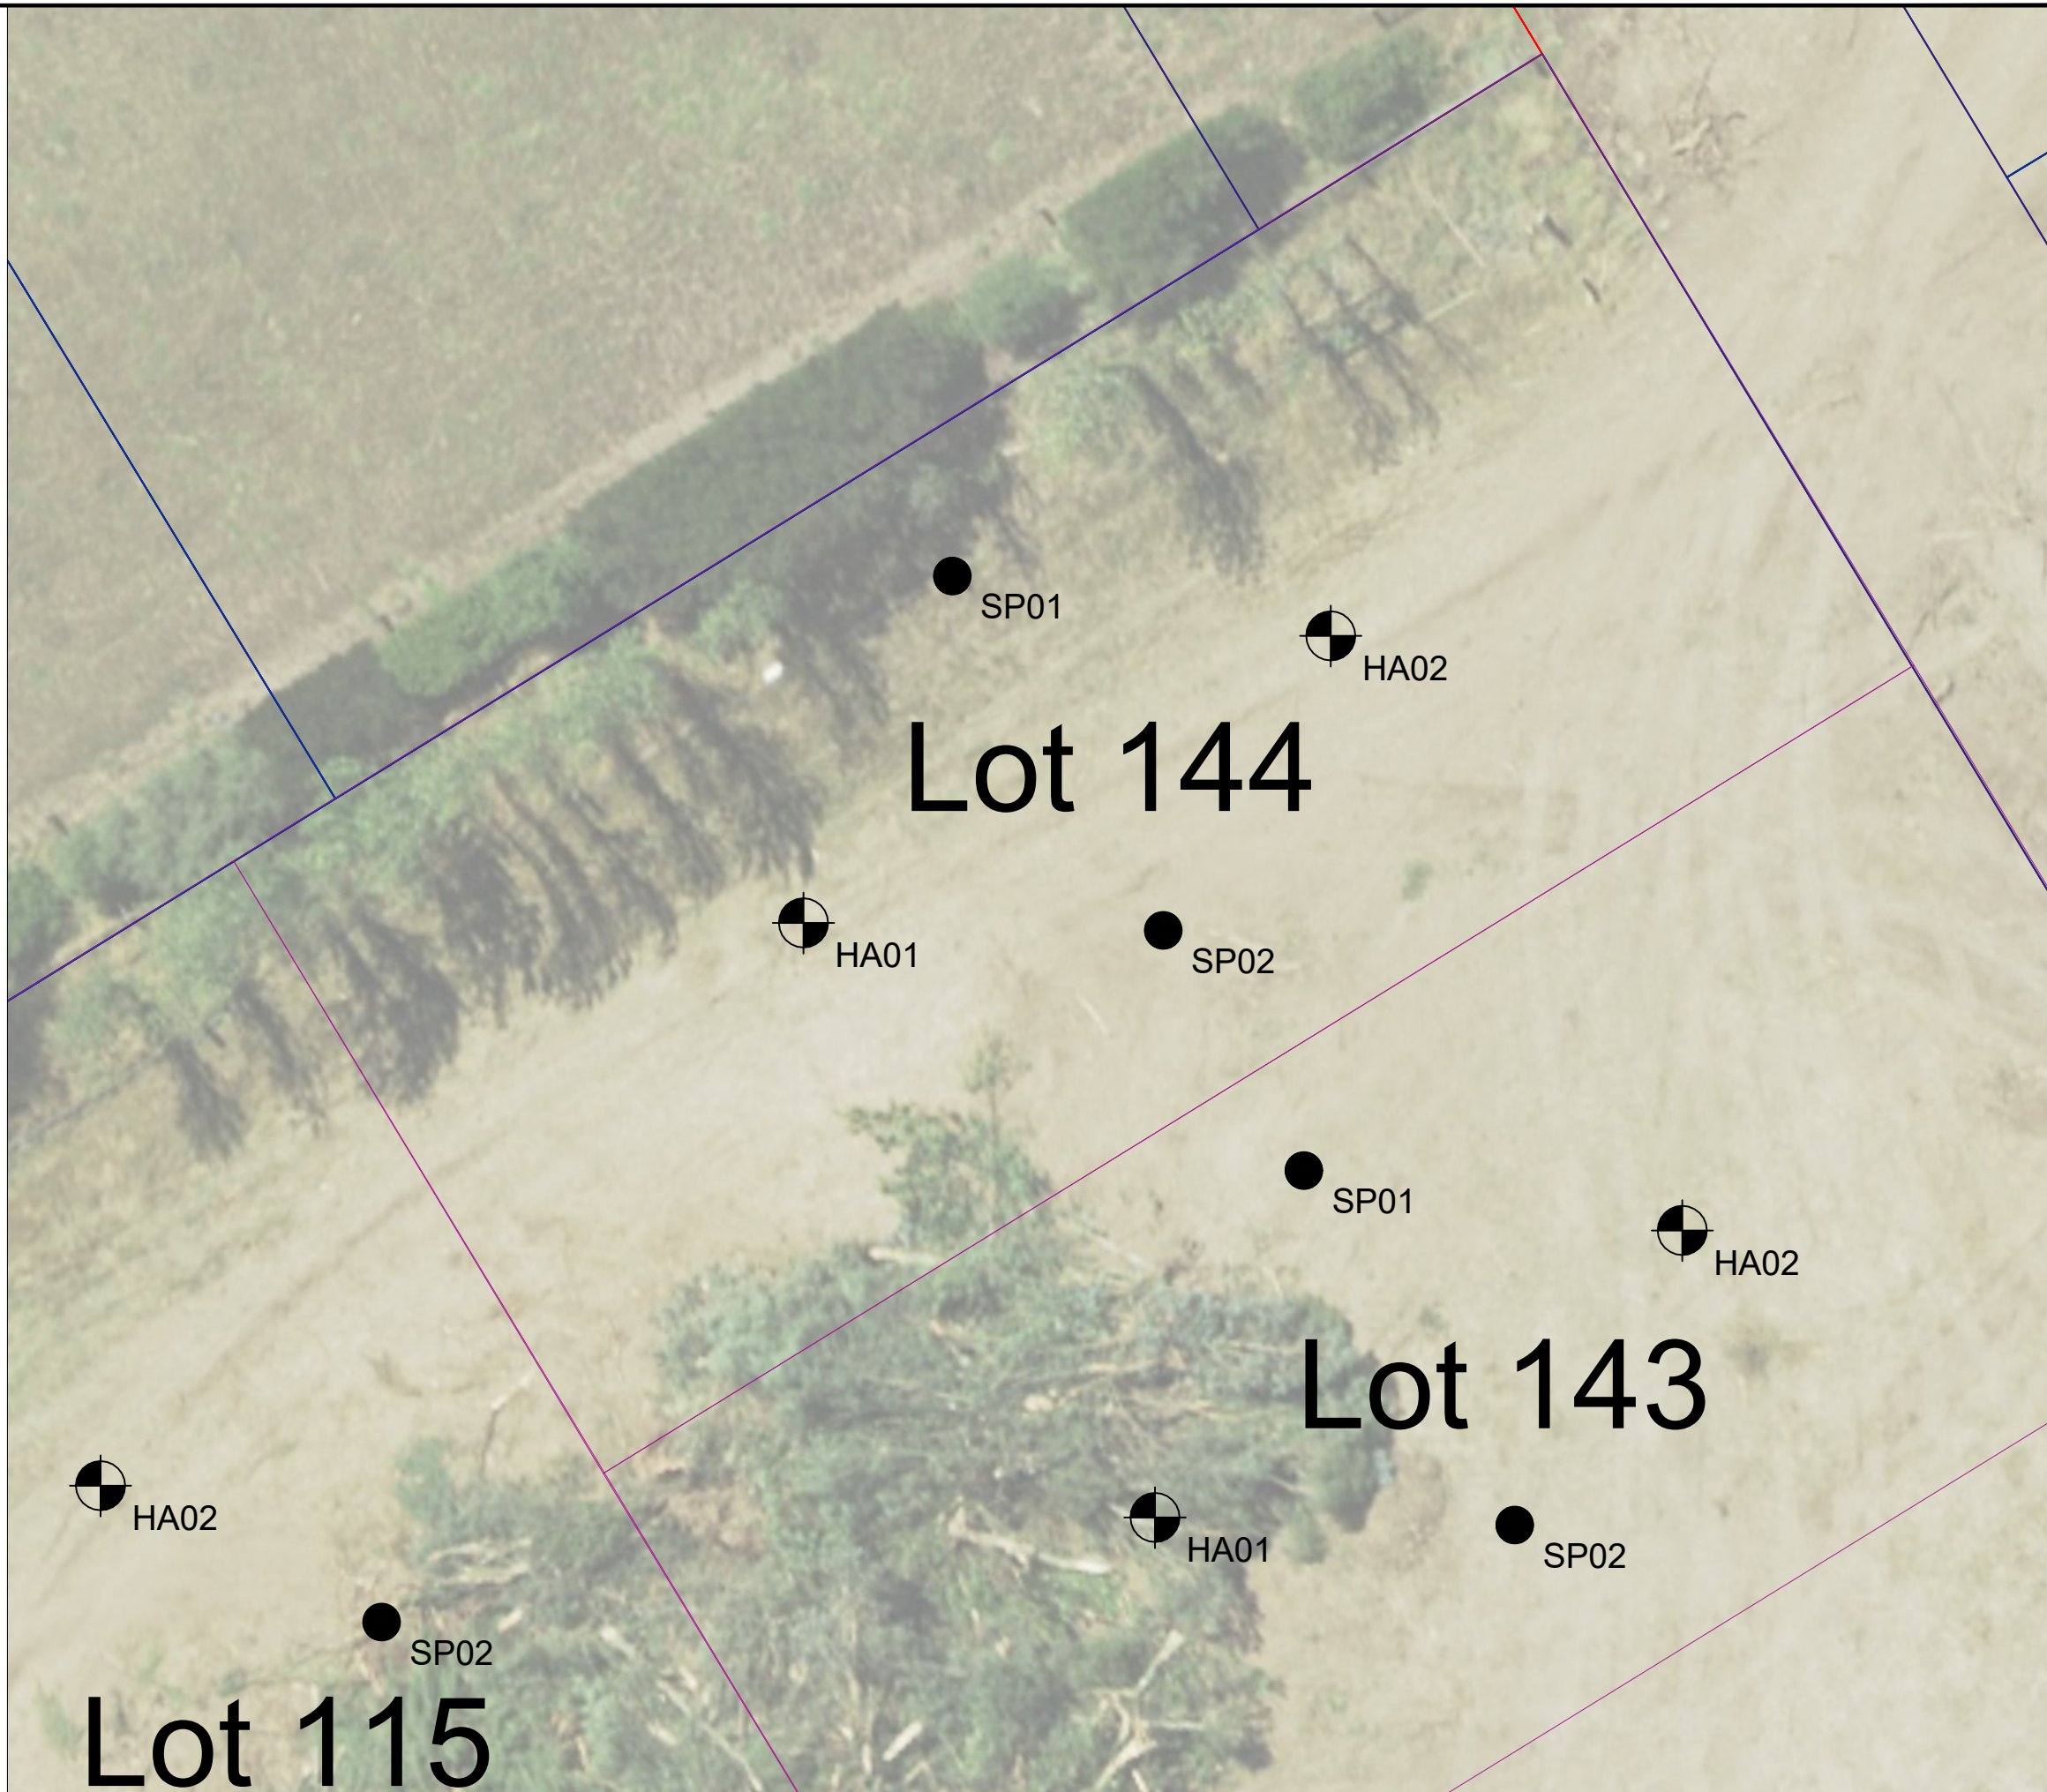
| Drawing No:<br>Lot 144/ TLP | Drawn by:<br>KB | Date:<br>15 September 2022 |

LandTech investigated the site on 16 September 2022, comprising two hand auger holes with corresponding Scala Penetrometer tests and two additional Scala Penetrometer tests. The test locations were measured from lot boundaries and/or surveyed centre pegs and are approximate only. The test locations are shown on the LandTech *Test Location Plan*, Drawing No. Lot 144/ TLP attached to this report.

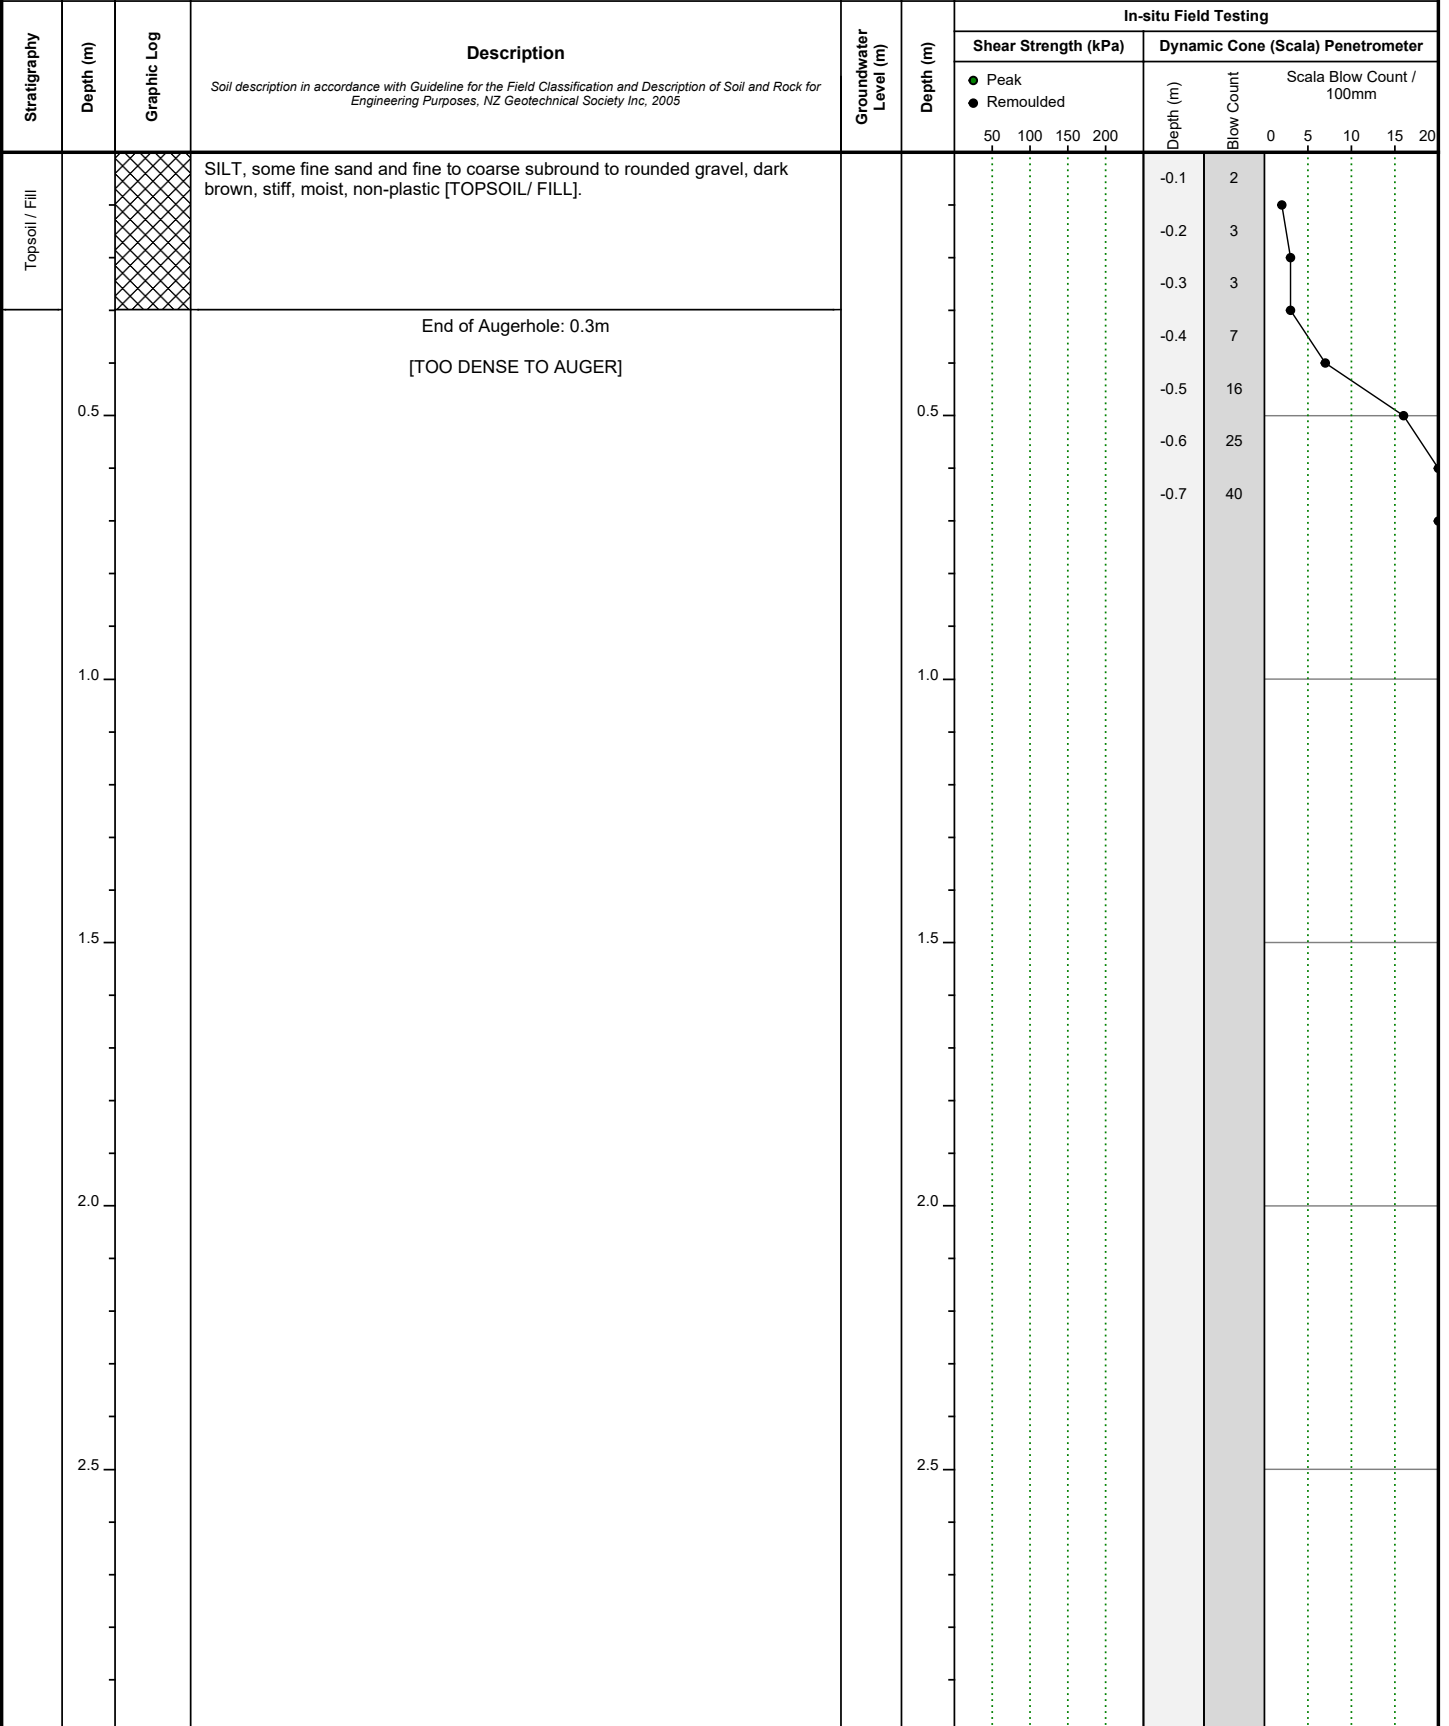
Augerhole No.: Lot 144 - HA01

Project No.: LTC22215      Coordinates: NZTM2000: E1549294.79, N5170174.75      Logged By: KP  
 Drill Type: 50 mm Hand Auger      Reduced Level: 42.50m (LVD137)      Shear Vane No.:  
 Date Started: 16-Sep-22      Ground Conditions: Near Level, Topsoil & Gravel      Calibration Factor:  
 Date Finished: 16-Sep-22      Groundwater Level (m): Not Encountered      Calibration Date:

Inferred gravels

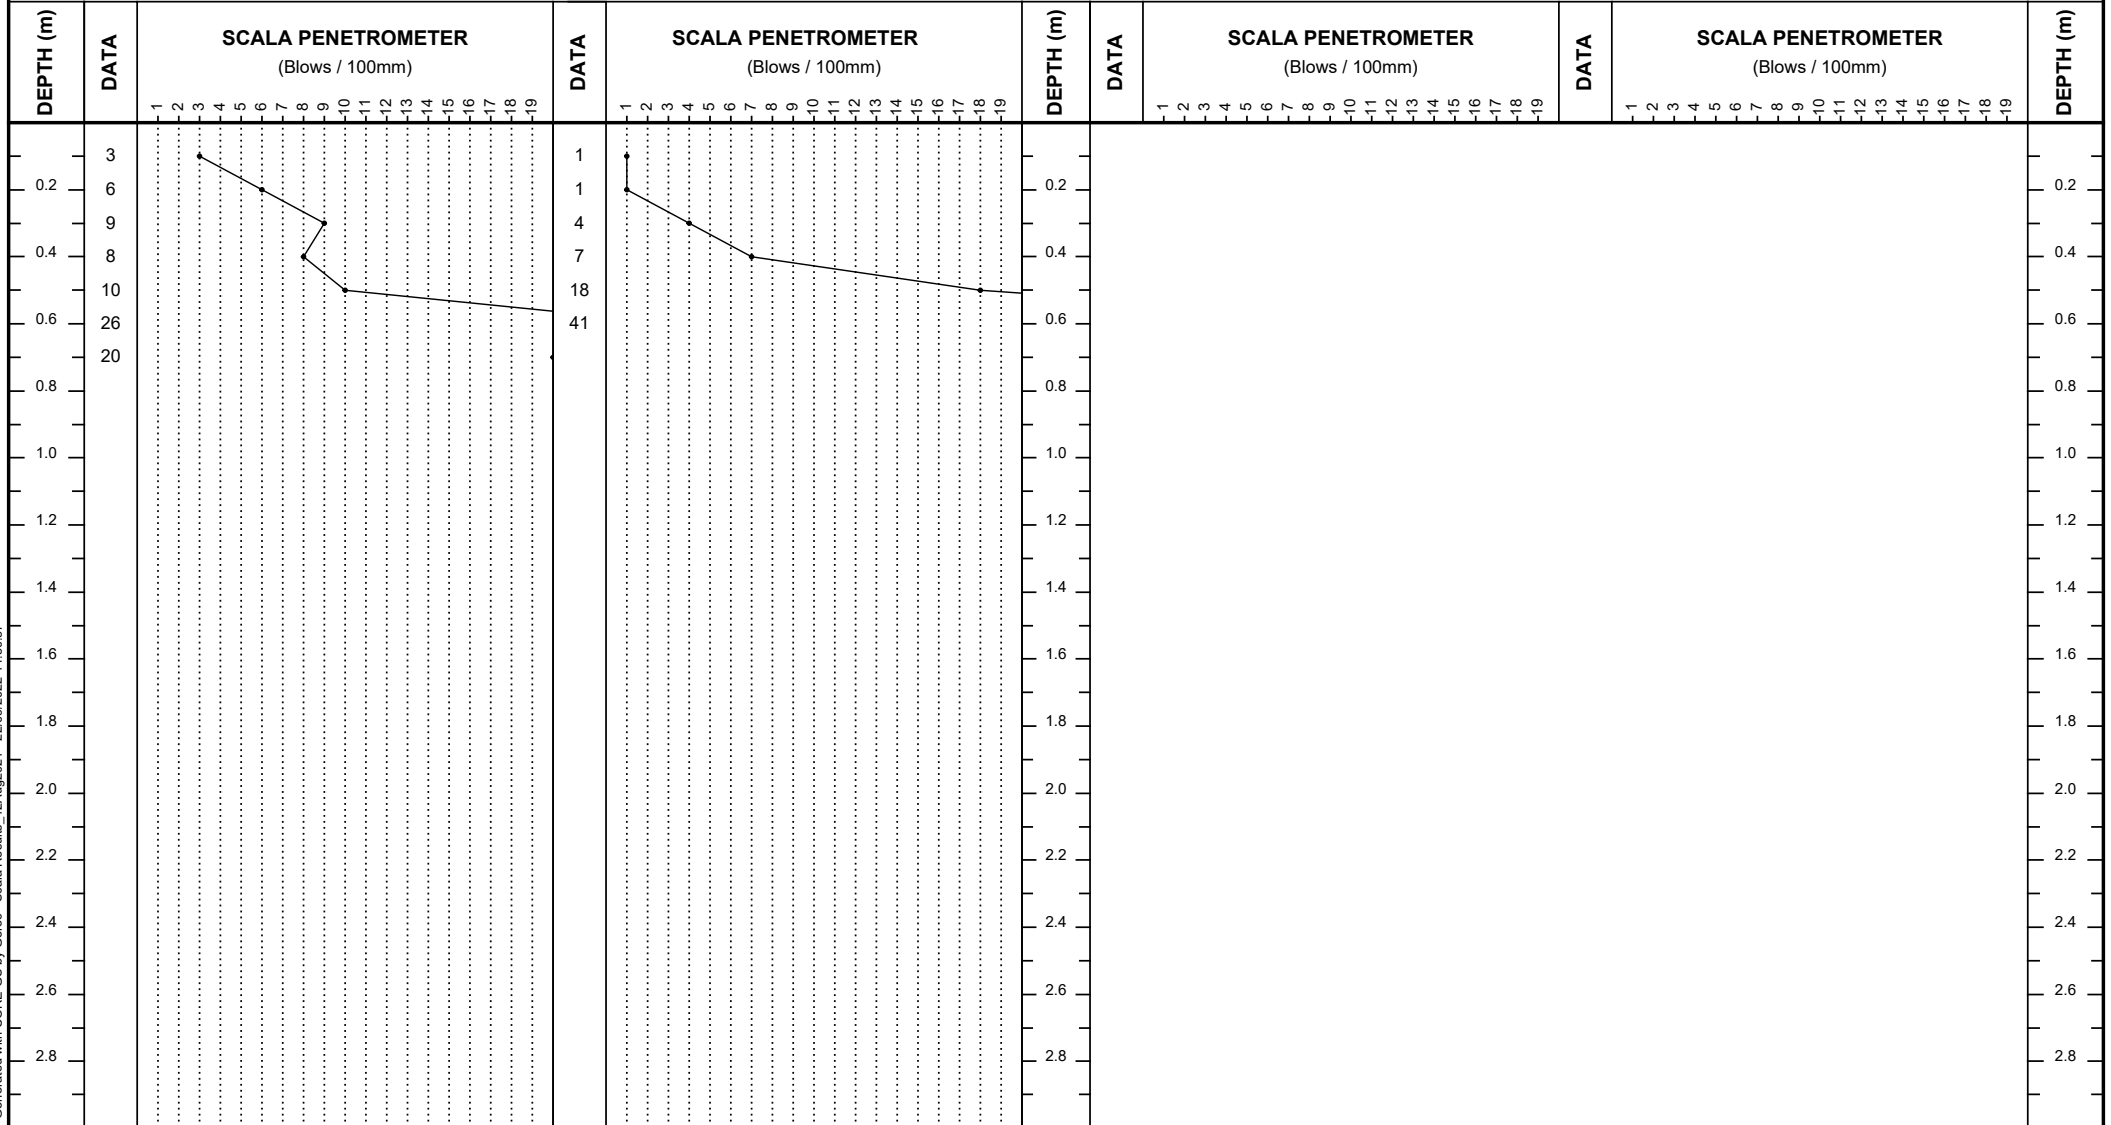
**Lot 144 - SP01**

The hand auger holes encountered topsoil/fill material from the ground surface to approximately 0.3m depths, underlain by inferred natural gravel. Groundwater was not encountered during testing. Scala Penetrometer testing at each of the four locations returned results between 1 and 40+ blows per 100mm penetration at the test positions, encountering refusal at depths between 0.6m and 0.7m below present ground level.
