Project No: LTC22215

**RE: SHALLOW SOIL TEST REPORT
LOT 138, 138 DUNNS CROSSING ROAD**

Lot 138, 138 Dunns Crossing Road
 ROLLESTON

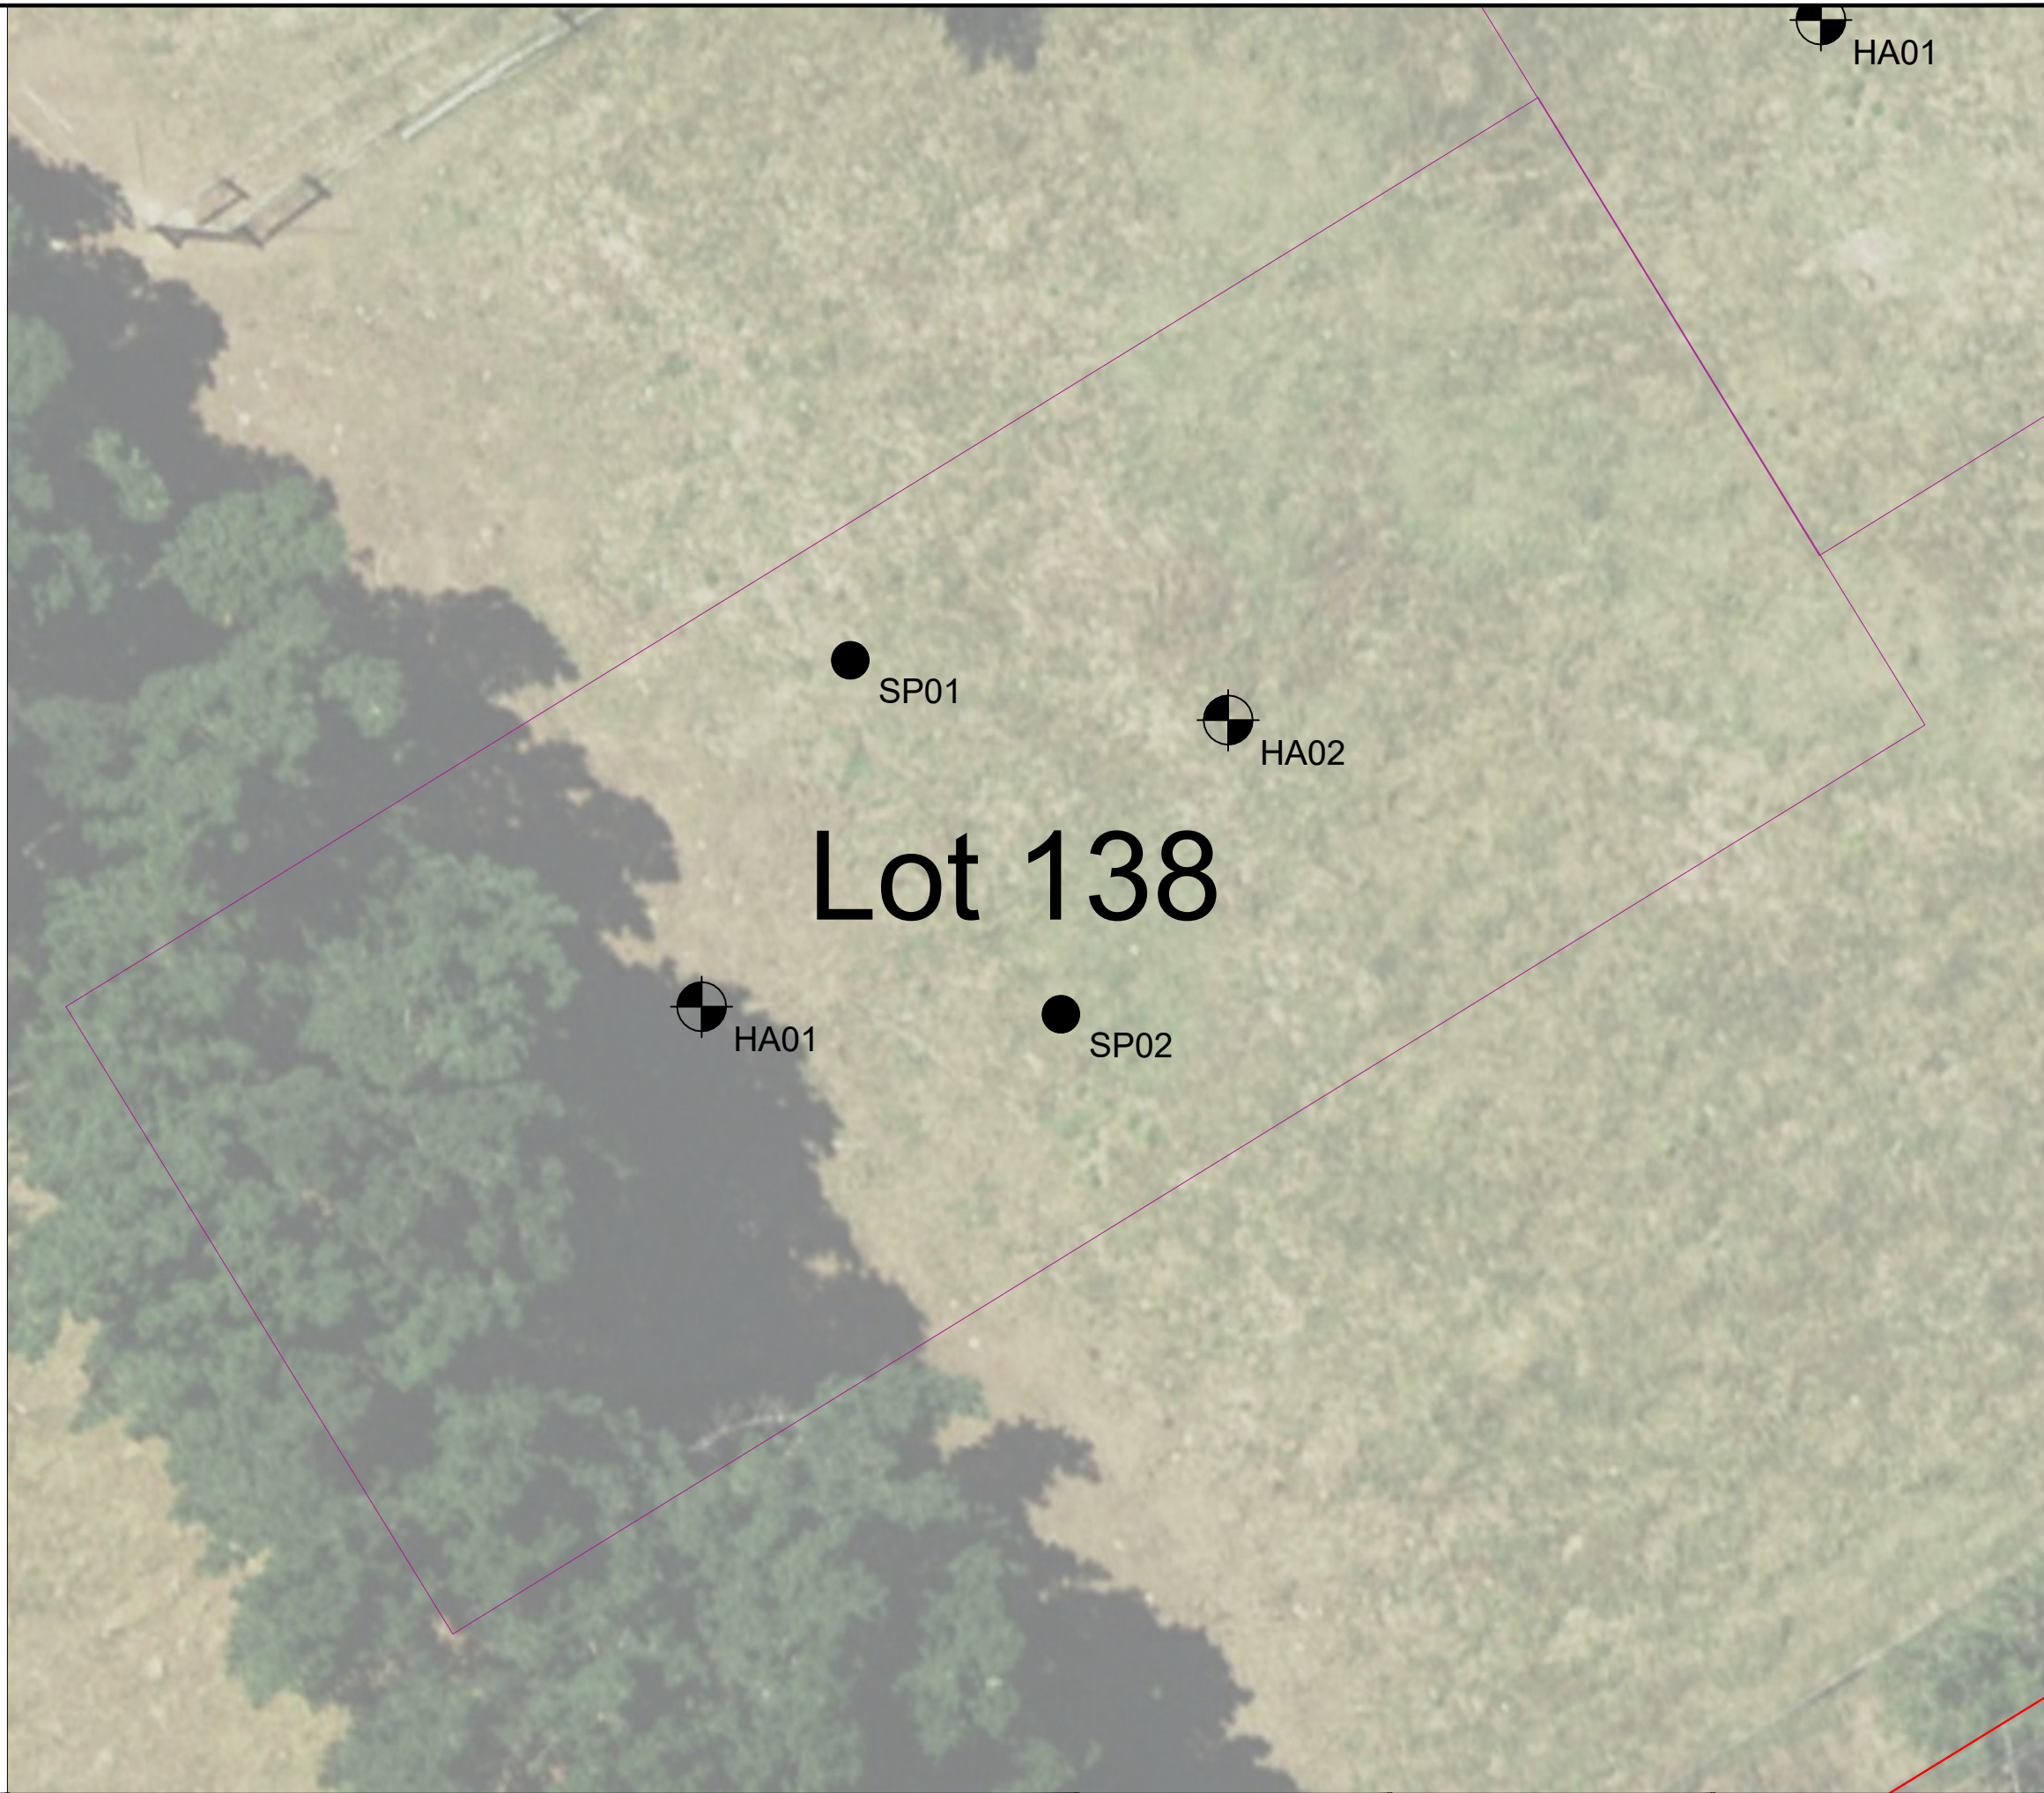
Test Location Plan

LandTech investigated the site on 19 September 2022, comprising two hand auger holes with corresponding Scala Penetrometer tests and two additional Scala Penetrometer tests. The test locations were measured from lot boundaries and/or surveyed centre pegs and are approximate only. The test locations are shown on the LandTech *Test Location Plan*, Drawing No. Lot 138/ TLP attached to this report.
