Project No: LTC22215

**RE: SHALLOW SOIL TEST REPORT
LOT 115, 138 DUNNS CROSSING ROAD**

Lot 115, 138 Dunns Crossing Road
ROLLESTON

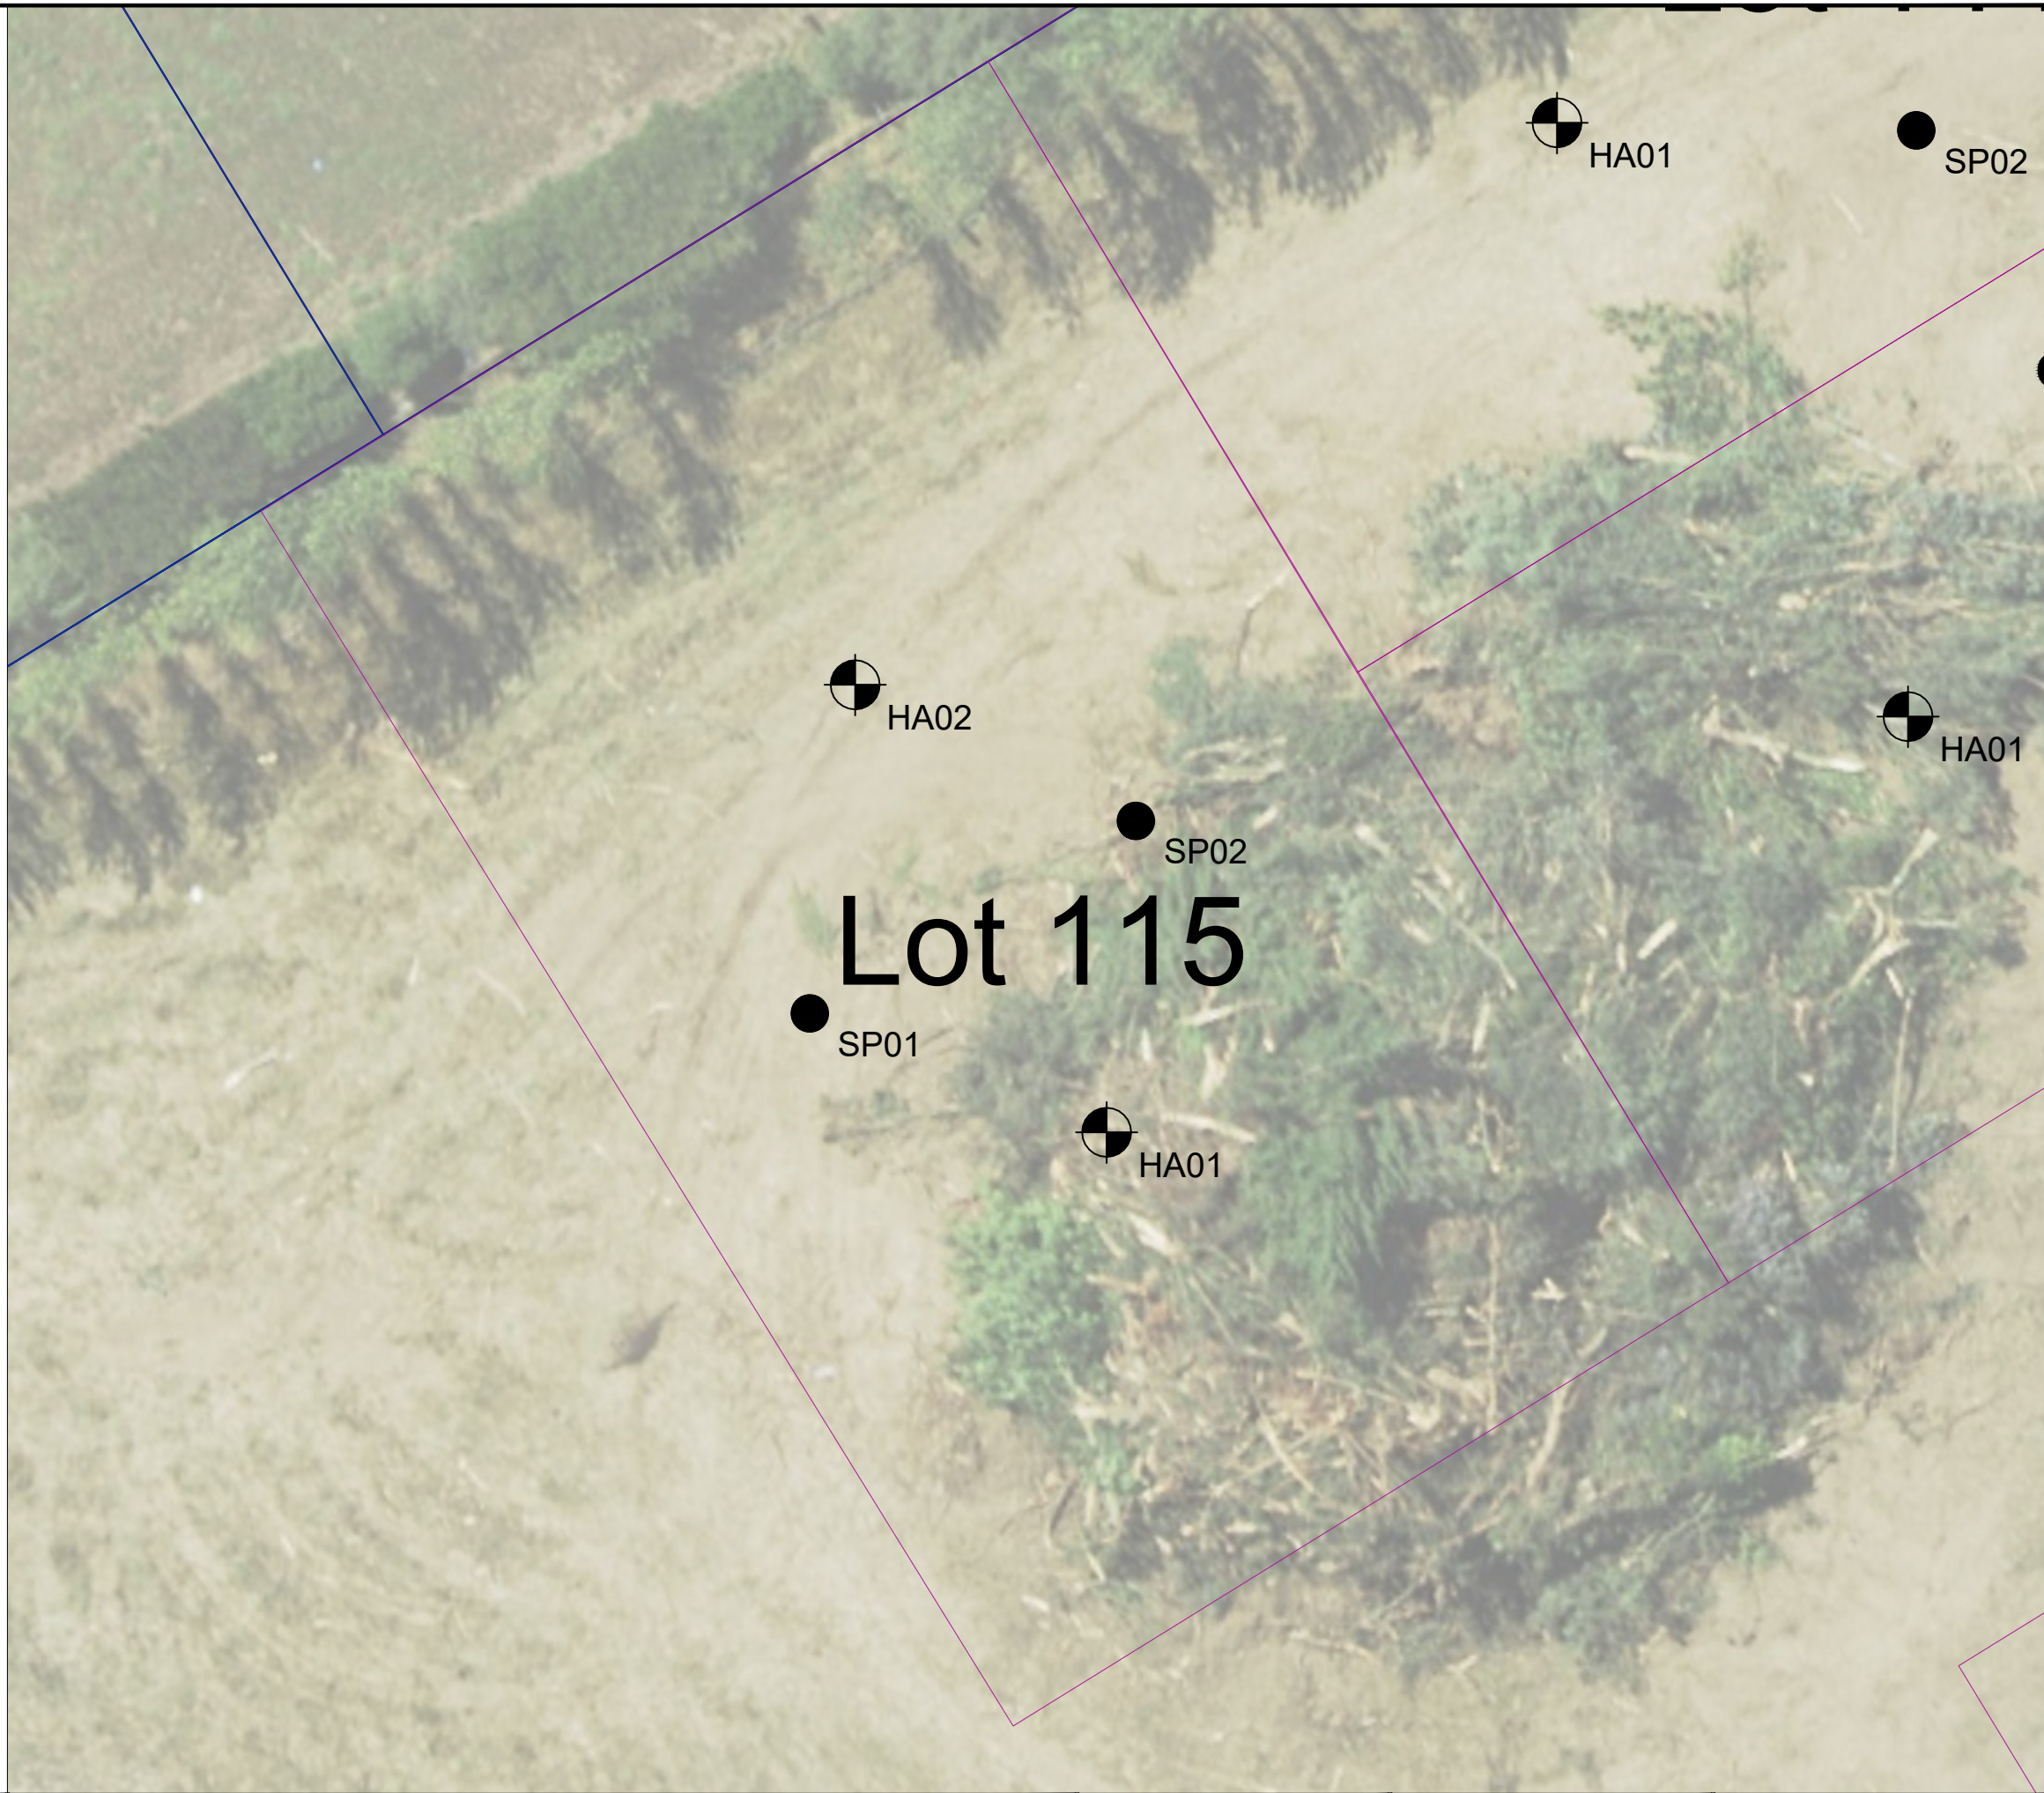
Test Location Plan

LandTech investigated the site on 16 September 2022, comprising two hand auger holes with corresponding Scala Penetrometer tests and two additional Scala Penetrometer tests. The test locations were measured from lot boundaries and/or surveyed centre pegs and are approximate only. The test locations are shown on the LandTech *Test Location Plan*, Drawing No. Lot 115/ TLP attached to this report.

The hand auger holes encountered topsoil/fill material from the ground surface to approximately 0.1m to 0.2m depths, underlain by inferred natural gravel. Groundwater was not encountered during testing. Scala Penetrometer testing at each of the four locations returned results between 4 and 40+ blows per 100mm penetration at the test positions, encountering refusal at depths between 0.4m and 0.6m below present ground level.

The two hand auger holes were carried out at either end of the lot; therefore, ground conditions could vary away from the test positions. Additionally, the tests refused within placed topsoil and inferred underlying natural ground. This bears the potential for greater depths of unsuitable topsoil and fill than those encountered within our hand augers, which should be considered during earthworks and foundation excavations.

From the lot-specific investigation for the site we conclude the site has “Good Ground”, and that dwelling foundations on this site can comprise NZS3604:2011 type foundations or codemark approved concrete slab foundations that are applicable for the site conditions (i.e. “good ground”). All foundations must be embedded to a minimum depth of 0.2m below ground level, into the underlying Natural Gravel or Engineered Fill. At these depths, either “Good Ground” or an Ultimate Bearing Capacity of 300kPa is available/inferred. If specific engineering design is being carried out a strength reduction factor of $\phi=0.5$ should be used. This depth has been supplied based on ground level at the time of testing. All topsoil and unsuitable materials should be removed below foundations and floor slab areas.

The subgrade should be inspected by a suitably qualified structural or geotechnical engineer or suitably experienced building inspector to confirm founding conditions meet the requirements of NZS3604:2011 “Good Ground”.
