23 September 2022

Project No: LTC22215

**RE: SHALLOW SOIL TEST REPORT
LOT 142, 138 DUNNS CROSSING ROAD**

Test Location Plan

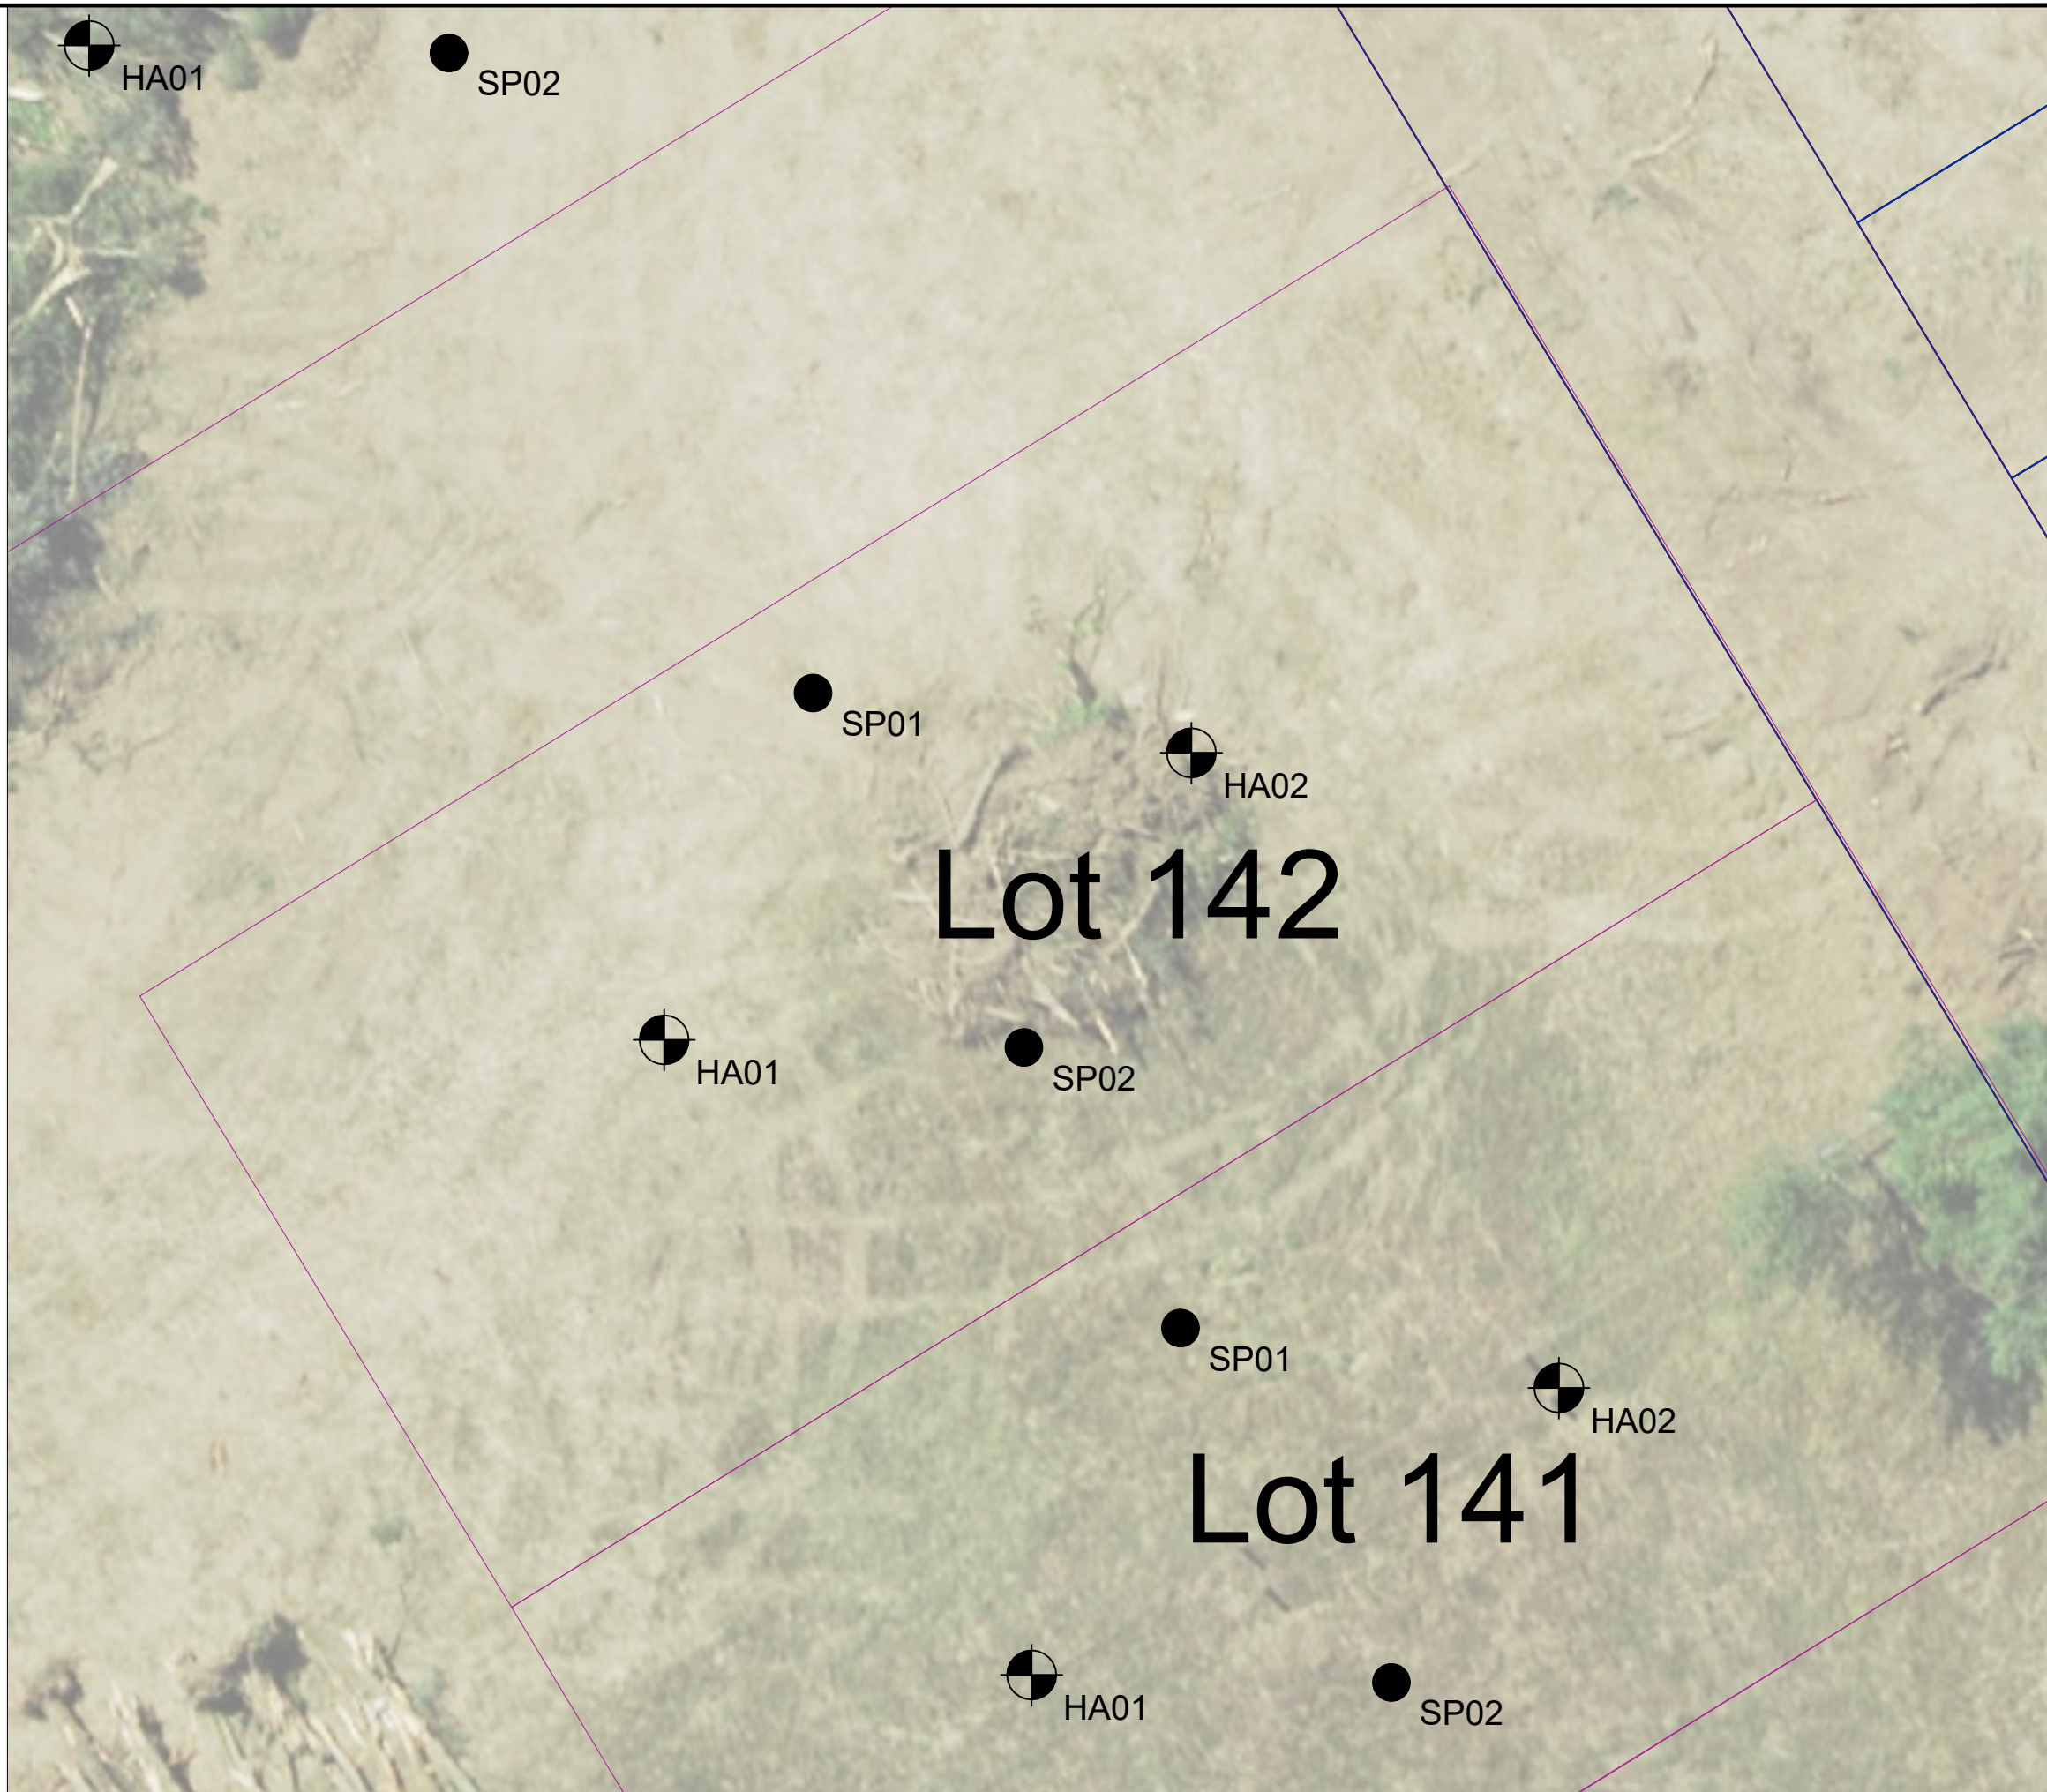
| Drawing No: Lot 142/TLP | Drawn by: KB | Date: 15 September 2022 |

LandTech investigated the site on 16 September 2022, comprising two hand auger holes with corresponding Scala Penetrometer tests and two additional Scala Penetrometer tests. The test locations were measured from lot boundaries and/or surveyed centre pegs and are approximate only. The test locations are shown on the LandTech *Test Location Plan*, Drawing No. Lot 142/ TLP attached to this report.

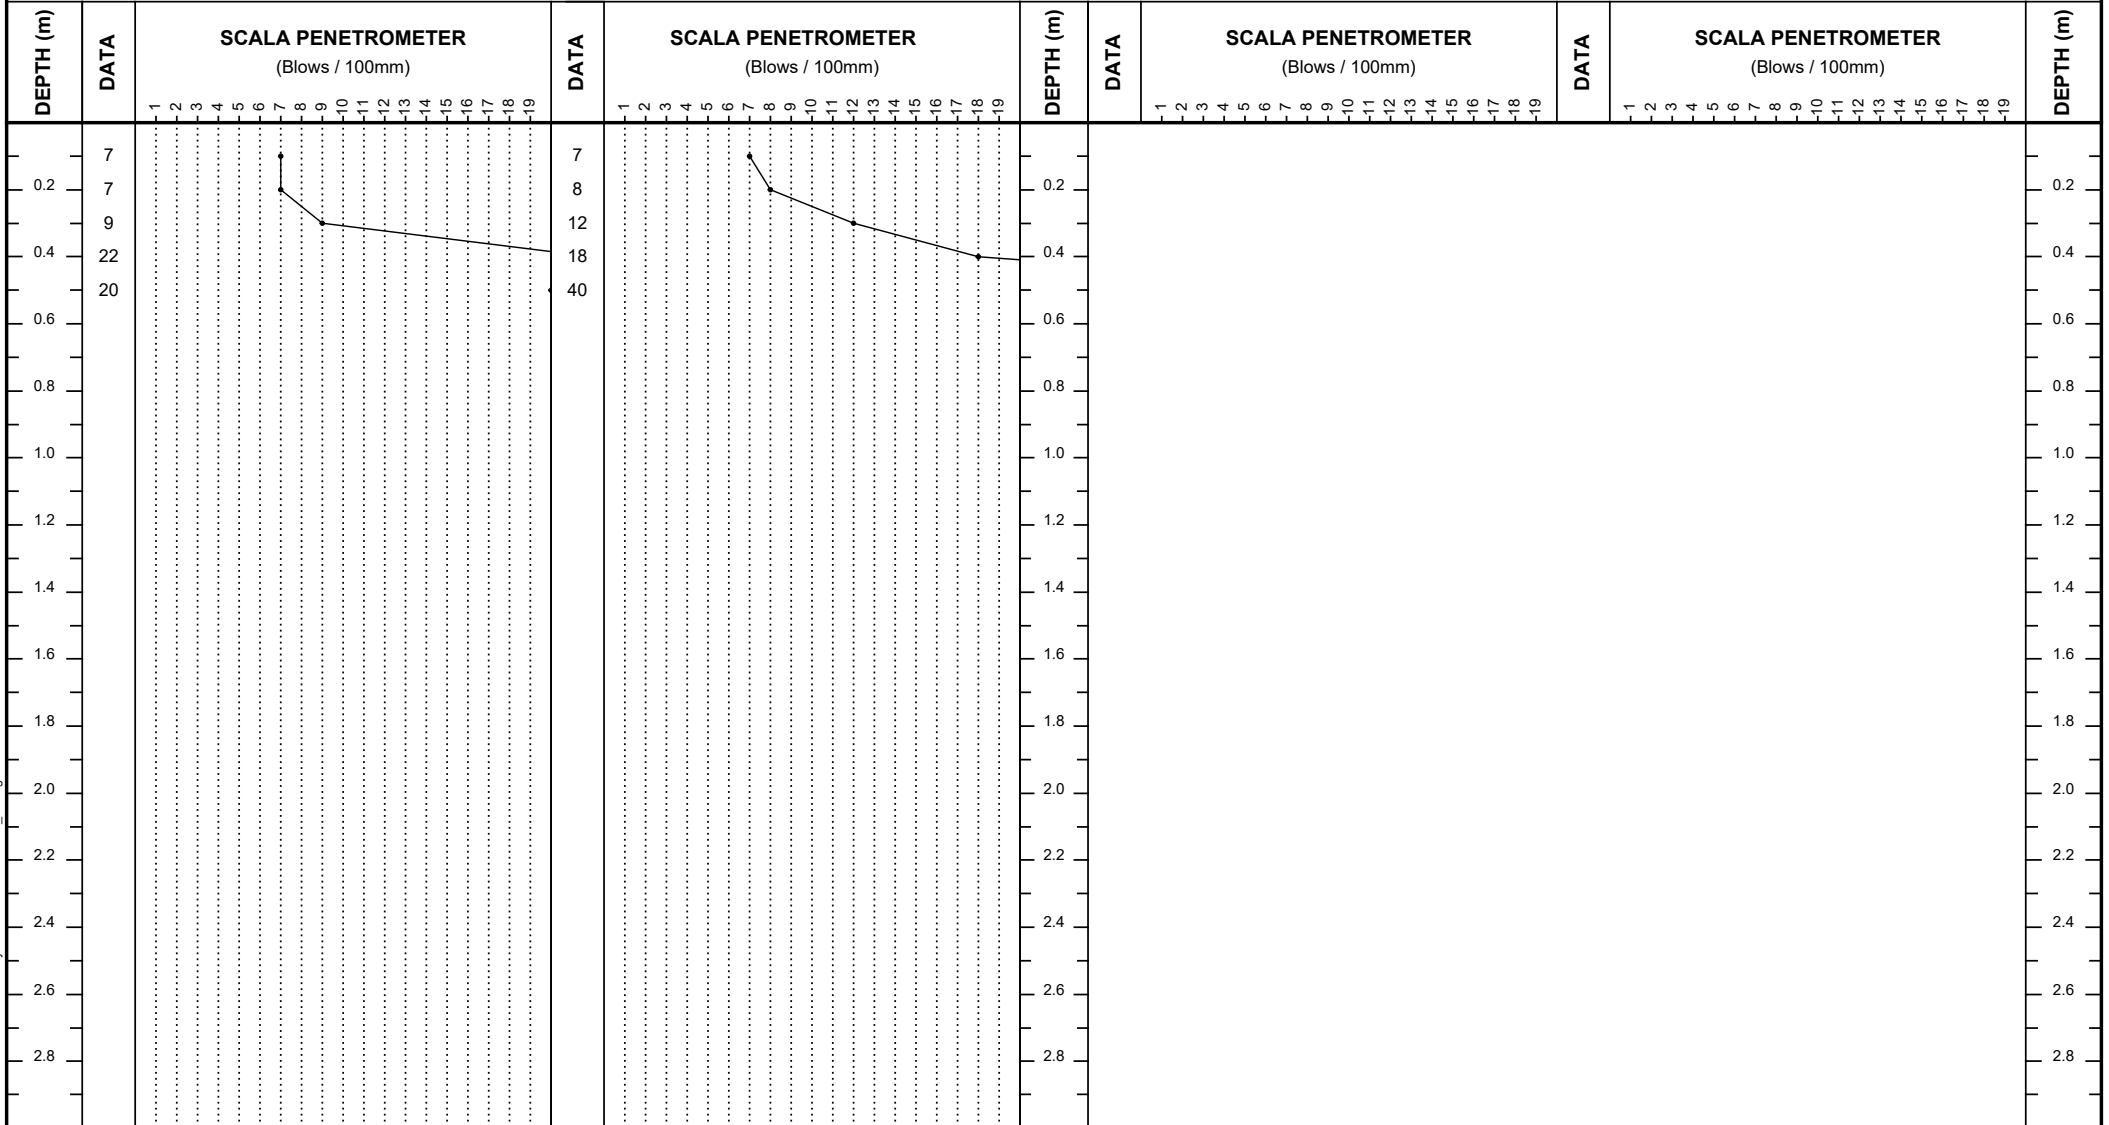
Lot 142 - SP01

The hand auger holes encountered topsoil/fill material from the ground surface to approximately 0.2m depths, underlain by inferred natural gravel. Groundwater was not encountered during testing. Scala Penetrometer testing at each of the four locations returned results between 1 and 40+ blows per 100mm penetration at the test positions, encountering refusal at depths between 0.5m and 0.6m below present ground level.
