Project No: LTC22215

**RE: SHALLOW SOIL TEST REPORT
LOT 113, 138 DUNNS CROSSING ROAD**

Test Location Plan
 Lot 113, 138 Dunns Crossing Road
 ROLLESTON

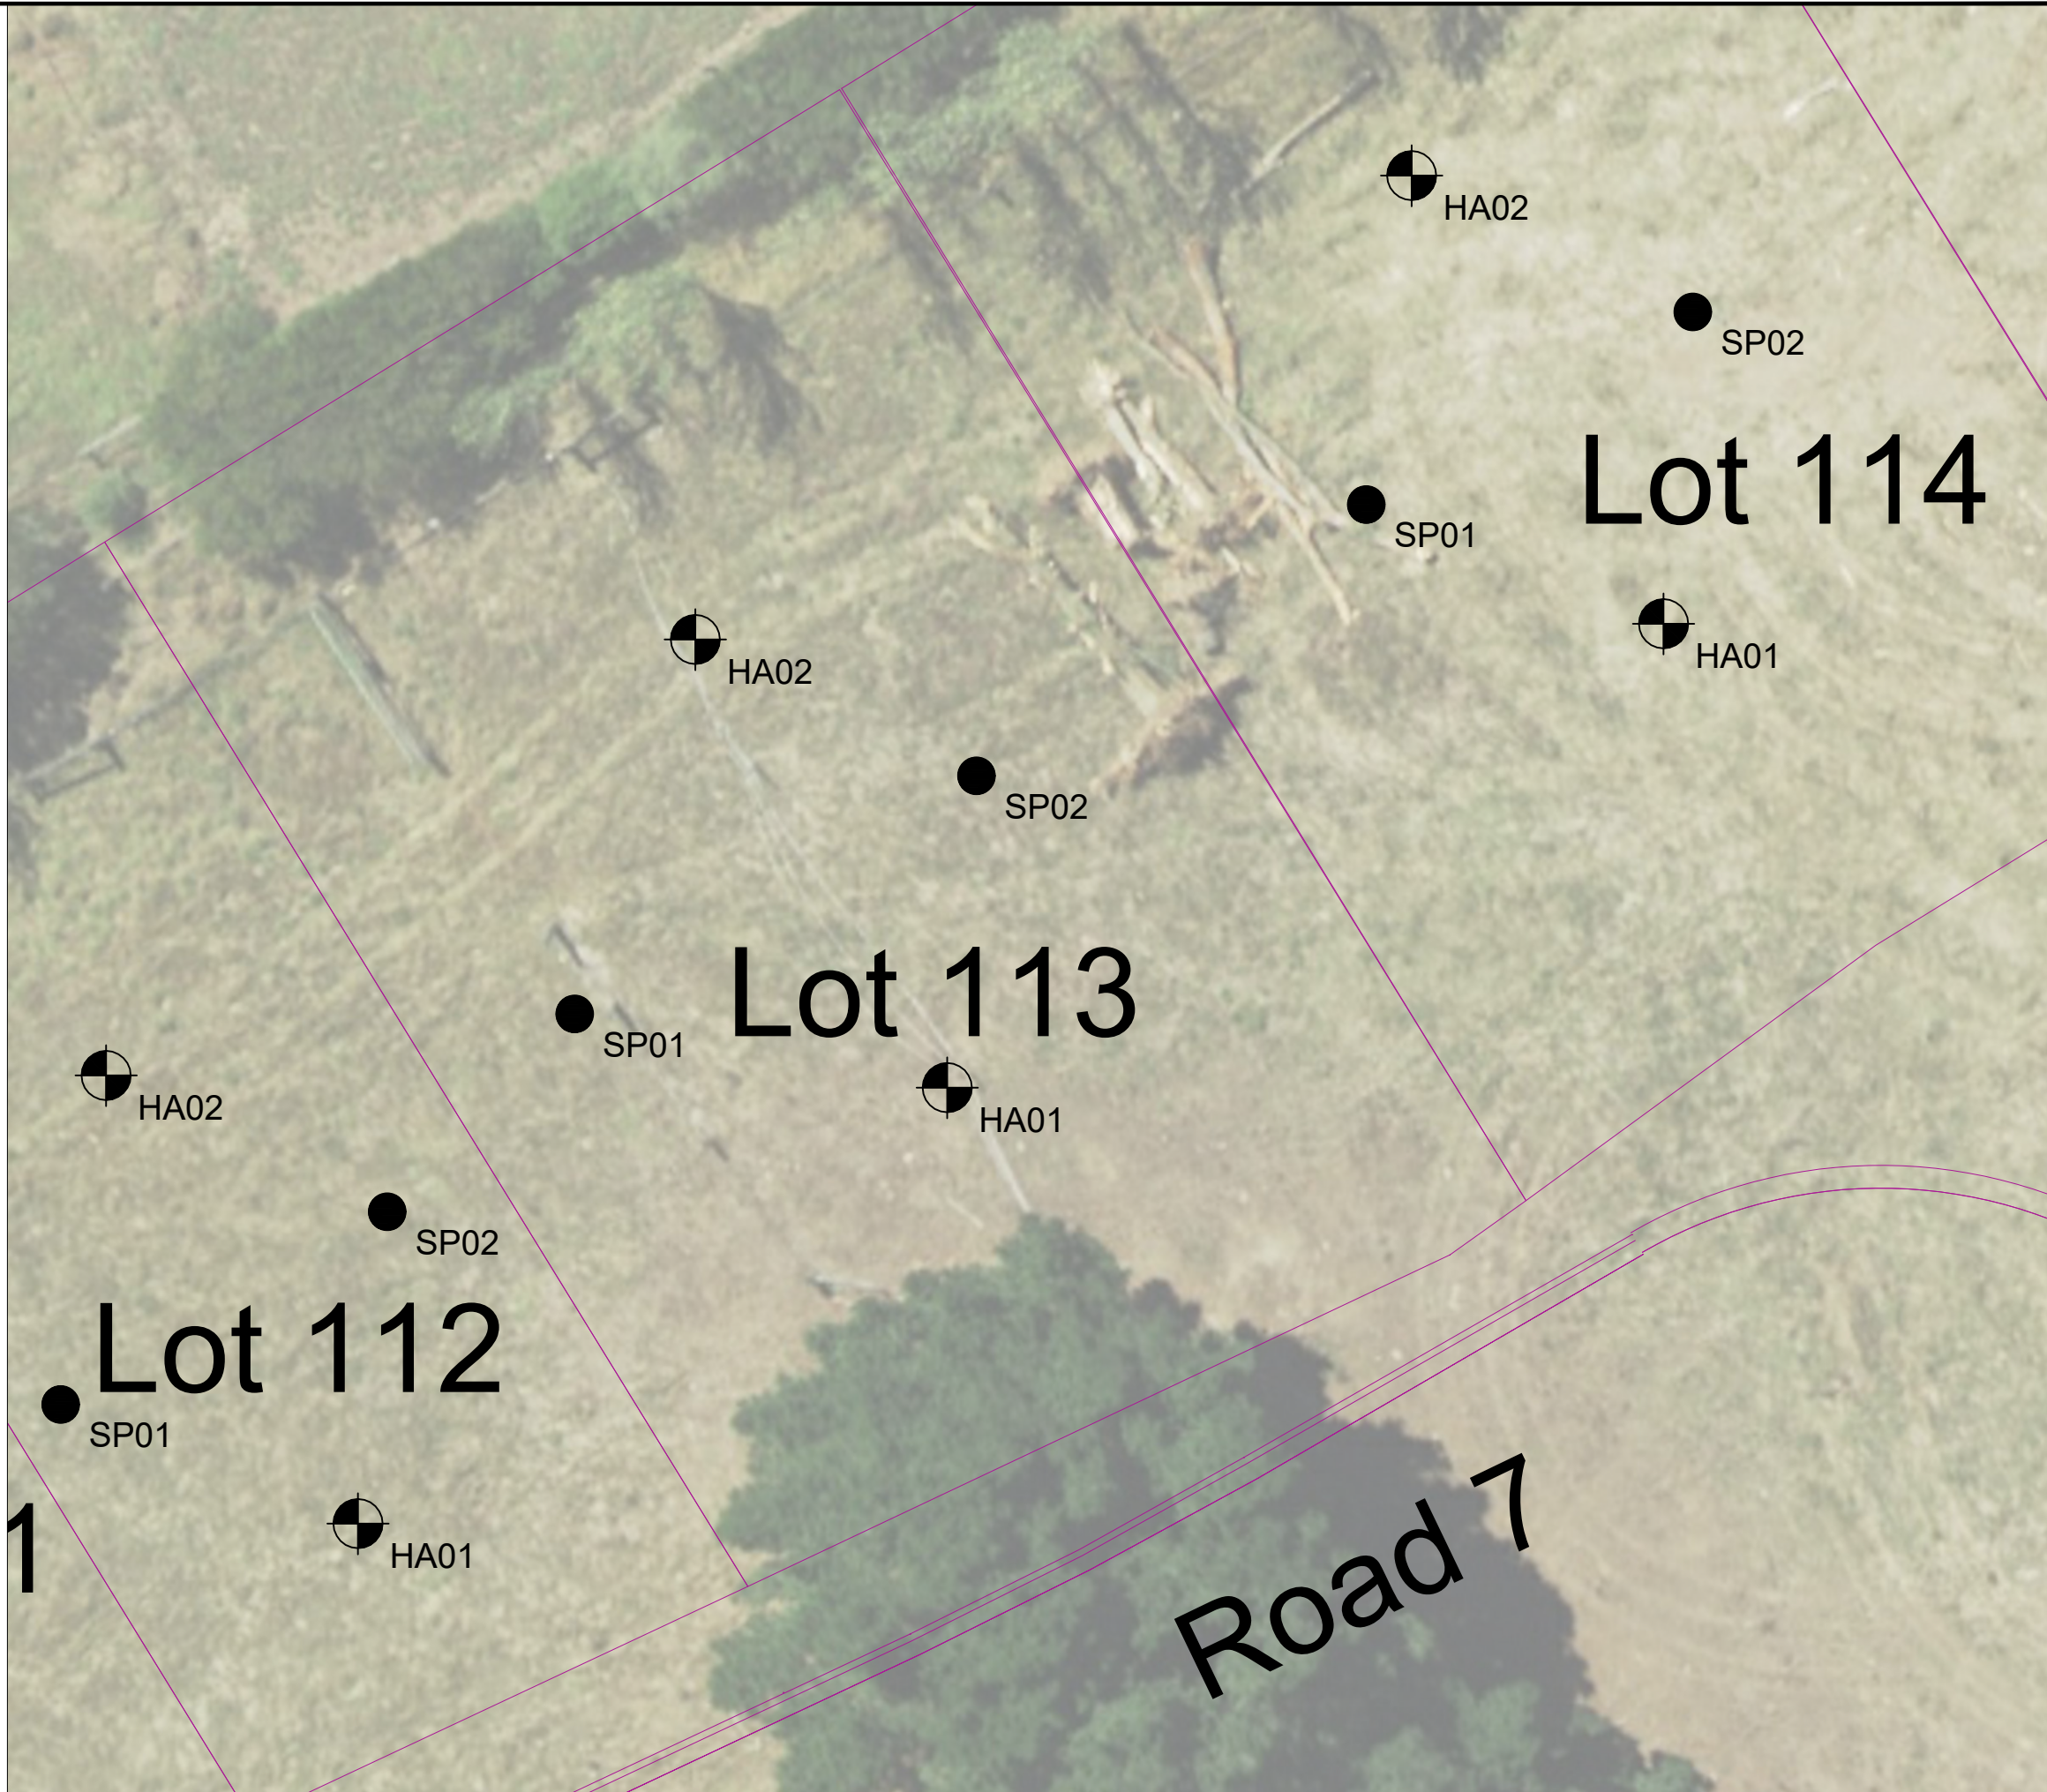
LandTech investigated the site on 16 September 2022, comprising two hand auger holes with corresponding Scala Penetrometer tests and two additional Scala Penetrometer tests. The test locations were measured from lot boundaries and/or surveyed centre pegs and are approximate only. The test locations are shown on the LandTech *Test Location Plan*, Drawing No. Lot 113/ TLP attached to this report.

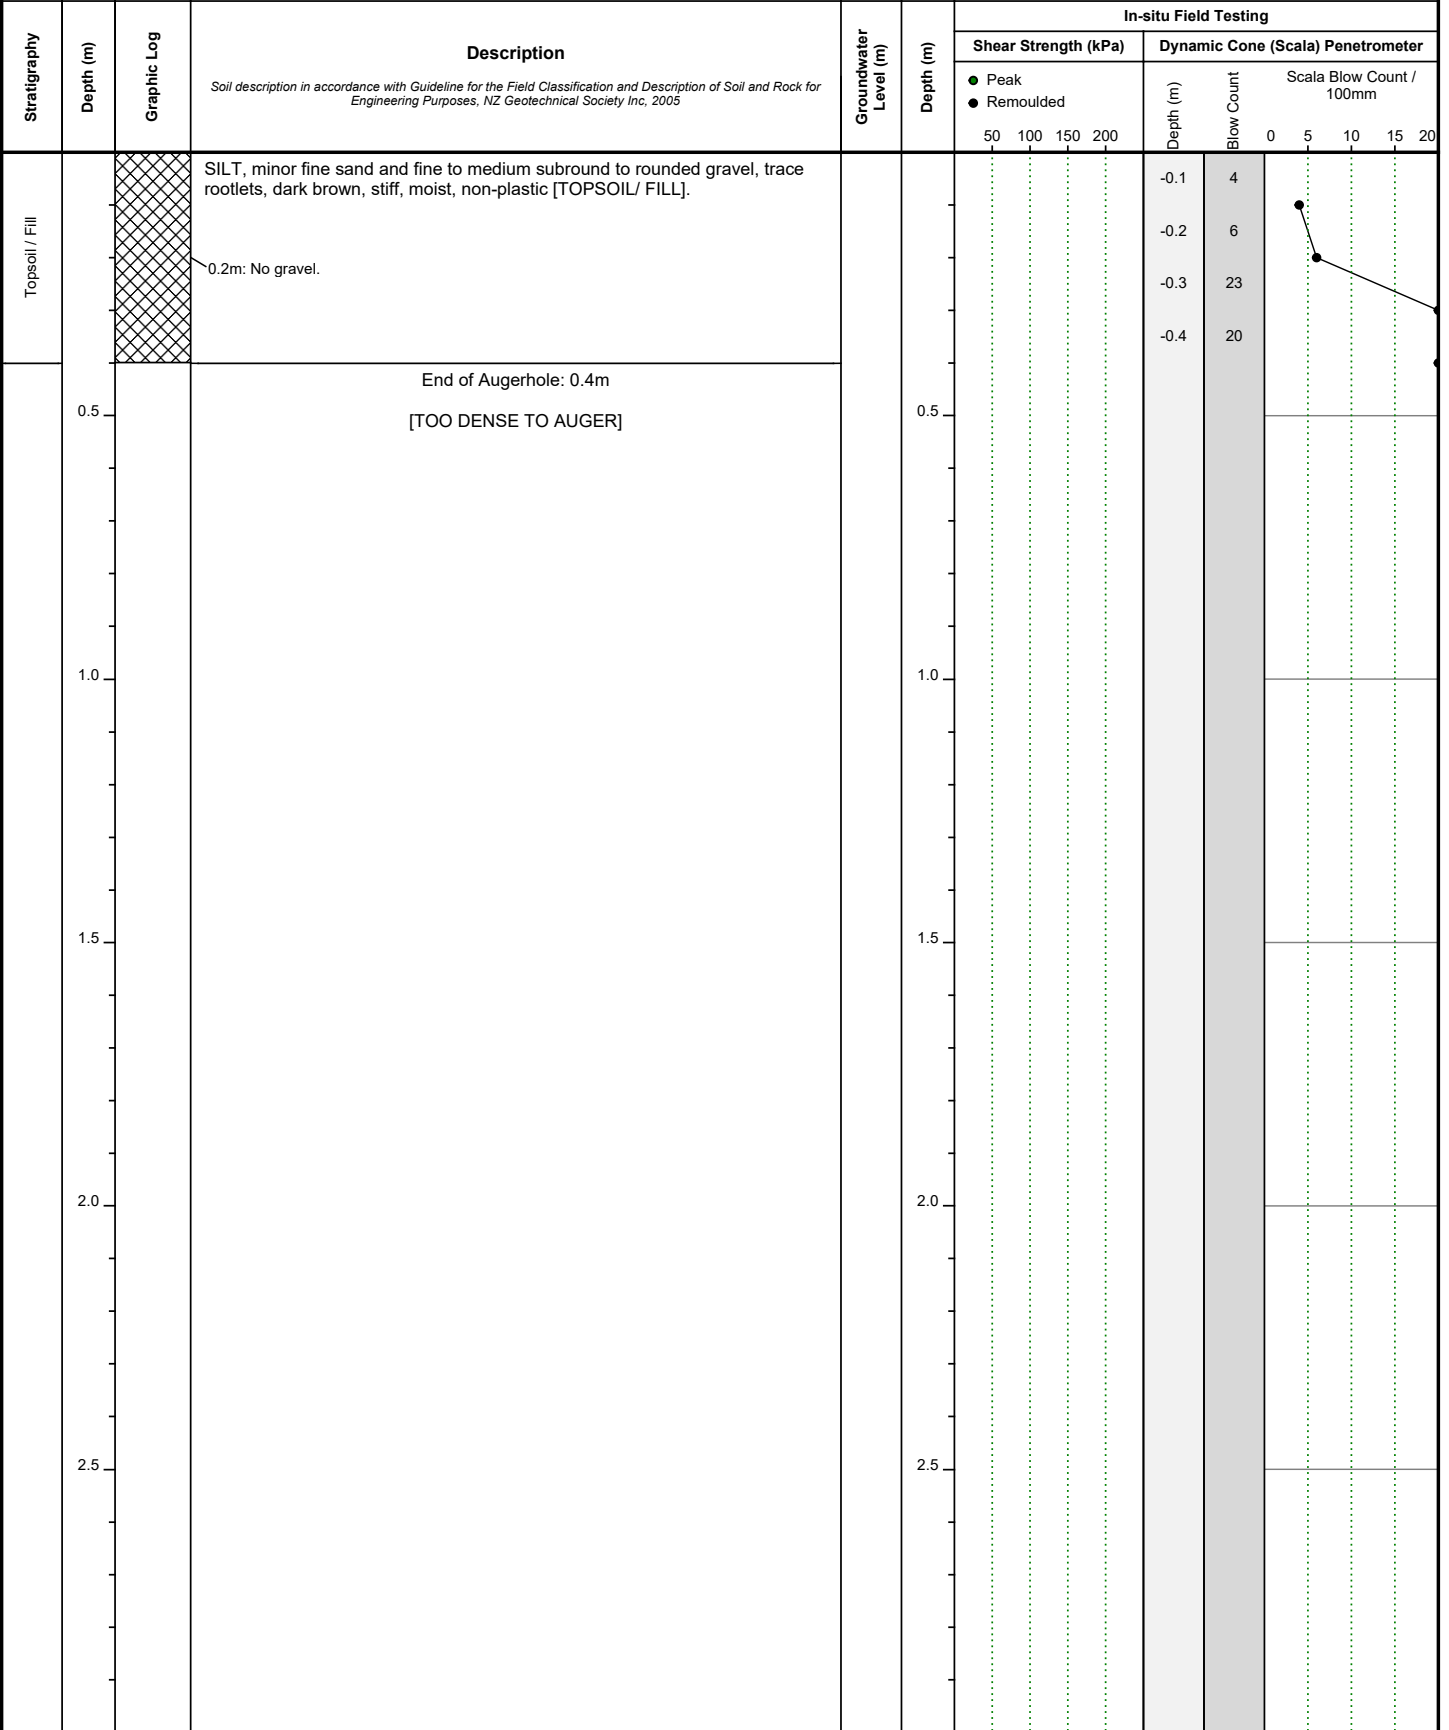
Augerhole No.: Lot 113 - HA02

Inferred gravels

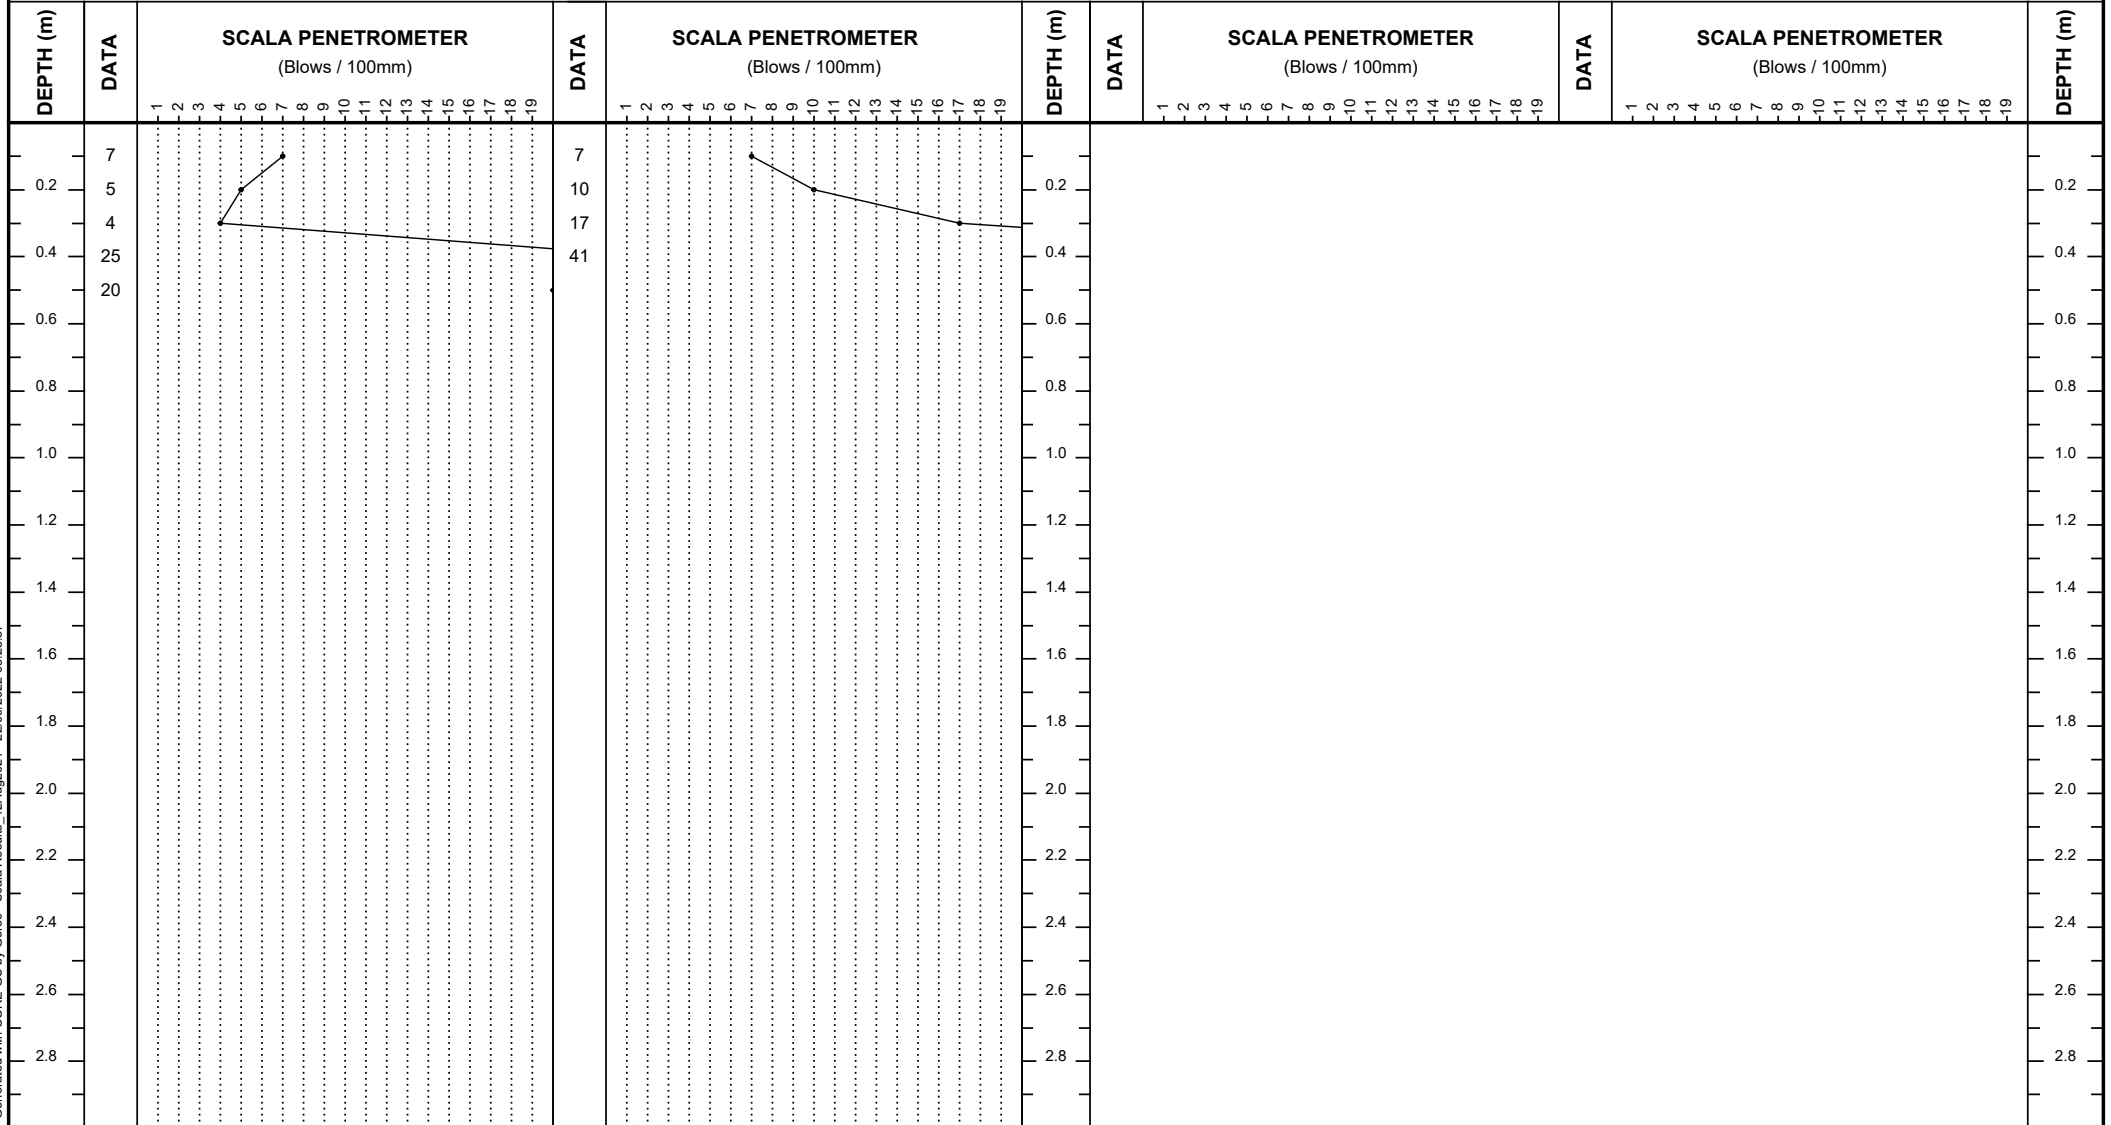
The hand auger holes encountered topsoil/fill material from the ground surface to approximately 0.2m and 0.4m depths, underlain by inferred natural gravel. Groundwater was not encountered during testing. Scala Penetrometer testing at each of the four locations returned results between 4 and 40+ blows per 100mm penetration at the test positions, encountering refusal at depths between 0.4m and 0.6m below present ground level.
