Project No: LTC22215

**RE: SHALLOW SOIL TEST REPORT
LOT 141, 138 DUNNS CROSSING ROAD**

Lot 141, 138 Dunns Crossing Road
ROLLESTON

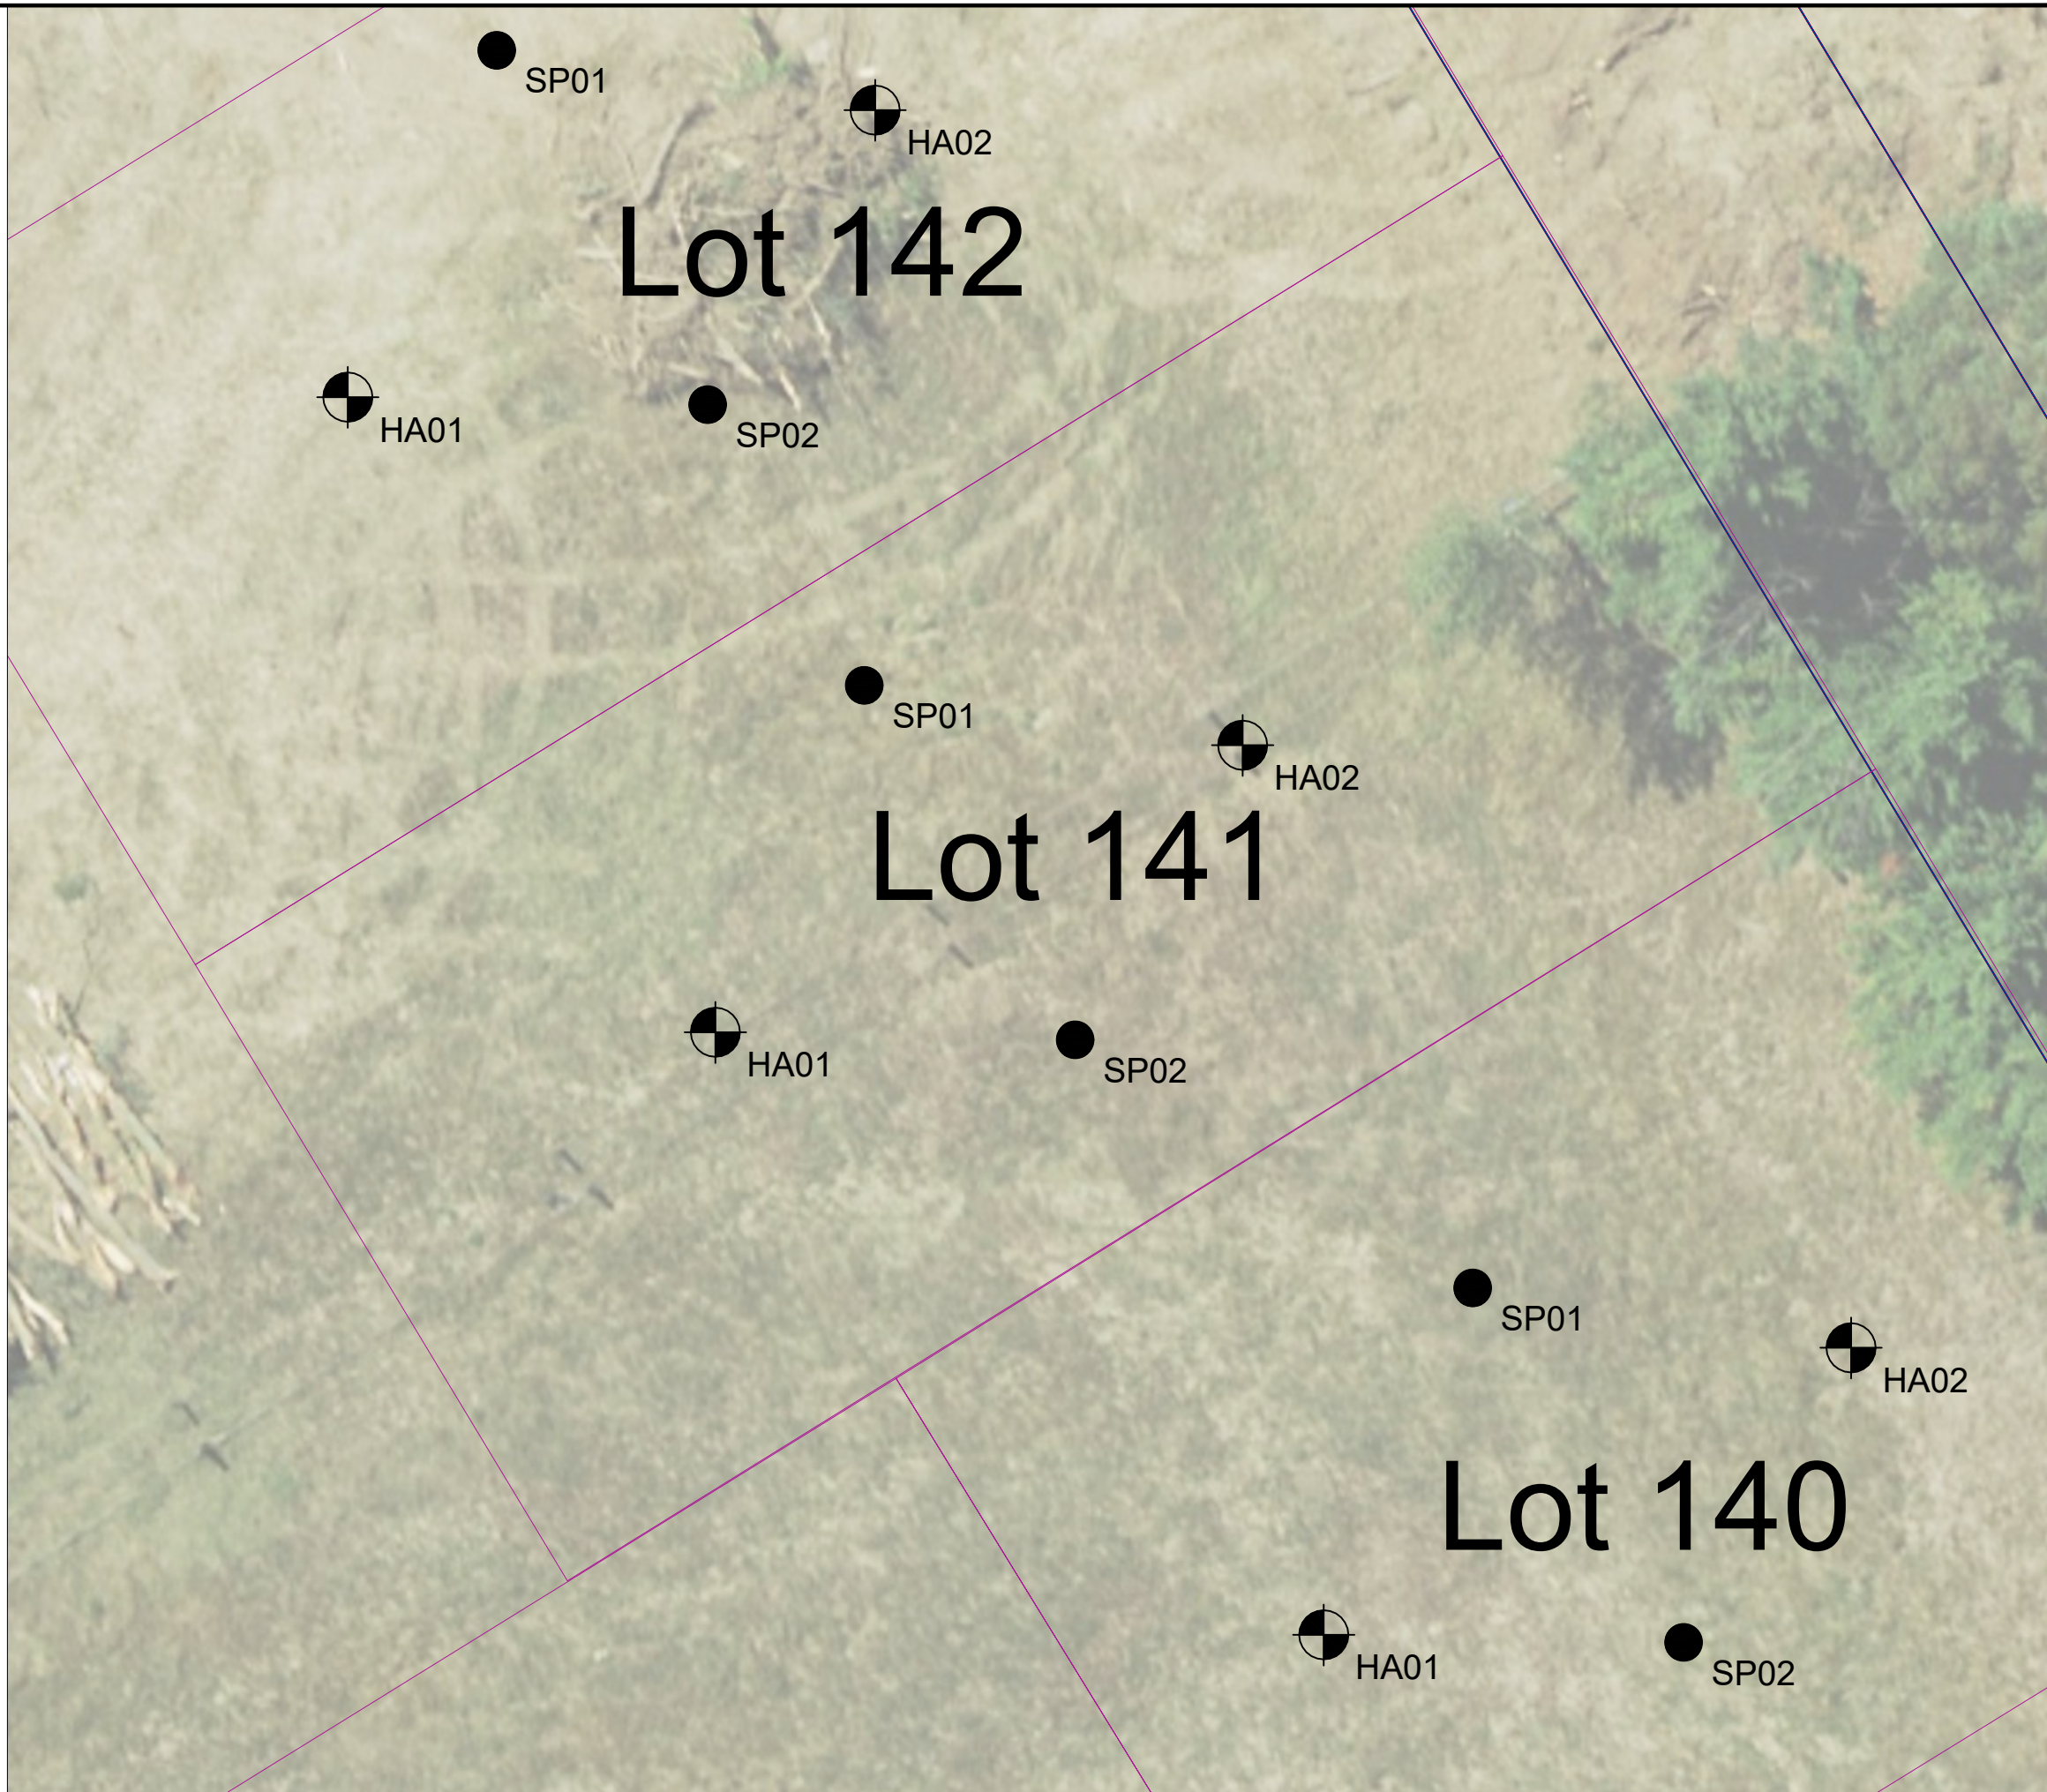
Test Location Plan

The hand auger holes encountered topsoil/fill material from the ground surface to approximately 0.2m to 0.3m depths, underlain by inferred natural gravel. Groundwater was not encountered during testing. Scala Penetrometer testing at each of the four locations returned results between 1 and 41 blows per 100mm penetration at the test positions, encountering refusal at depths between 0.4m and 0.8m below present ground level.

From the lot-specific investigation for the site we conclude the site has “Good Ground”, and that dwelling foundations on this site can comprise NZS3604:2011 type foundations or codemark approved concrete slab foundations that are applicable for the site conditions (i.e. “good ground”). All foundations must be embedded to a minimum depth of 0.3m below ground level, into the underlying Natural Gravel or Engineered Fill. At these depths, either “Good Ground” or an Ultimate Bearing Capacity of 300kPa is available/inferred. If specific engineering design is being carried out a strength reduction factor of $\phi=0.5$ should be used. This depth has been supplied based on ground level at the time of testing. All topsoil and unsuitable materials should be removed below foundations and floor slab areas.
