Project No: LTC22215

**RE: SHALLOW SOIL TEST REPORT  
LOT 117, 138 DUNNS CROSSING ROAD**

Test Location Plan

Lot 117, 138 Dunns Crossing Road  
ROLLESTON

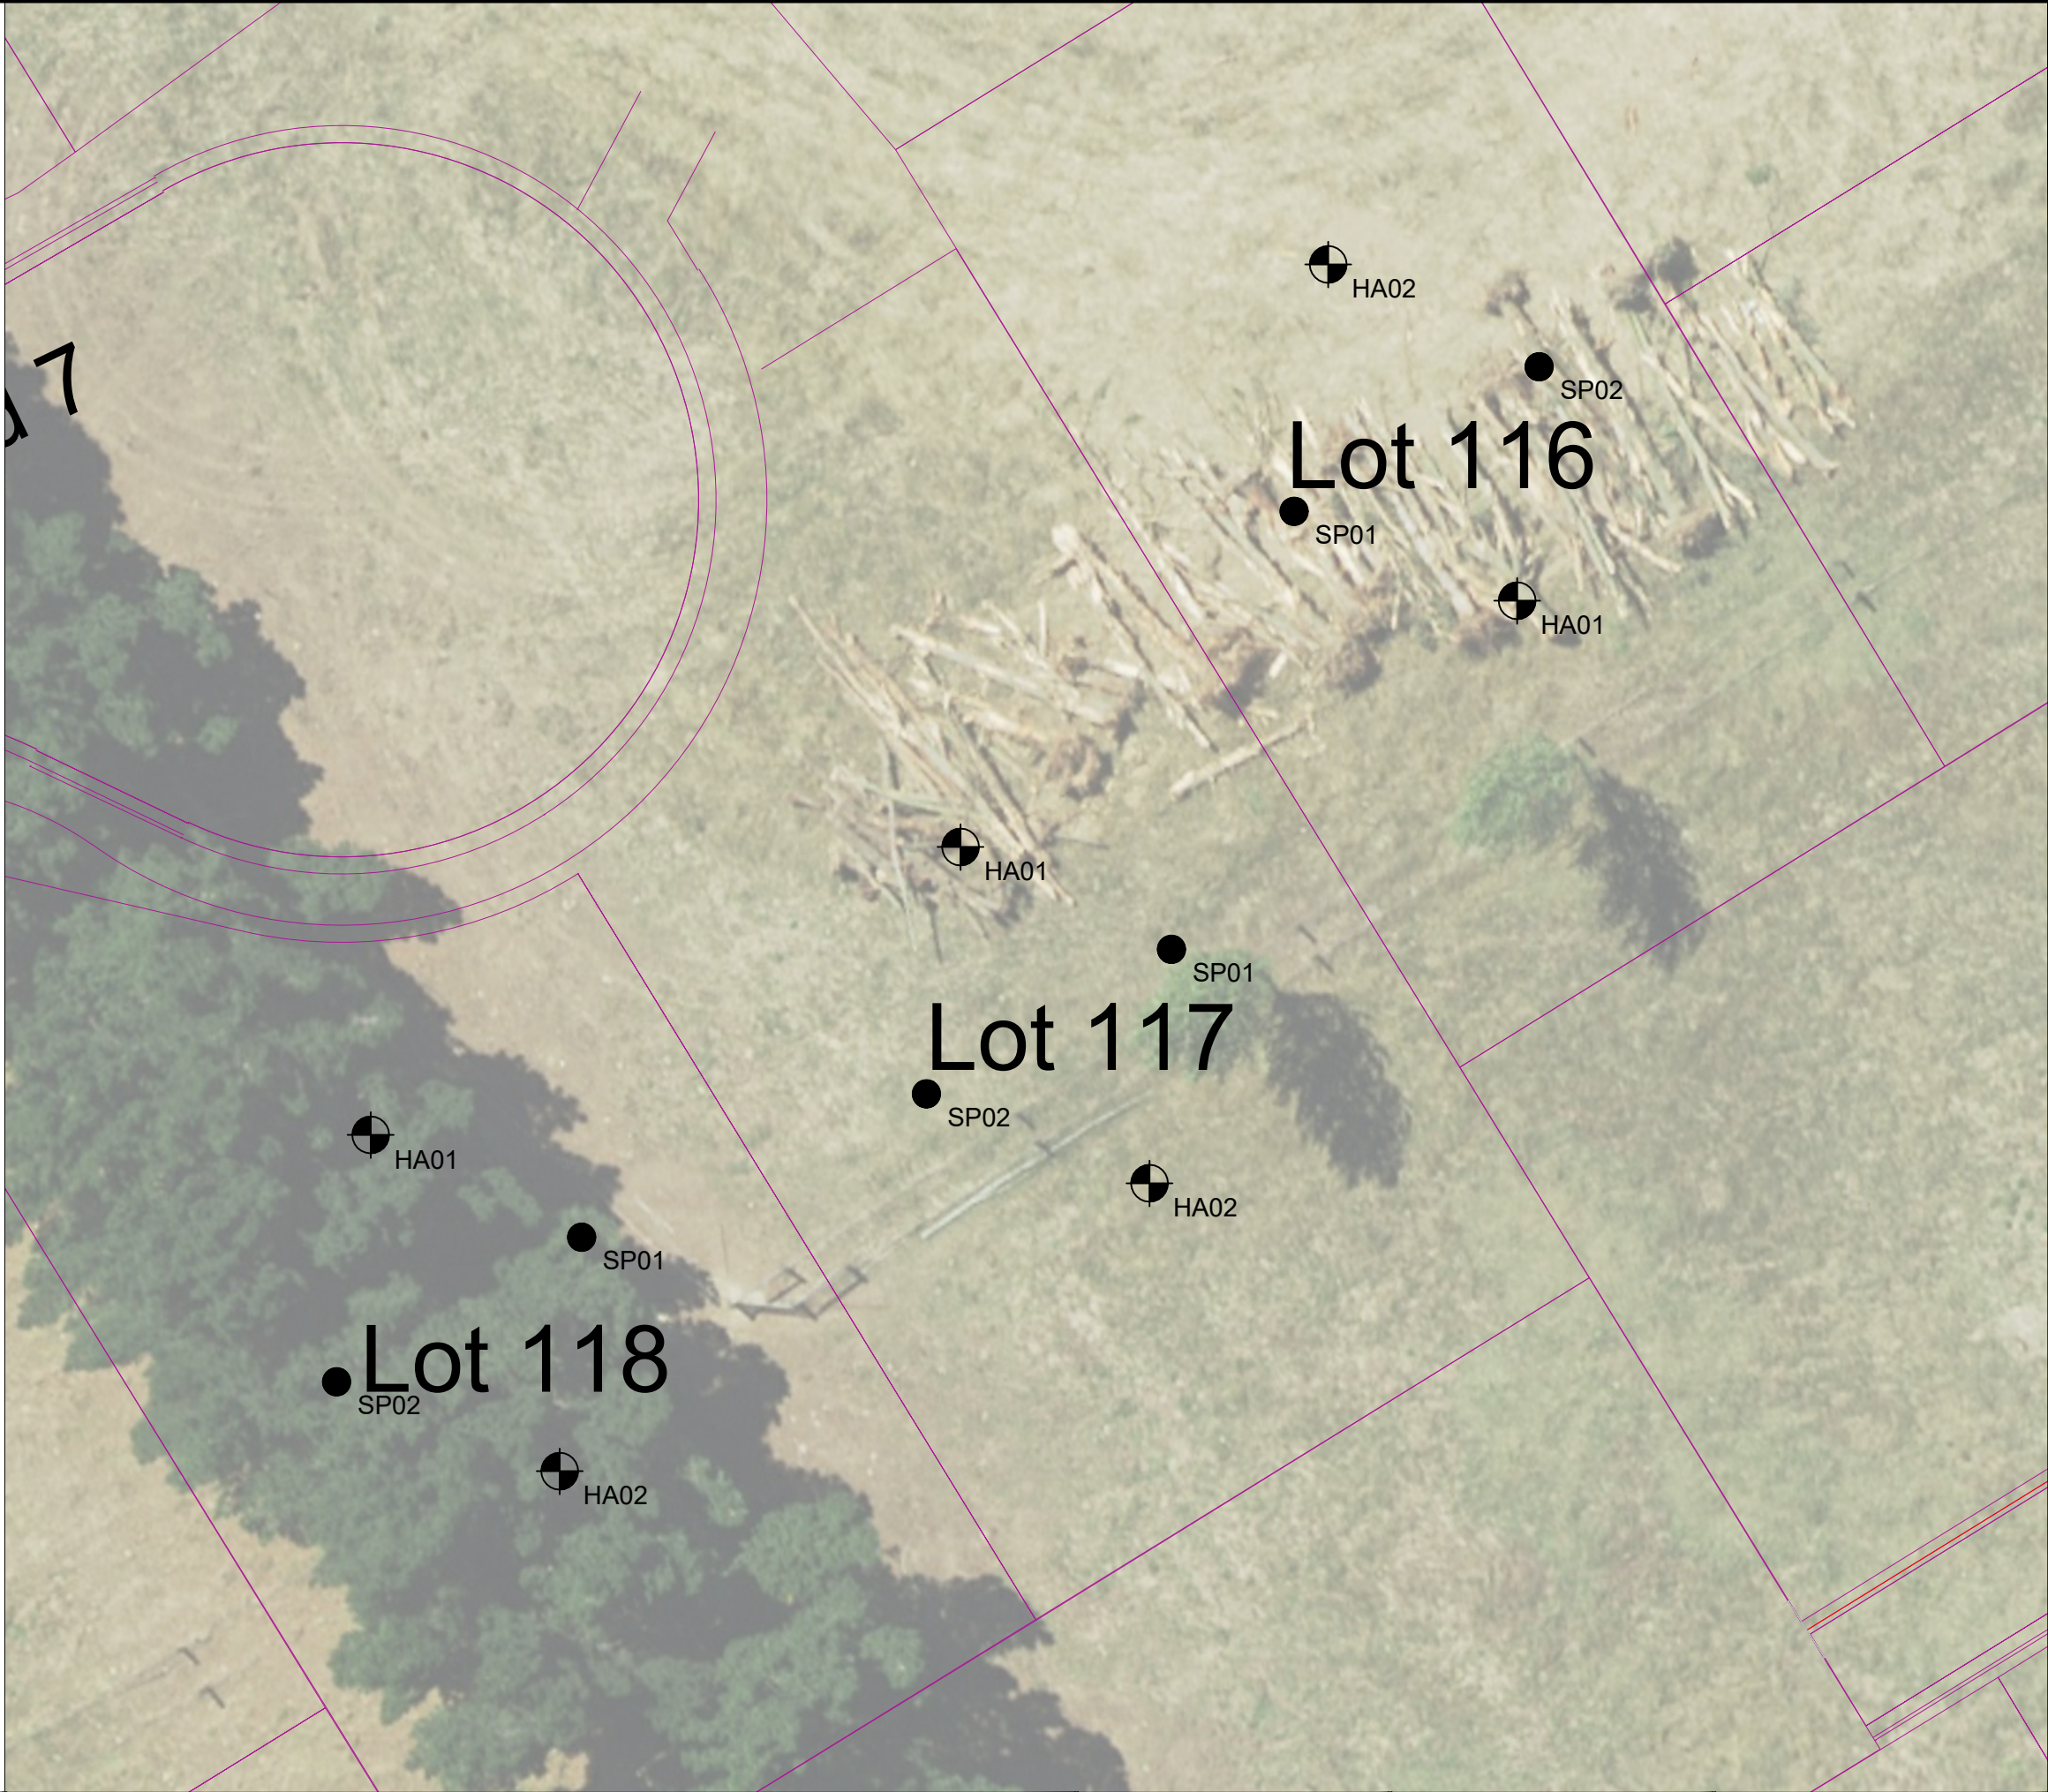
Drawing No. Lot 117/ TLP	Drawn by: KB	Date: 15 September 2022
Scale: 1: 200 (A3)	Checked by: L Tech	Revision: A
Filename: LTC22215 - Master Plan Drawings.dwg

LandTech investigated the site on 19 September 2022, comprising two hand auger holes with corresponding Scala Penetrometer tests and two additional Scala Penetrometer tests. The test locations were measured from lot boundaries and/or surveyed centre pegs and are approximate only. The test locations are shown on the LandTech *Test Location Plan*, Drawing No. Lot 117/ TLP attached to this report.

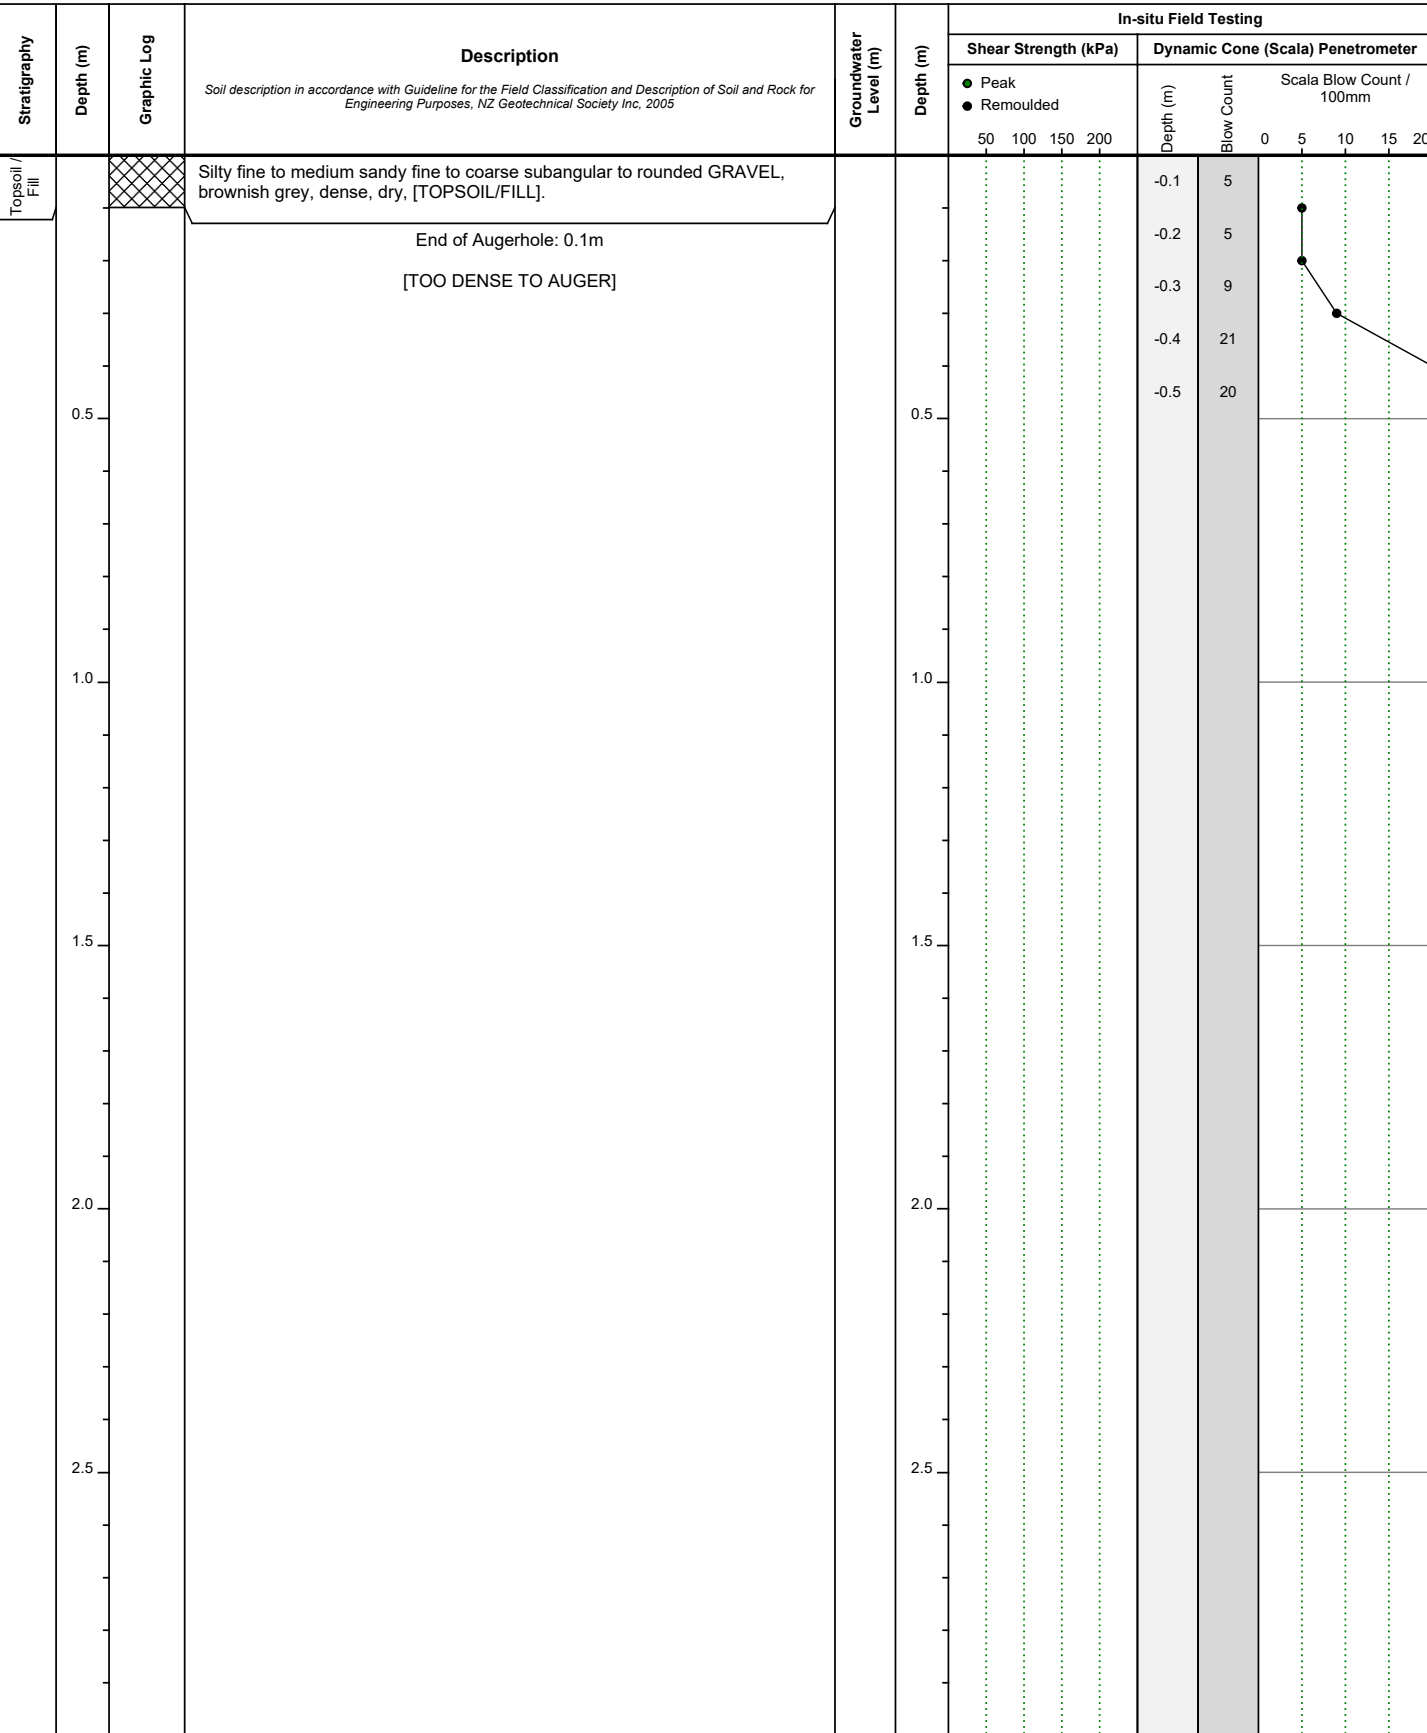
**Augerhole No.:** Lot 117 - HA02

Inferred gravels	<small>In-situ testing in accordance with the following standards: Scala Penetrometer Testing: NZS 4402:1988, Test 6.5.2, Dynamic Cone Penetrometer Shear Vane Testing: Guideline for Hand Held Shear Vane Test, NZGS, August 2001</small>
------------------	--

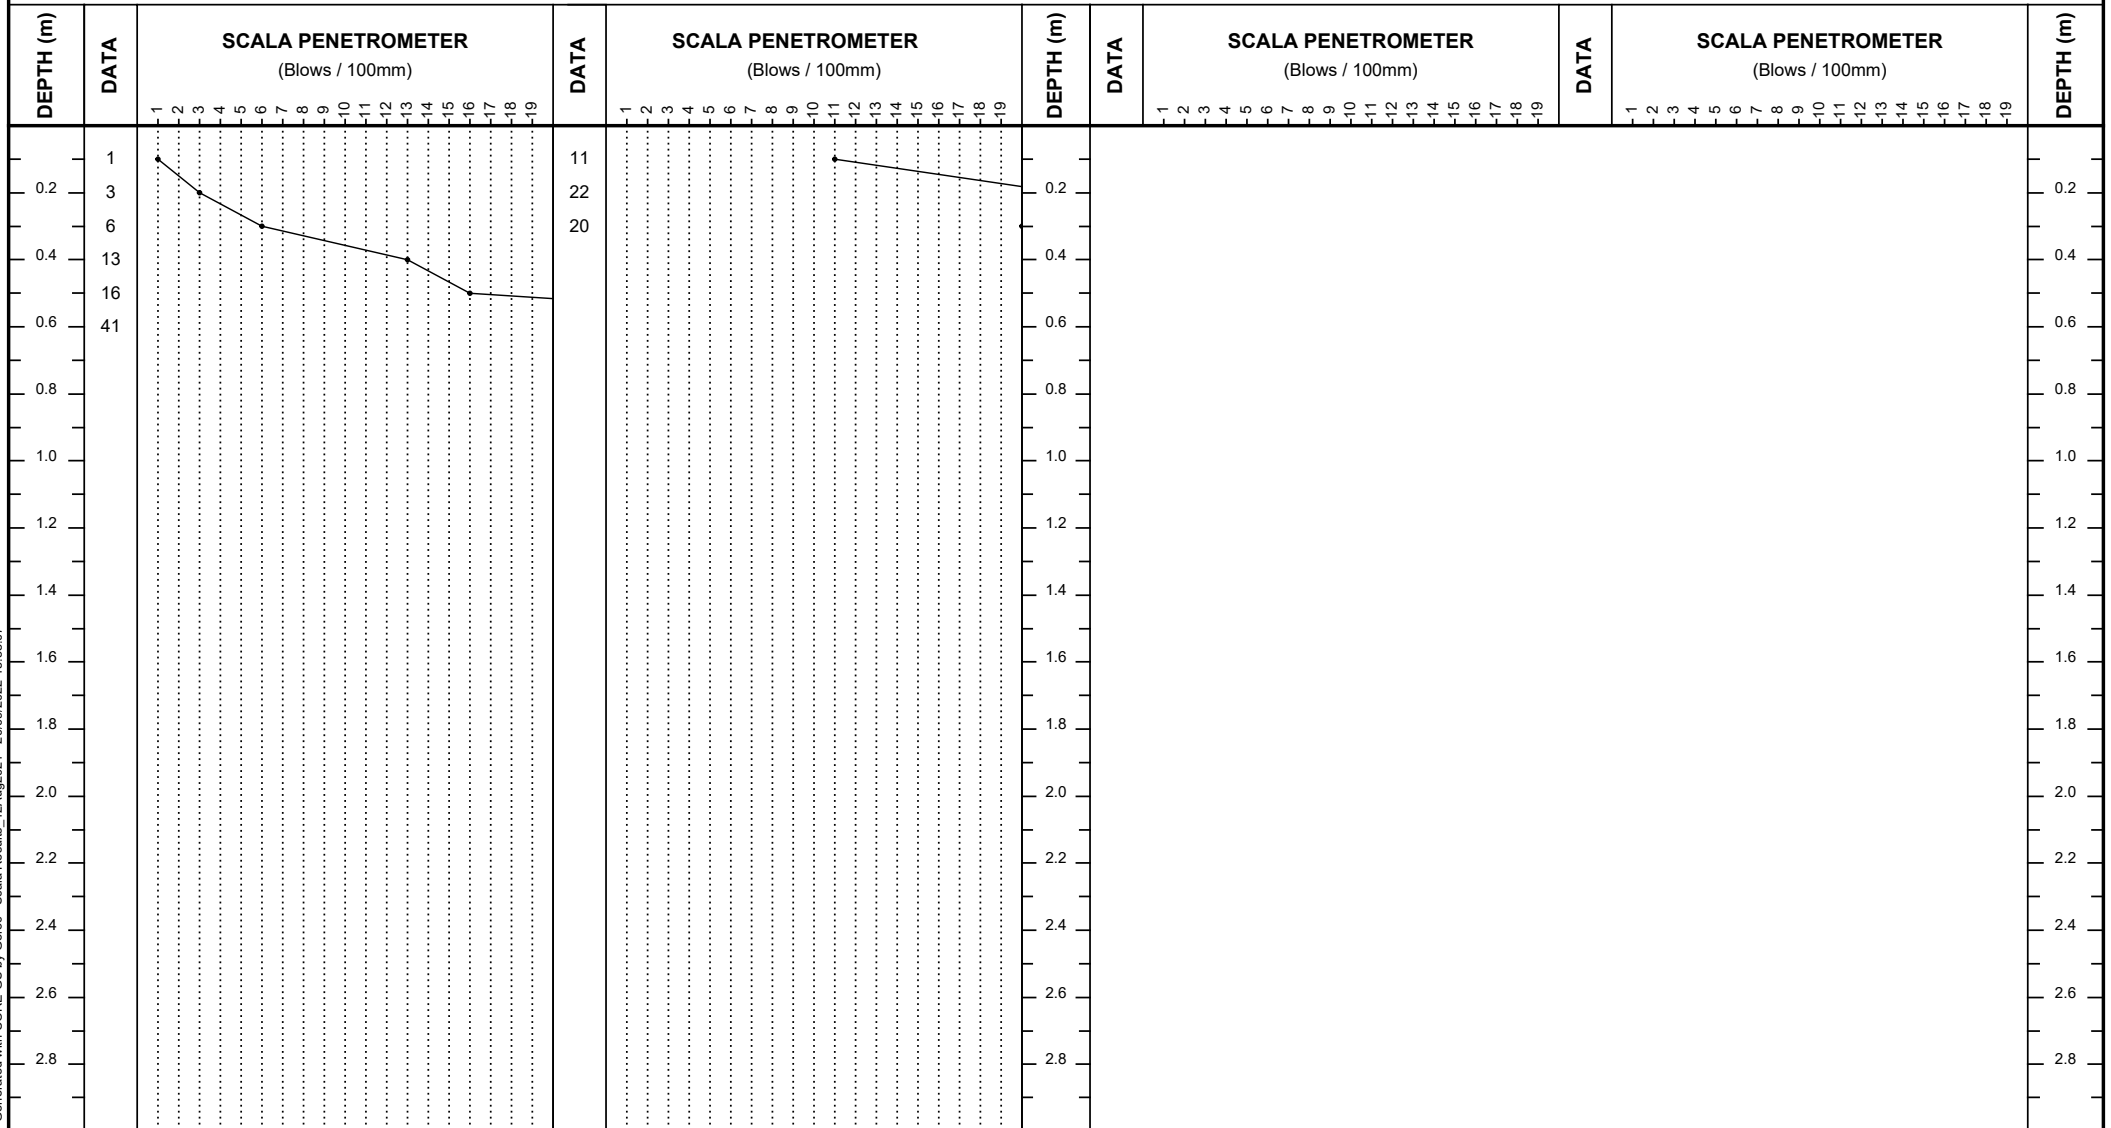
**Lot 117 - SP01**

The hand auger holes encountered topsoil/fill material from the ground surface to approximately 0.1m depths, underlain by inferred natural gravel. Groundwater was not encountered during testing. Scala Penetrometer testing at each of the four locations returned results between 1 and 40+ blows per 100mm penetration at the test positions, encountering refusal at depths between 0.3m and 0.6m below present ground level.
