27 October 2022

Project No: LTC22215

RE: SHALLOW SOIL TEST REPORT
LOT 212, 138 & 5/144 DUNNS CROSSING ROAD

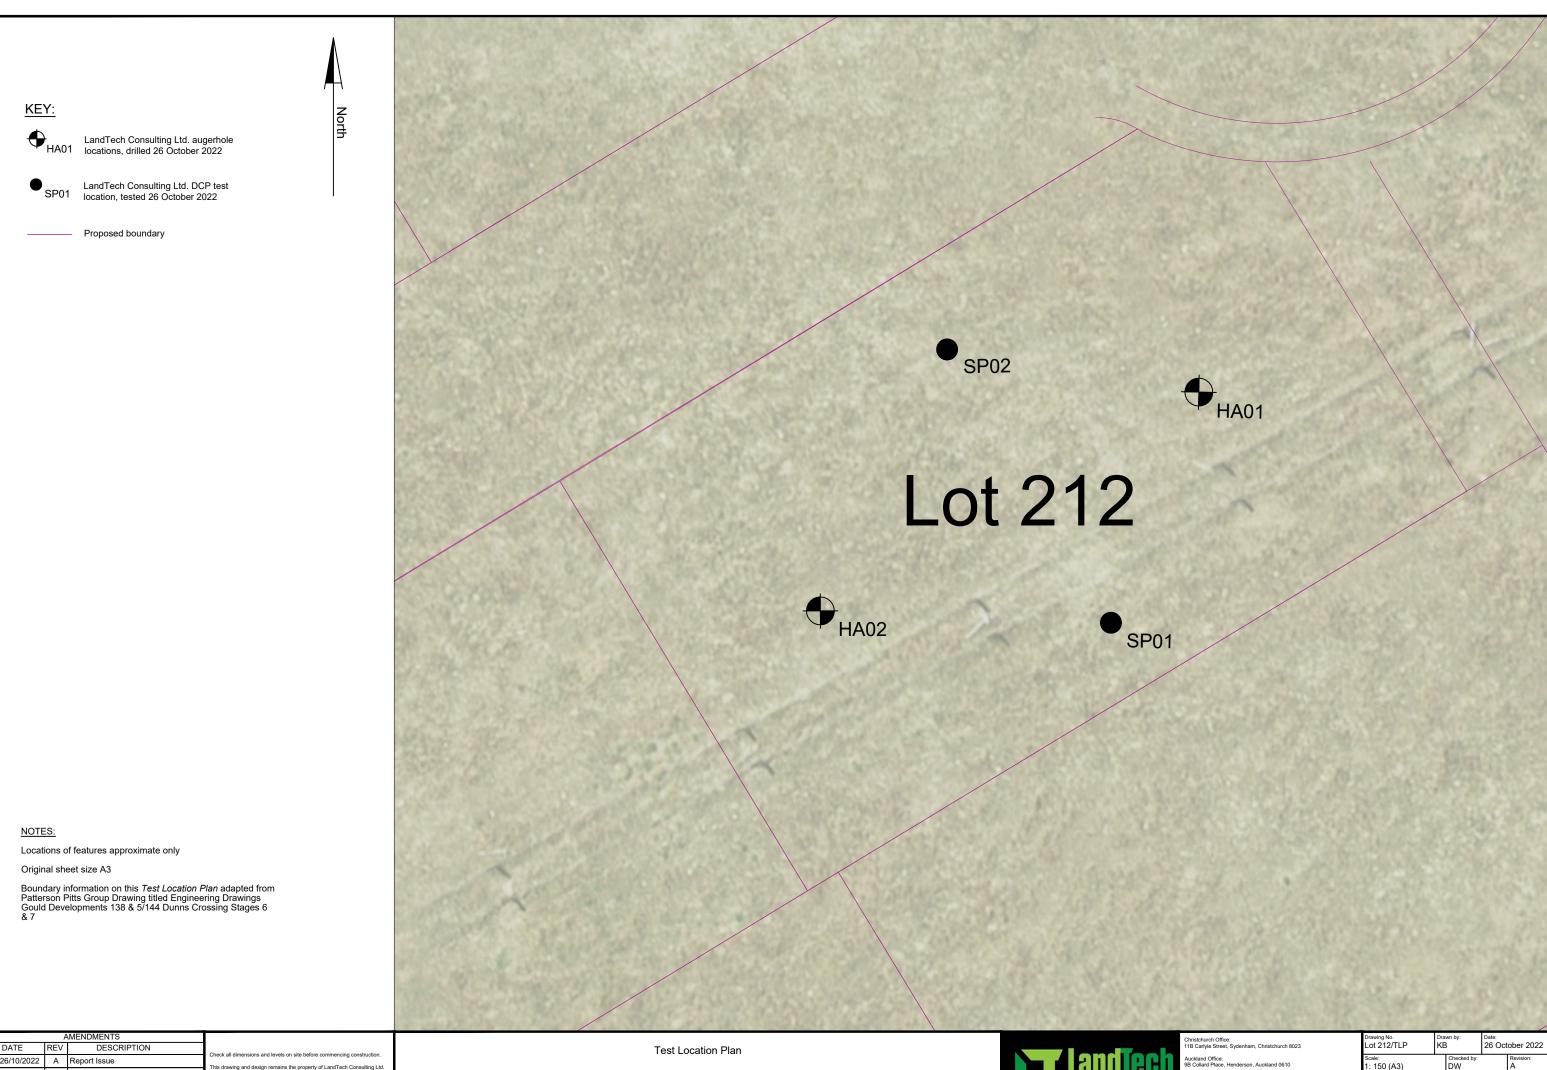
Lot 212, 138 Dunns Crossing Road ROLLESTON

LandTech investigated the site on 26 October 2022, comprising two hand auger holes with corresponding Scala Penetrometer tests and two additional Scala Penetrometer tests. The test locations were measured from lot boundaries and/or surveyed centre pegs and are approximate only. The test locations are shown on the LandTech *Test Location Plan*, Drawing No. Lot 212/ TLP attached to this report.
