Project No: LTC22215

**RE: SHALLOW SOIL TEST REPORT  
LOT 118, 138 DUNNS CROSSING ROAD**

Lot 118, 138 Dunns Crossing Road  
 ROLLESTON

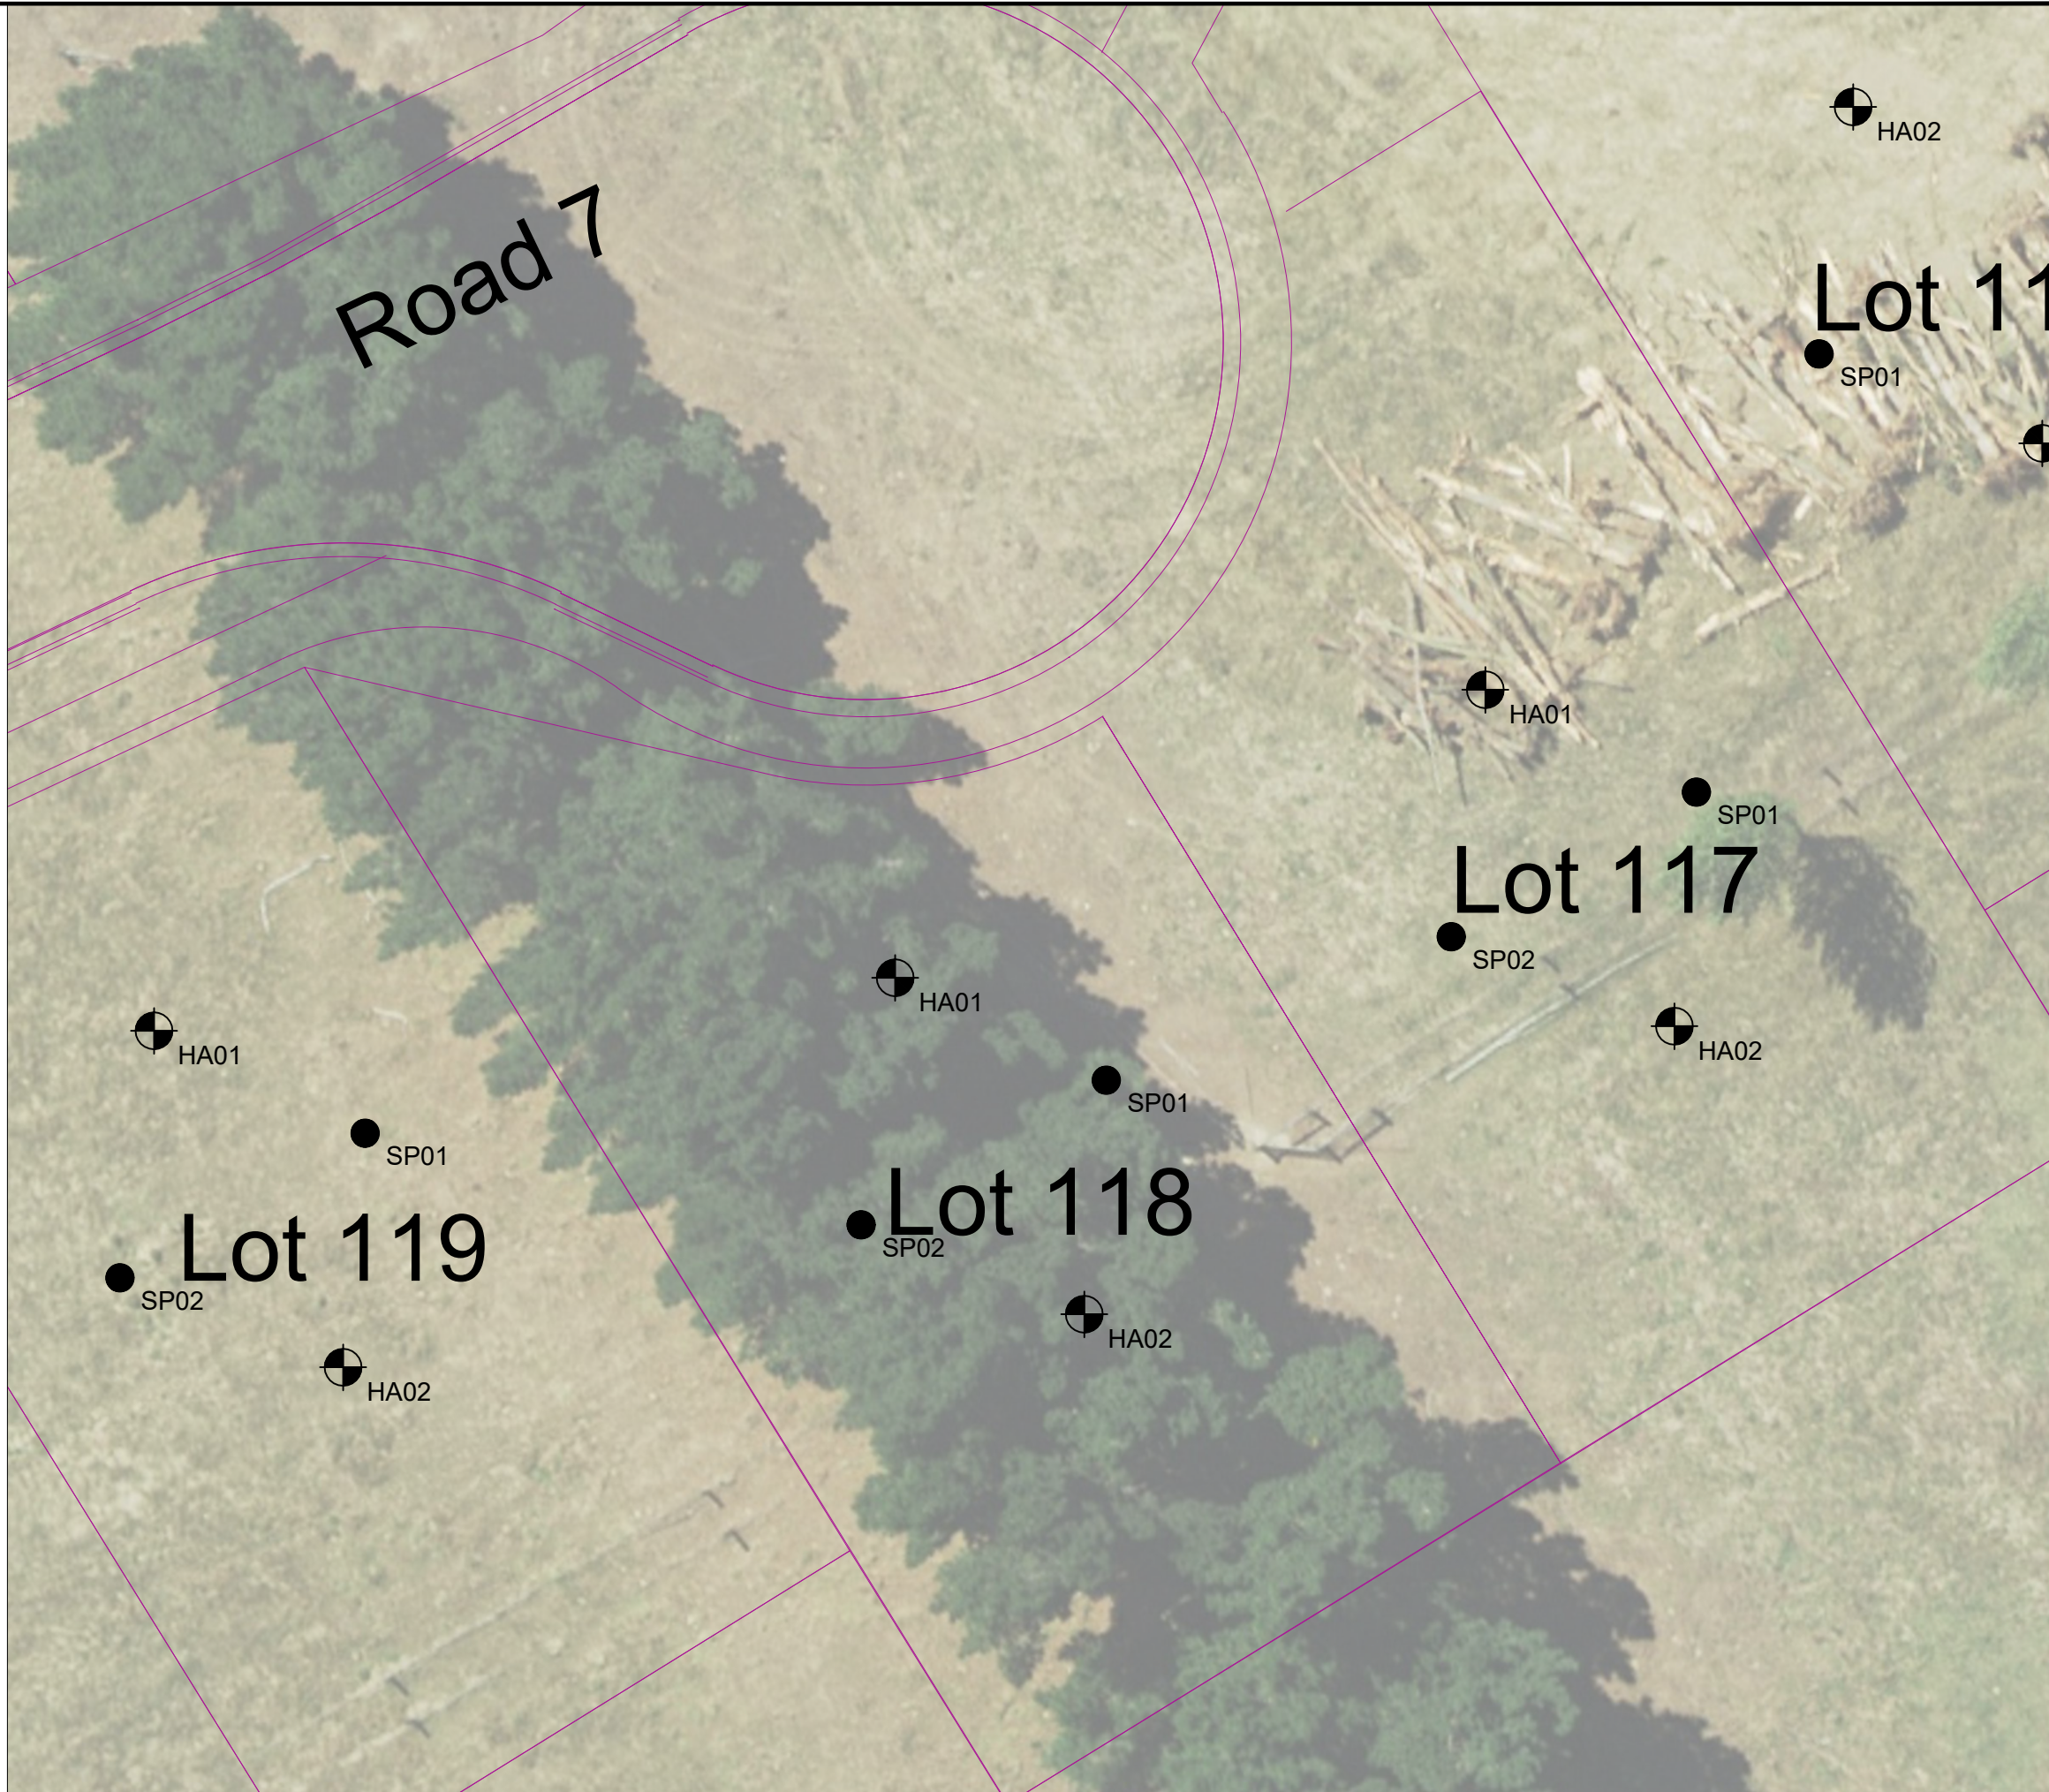
**Test Location Plan**

LandTech investigated the site on 19 September 2022, comprising two hand auger holes with corresponding Scala Penetrometer tests and two additional Scala Penetrometer tests. The test locations were measured from lot boundaries and/or surveyed centre pegs and are approximate only. The test locations are shown on the LandTech *Test Location Plan*, Drawing No. Lot 118/ TLP attached to this report.

The hand auger holes encountered topsoil/fill material from the ground surface to approximately 0.2m depths, underlain by inferred natural gravel. Groundwater was not encountered during testing. Scala Penetrometer testing at each of the four locations returned results between 2 and 40+ blows per 100mm penetration at the test positions, encountering refusal at depths between 0.4m and 0.5m below present ground level.
