Project No: LTC22215

**RE: SHALLOW SOIL TEST REPORT
LOT 119, 138 DUNNS CROSSING ROAD**

Test Location Plan
 Lot 119, 138 Dunns Crossing Road
 ROLLESTON

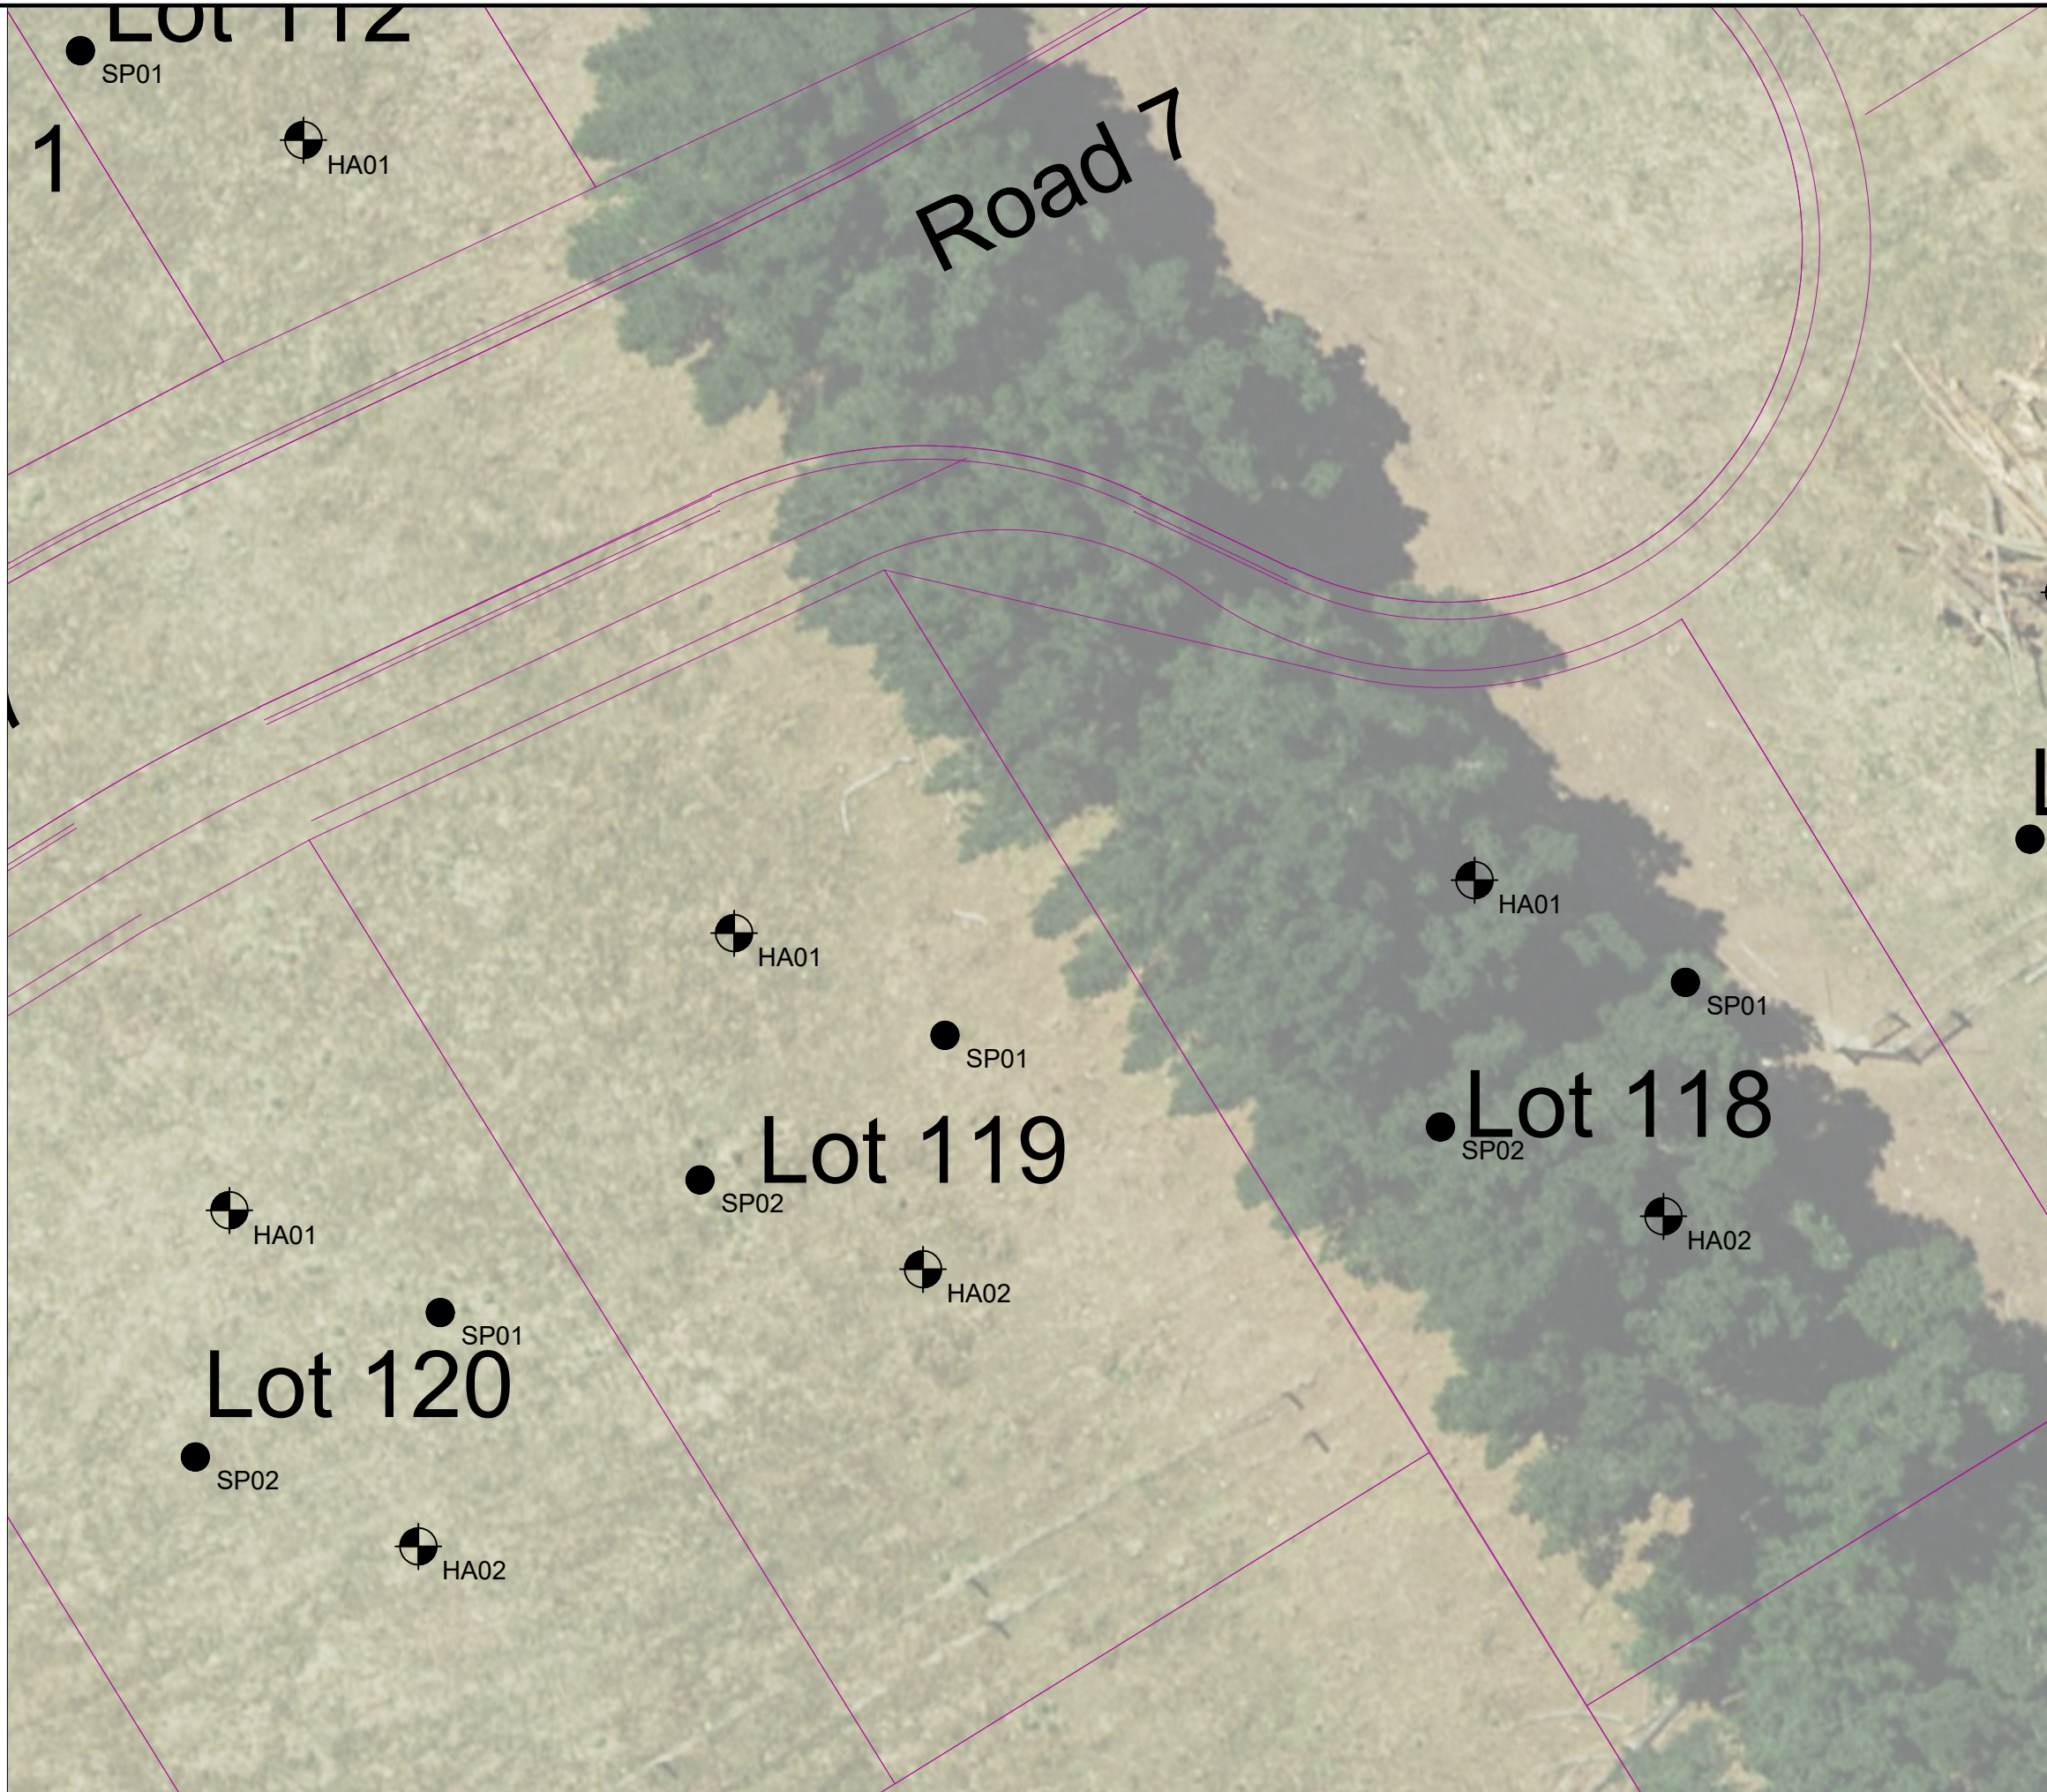
LandTech investigated the site on 19 September 2022, comprising two hand auger holes with corresponding Scala Penetrometer tests and two additional Scala Penetrometer tests. The test locations were measured from lot boundaries and/or surveyed centre pegs and are approximate only. The test locations are shown on the LandTech *Test Location Plan*, Drawing No. Lot 119/ TLP attached to this report.
