Project No: LTC22215

**RE: SHALLOW SOIL TEST REPORT
LOT 136, 138 DUNNS CROSSING ROAD**

Test Location Plan
 Lot 136, 138 Dunns Crossing Road
 ROLLESTON

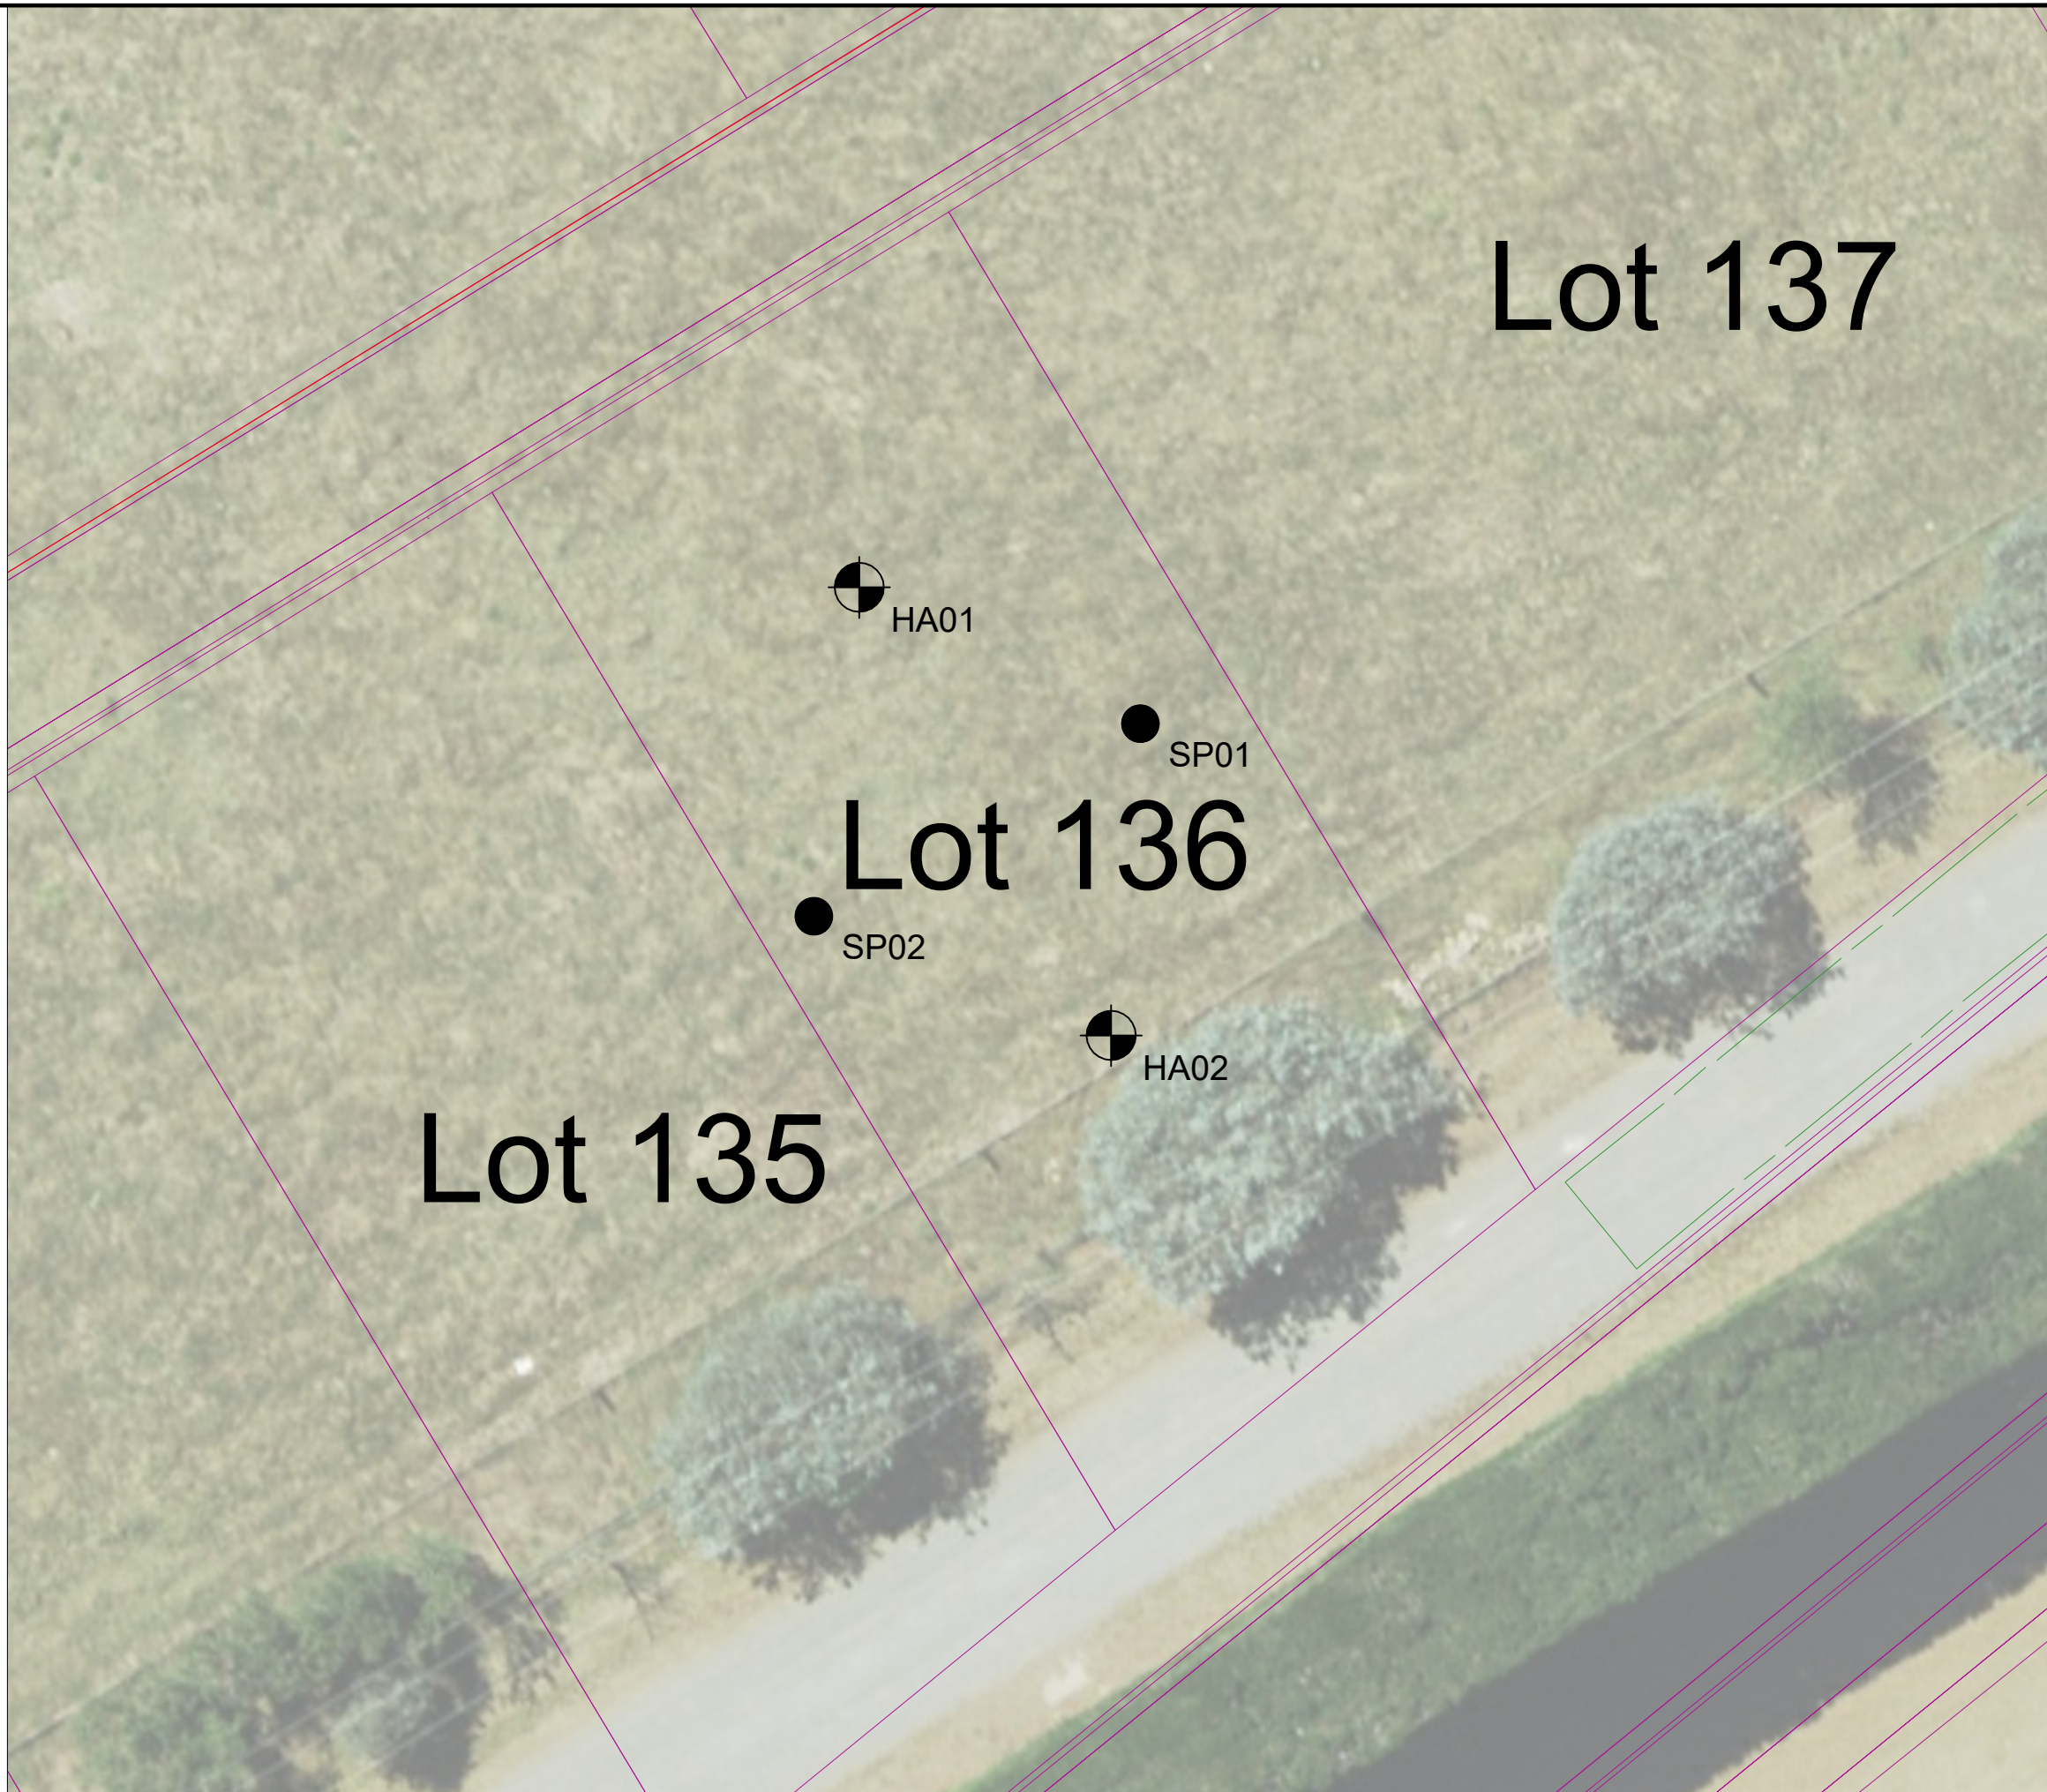
Drawing No: Lot 136/TLP	Drawn by: KB	Date: 15 September 2022
Scale: 1: 150 (A3)	Checked by: DW	Revision: A
Filename: LTC22215 - Master Plan Drawings.dwg

LandTech investigated the site on 22 September 2022, comprising two hand auger holes with corresponding Scala Penetrometer tests and two additional Scala Penetrometer tests. The test locations were measured from lot boundaries and/or surveyed centre pegs and are approximate only. The test locations are shown on the LandTech *Test Location Plan*, Drawing No. Lot 136/ TLP attached to this report.

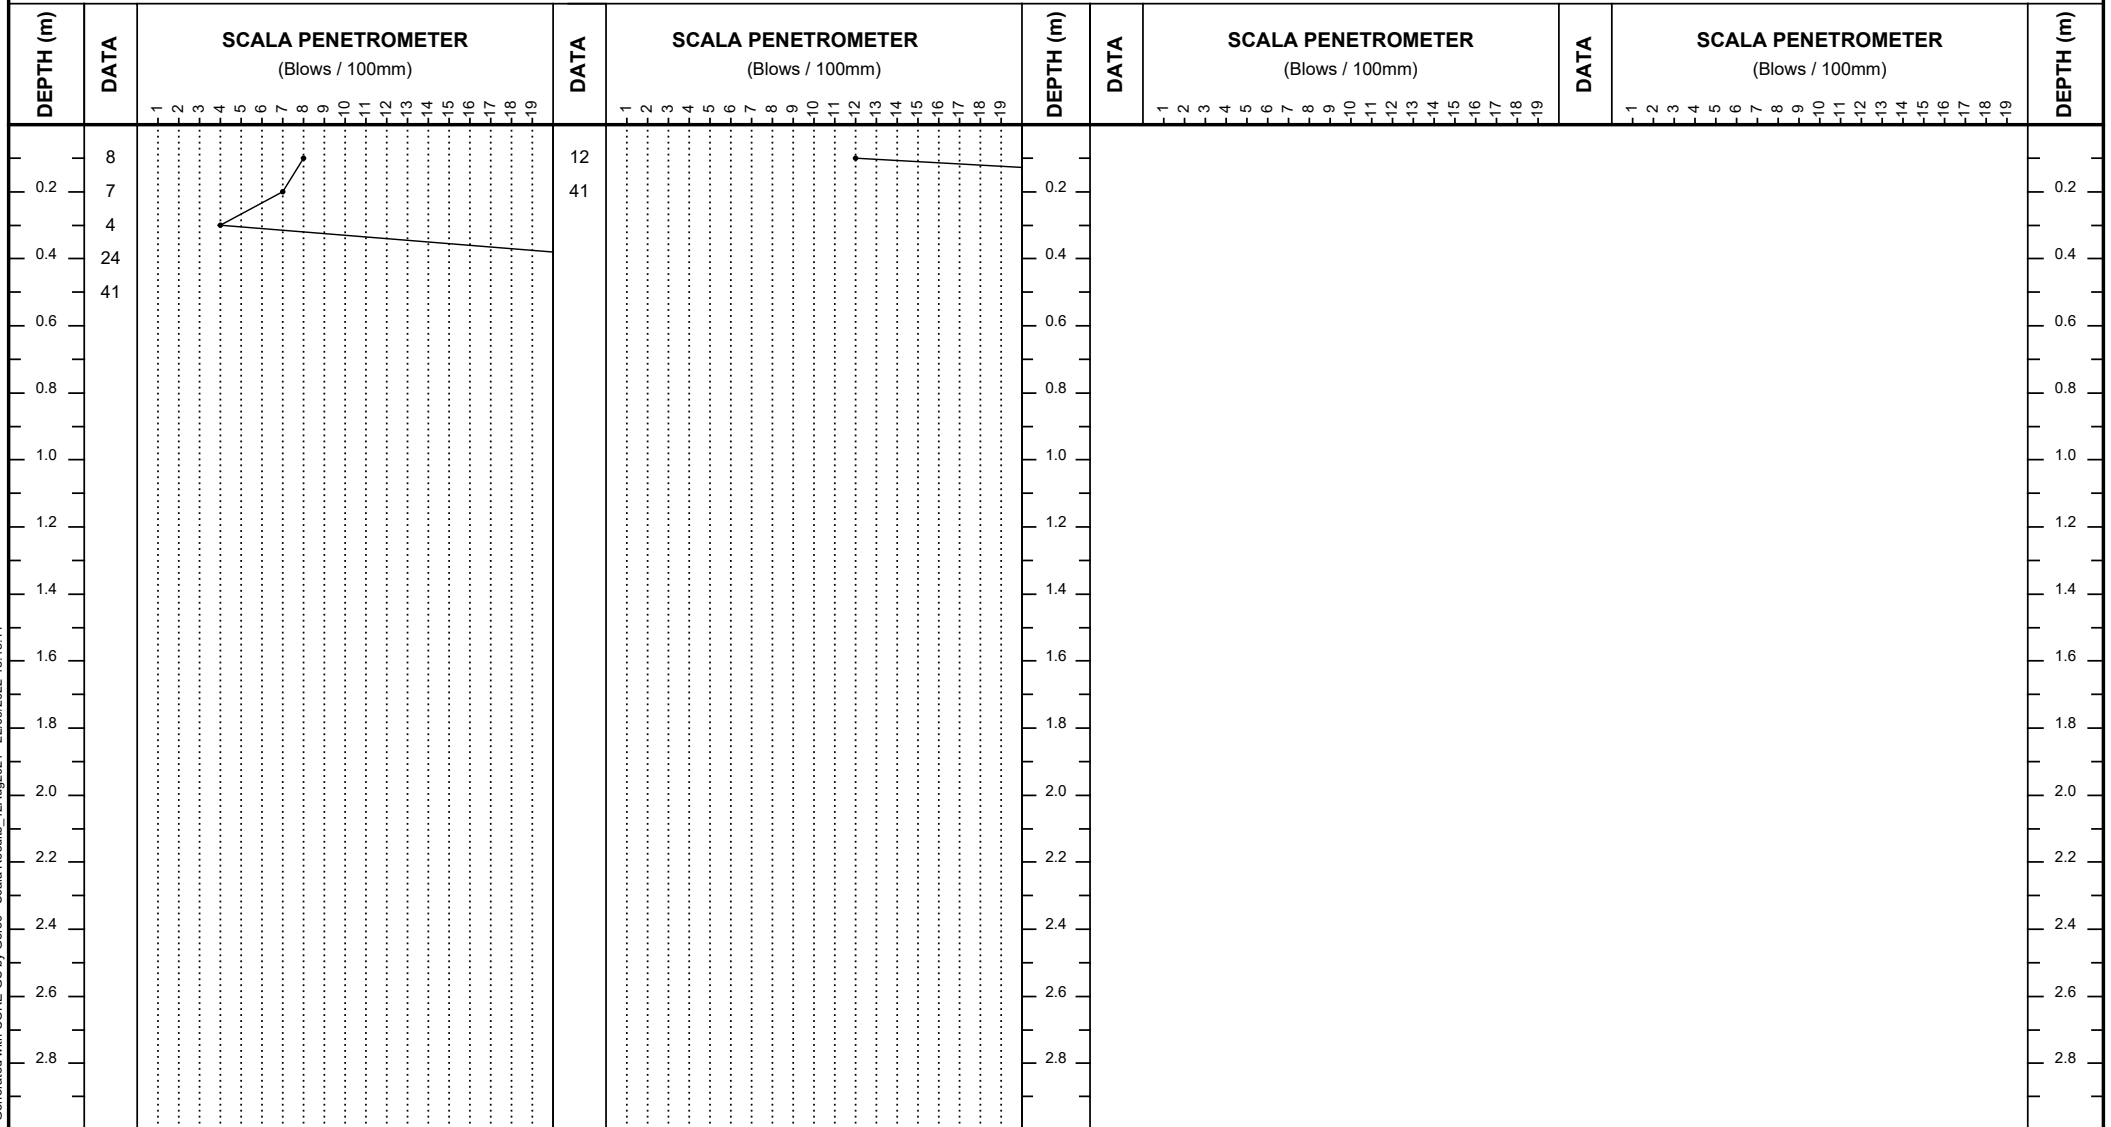
The hand auger holes encountered topsoil/fill material from the ground surface to approximately 0.1m depths, underlain by inferred natural gravel. Groundwater was not encountered during testing. Scala Penetrometer testing at each of the four locations returned results between 4 and 40+ blows per 100mm penetration at the test positions, encountering refusal at depths between 0.2m and 0.5m below present ground level.
