Project No: LTC22215

**RE: SHALLOW SOIL TEST REPORT
LOT 122, 138 DUNNS CROSSING ROAD**

Test Location Plan
 Lot 122, 138 Dunns Crossing Road
 ROLLESTON

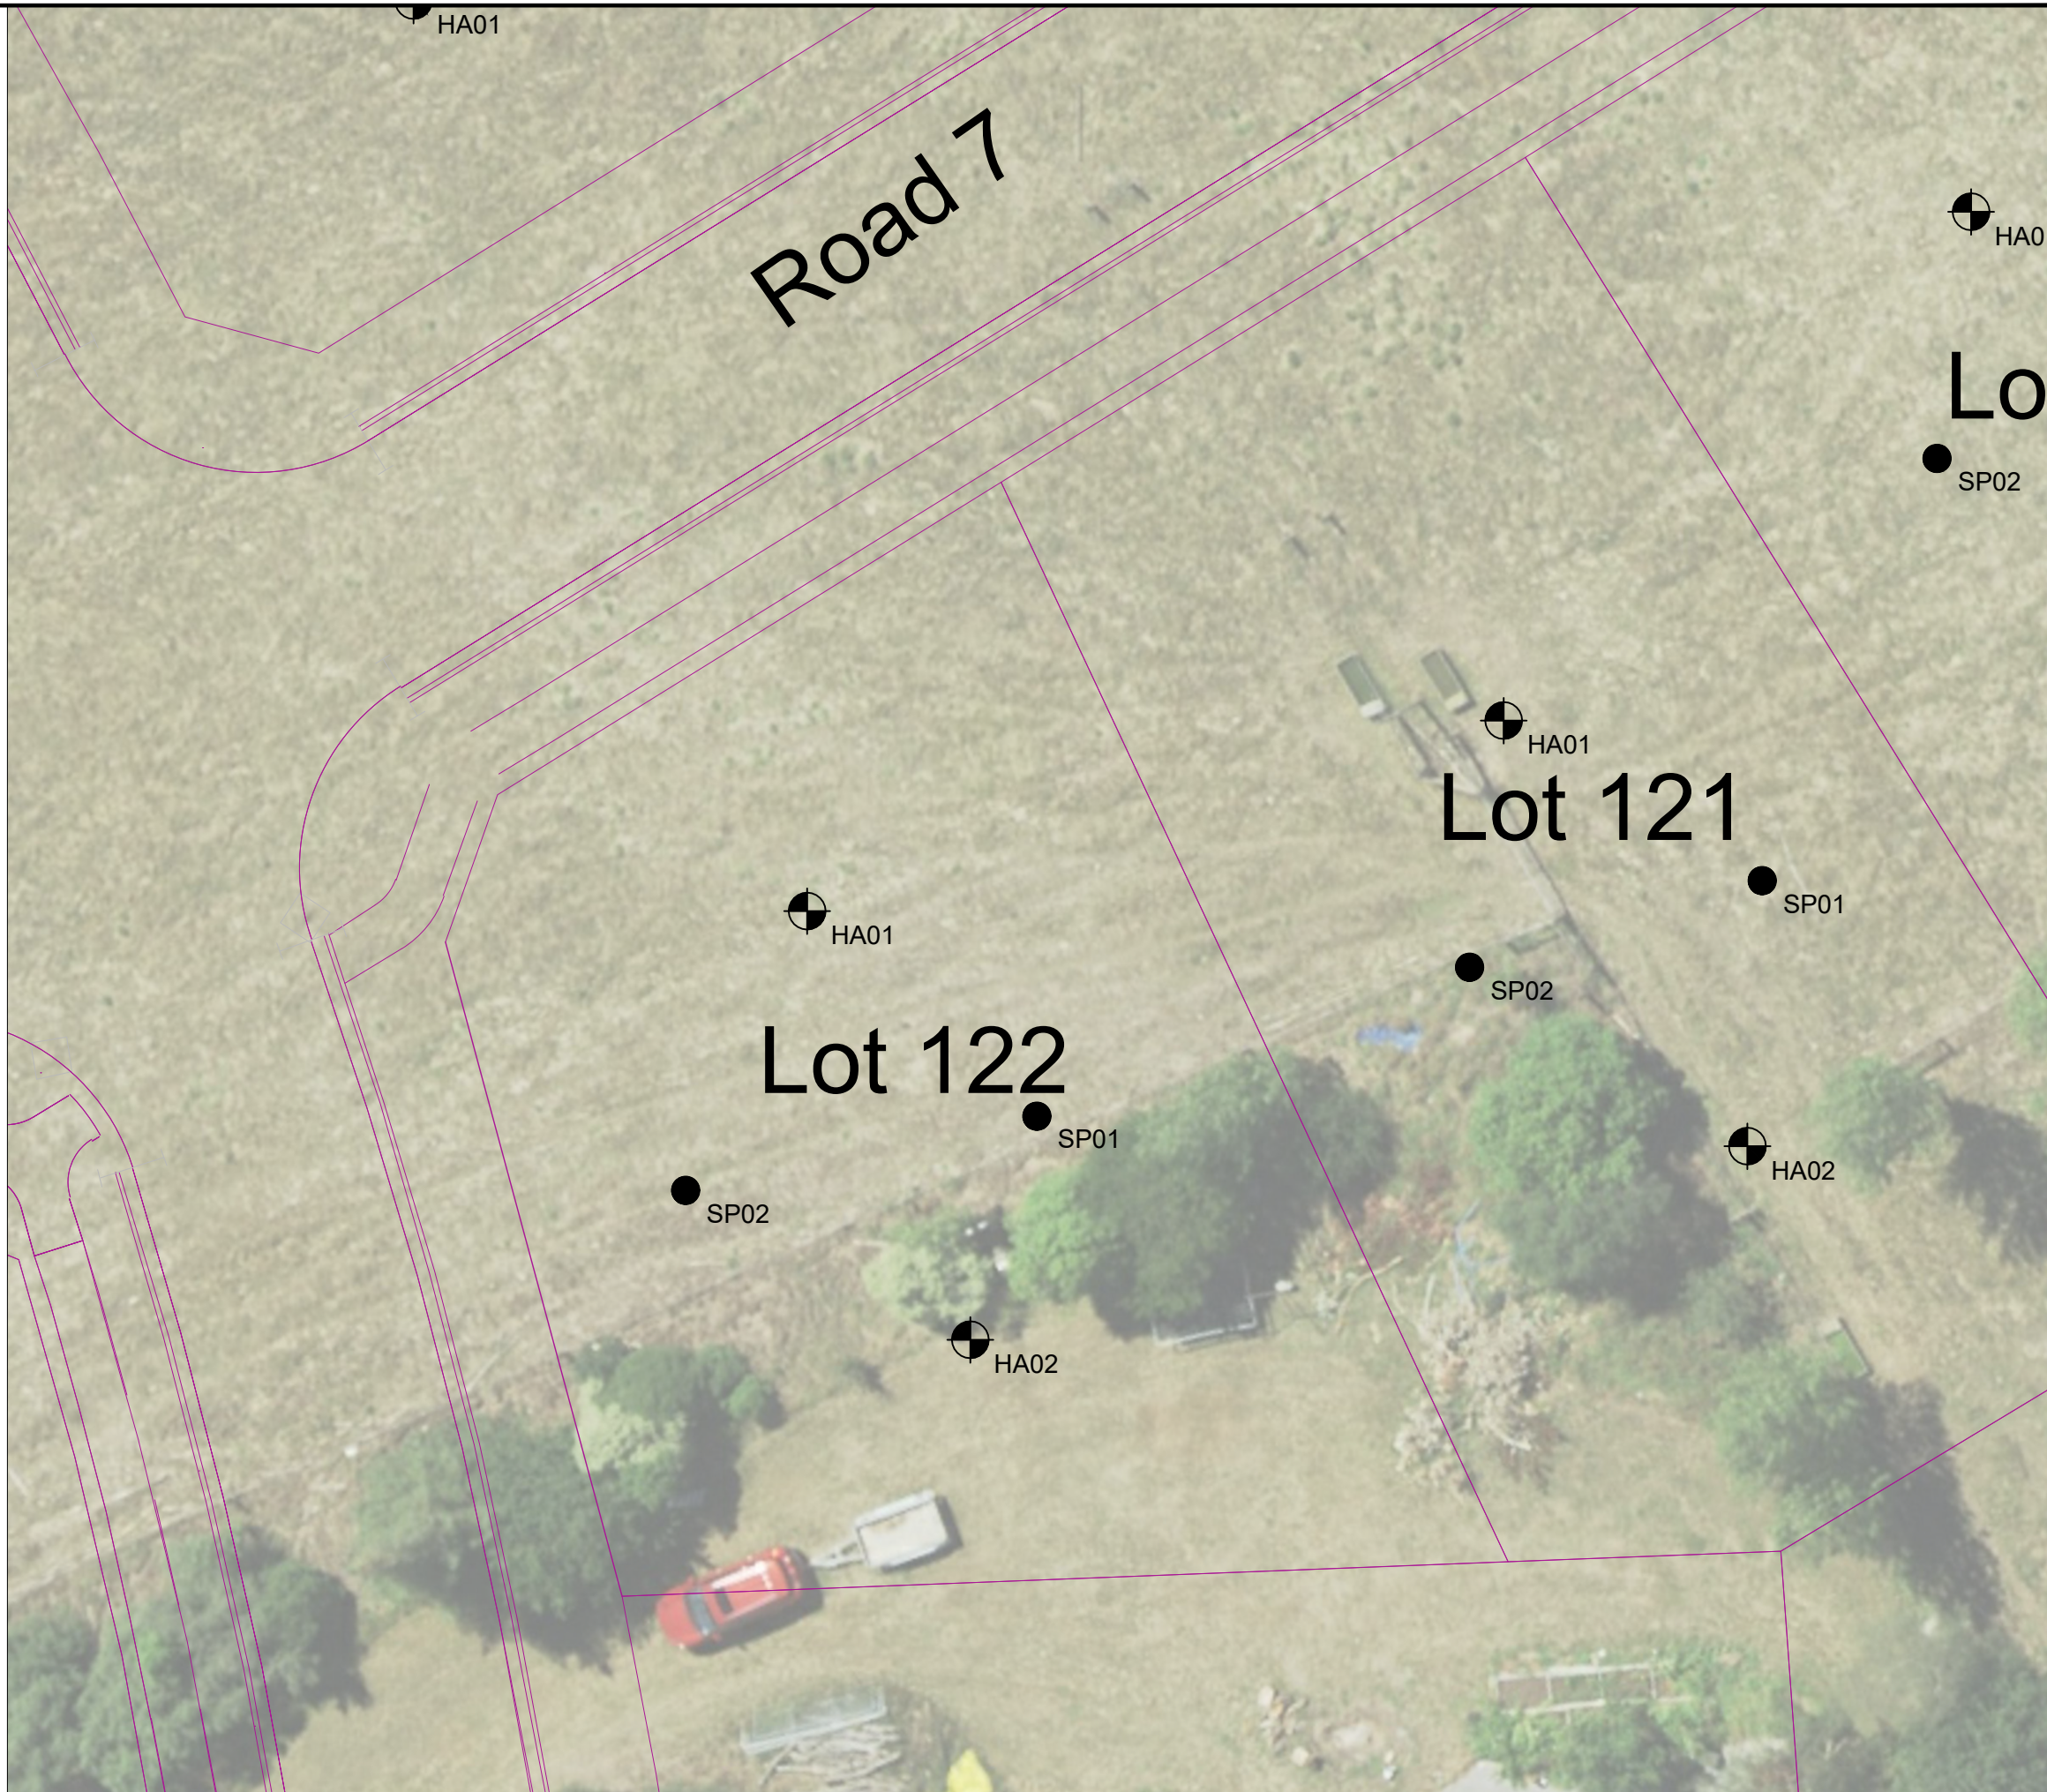
Drawing No: Lot 122/TLP	Drawn by: KB	Date: 15 September 2022
Scale: 1: 200 (A3)	Checked by: DW	Revision: A
Filename: LTC22215 - Master Plan Drawings.dwg

LandTech investigated the site on 19 September 2022, comprising two hand auger holes with corresponding Scala Penetrometer tests and two additional Scala Penetrometer tests. The test locations were measured from lot boundaries and/or surveyed centre pegs and are approximate only. The test locations are shown on the LandTech *Test Location Plan*, Drawing No. Lot 122/ TLP attached to this report.

HA01 LandTech Consulting Ltd. augerhole locations, drilled 19 September 2022
-

SP01 LandTech Consulting Ltd. DCP test location, tested 19 September 2022
- Proposed boundary

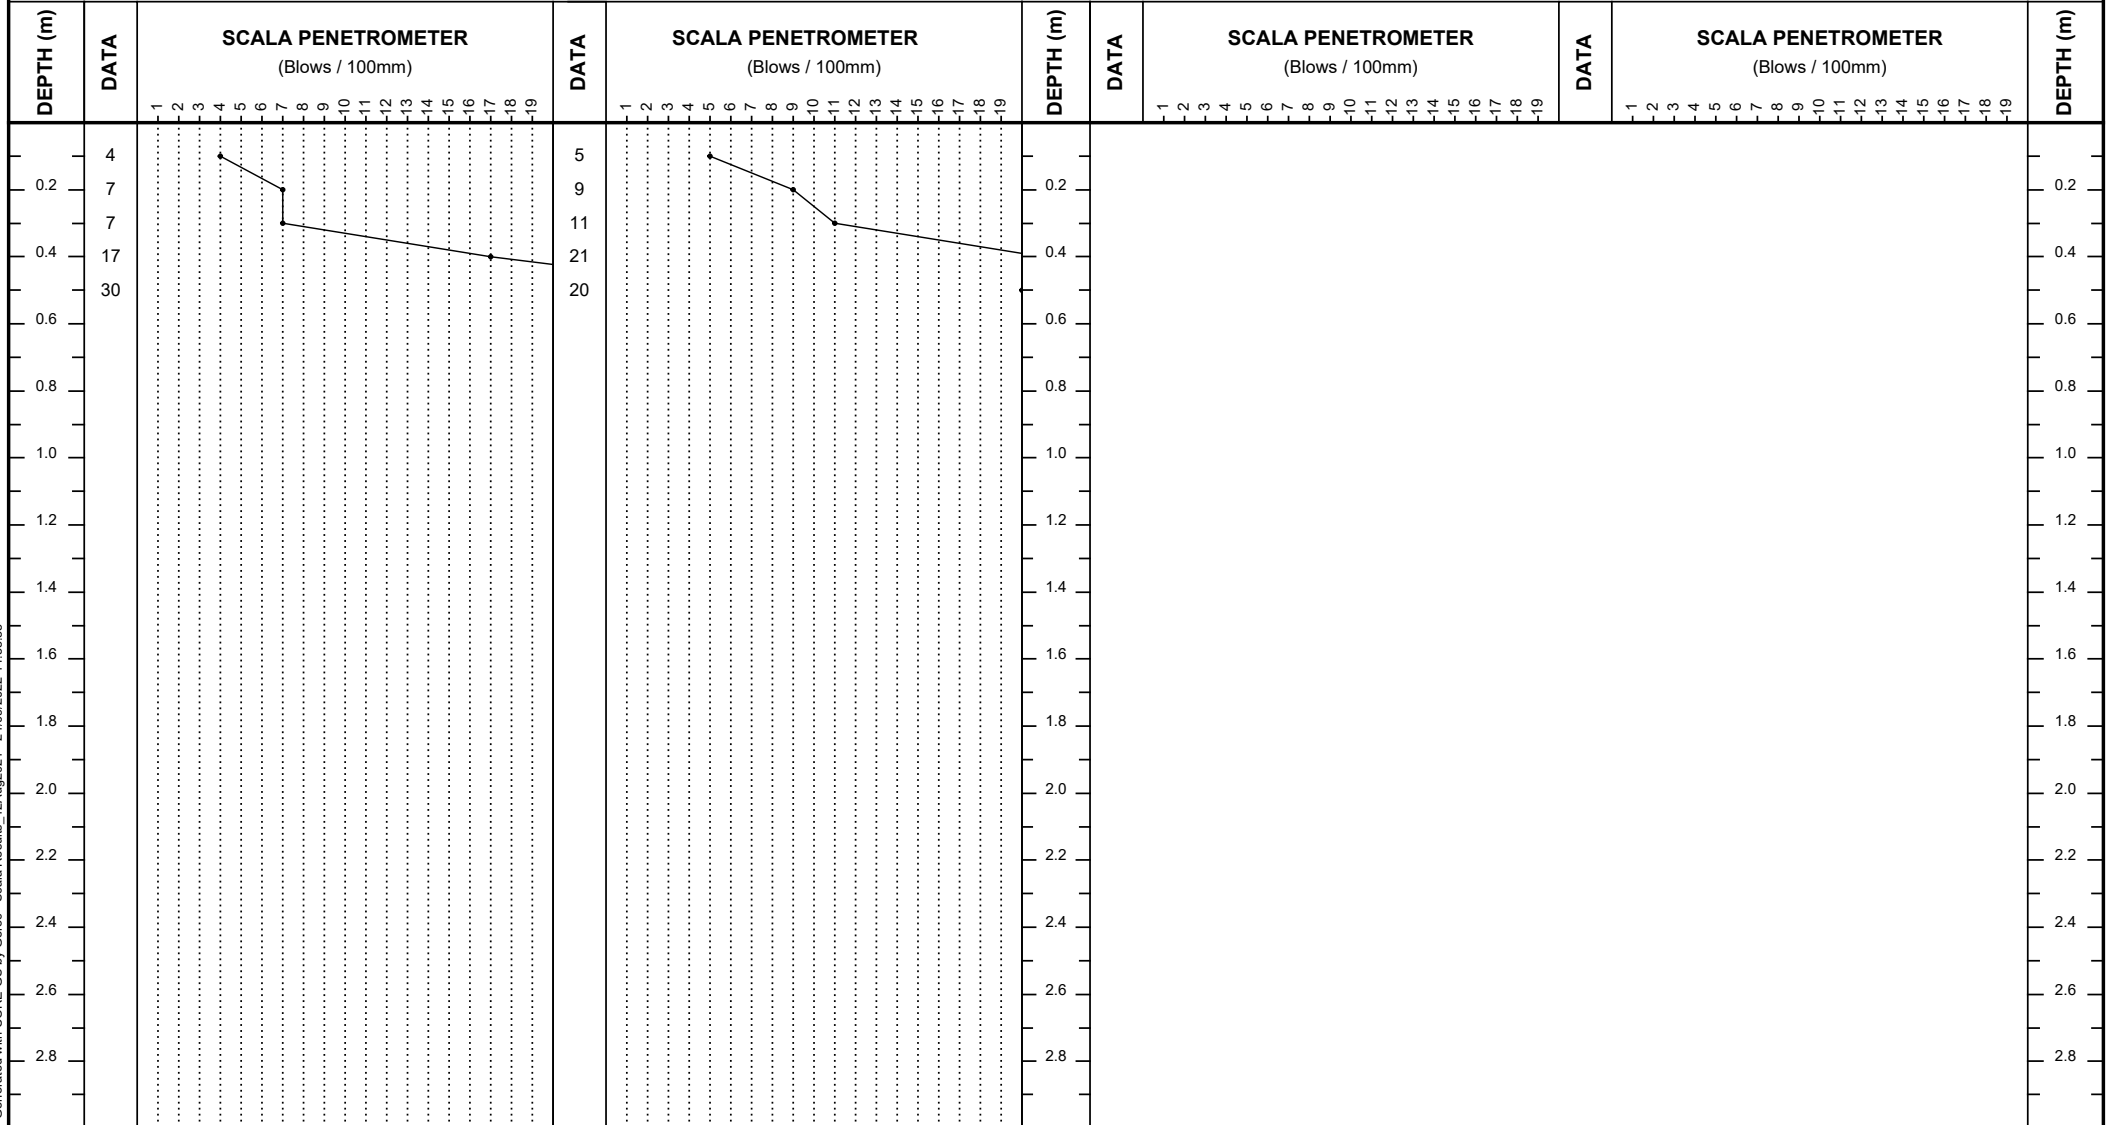
Lot 122 - SP01

The hand auger holes encountered topsoil/fill material from the ground surface to approximately 0.1m depths, underlain by inferred natural gravel. Groundwater was not encountered during testing. Scala Penetrometer testing at each of the four locations returned results between 4 and 30+ blows per 100mm penetration at the test positions, encountering refusal at depths of 0.5m below present ground level.

Tested By: KB
Ground Conditions: Near Level, Fill
Coordinates: NZTM2000 E 1549202.48
 N 5170062.22
Test Date: 19-Sep-22

Tested By: KB
Ground Conditions: Near Level, Fill
Coordinates: NZTM2000 E 1549191.95
 N 5170060.00
Test Date: 19-Sep-22

From the lot-specific investigation for the site we conclude the site has “Good Ground”, and that dwelling foundations on this site can comprise NZS3604:2011 type foundations or codemark approved concrete slab foundations that are applicable for the site conditions (i.e. “good ground”). All foundations must be embedded to a minimum depth of 0.2m below ground level, into the underlying Natural Gravel or Engineered Fill. At these depths, either “Good Ground” or an Ultimate Bearing Capacity of 300kPa is available/inferred. If specific engineering design is being carried out a strength reduction factor of $\phi=0.5$ should be used. This depth has been supplied based on ground level at the time of testing. All topsoil and unsuitable materials should be removed below foundations and floor slab areas.
