28 October 2022 Project No: LTC22215

SHALLOW SOIL TEST REPORT LOT 197, 138 & 5/144 DUNNS CROSSING ROAD

LandTech Consulting Limited (LandTech) were engaged by Gould Developments Limited to carry out lot specific shallow soil testing for the subdivision at 138 & 5/144 Dunns Crossing Road. This shallow soil test report is for Lot 197 of the subdivision herein referred to as the site. The purpose of the shallow soil testing is to confirm subsurface conditions and provide geotechnical recommendations with regards to future residential foundations within the site.

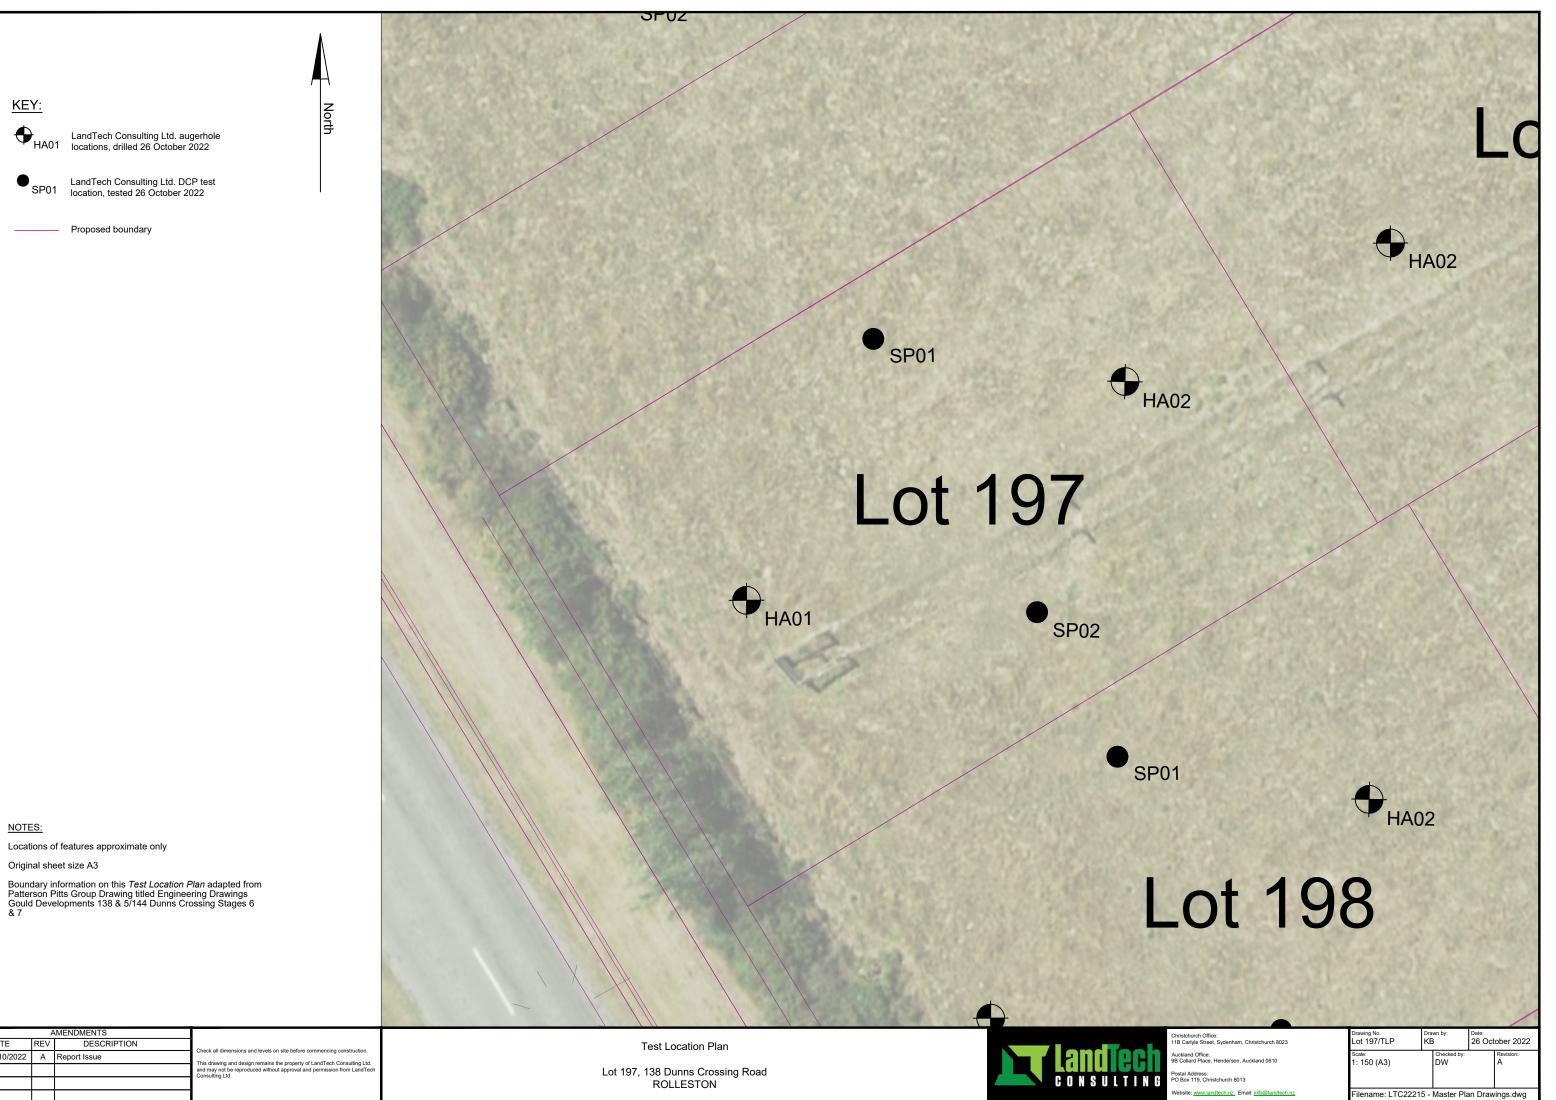
LandTech investigated the site on 26 October 2022, comprising two hand auger holes with corresponding Scala Penetrometer tests and two additional Scala Penetrometer tests. The test locations were measured from lot boundaries and/or surveyed centre pegs and are approximate only. The test locations are shown on the LandTech *Test Location Plan*, Drawing No. Lot 197/ TLP attached to this report.
