28 October 2022 Project No: LTC22215

SHALLOW SOIL TEST REPORT LOT 194, 138 & 5/144 DUNNS CROSSING ROAD

LandTech Consulting Limited (LandTech) were engaged by Gould Developments Limited to carry out lot specific shallow soil testing for the subdivision at 138 & 5/144 Dunns Crossing Road. This shallow soil test report is for Lot 194 of the subdivision herein referred to as the site. The purpose of the shallow soil testing is to confirm subsurface conditions and provide geotechnical recommendations with regards to future residential foundations within the site.

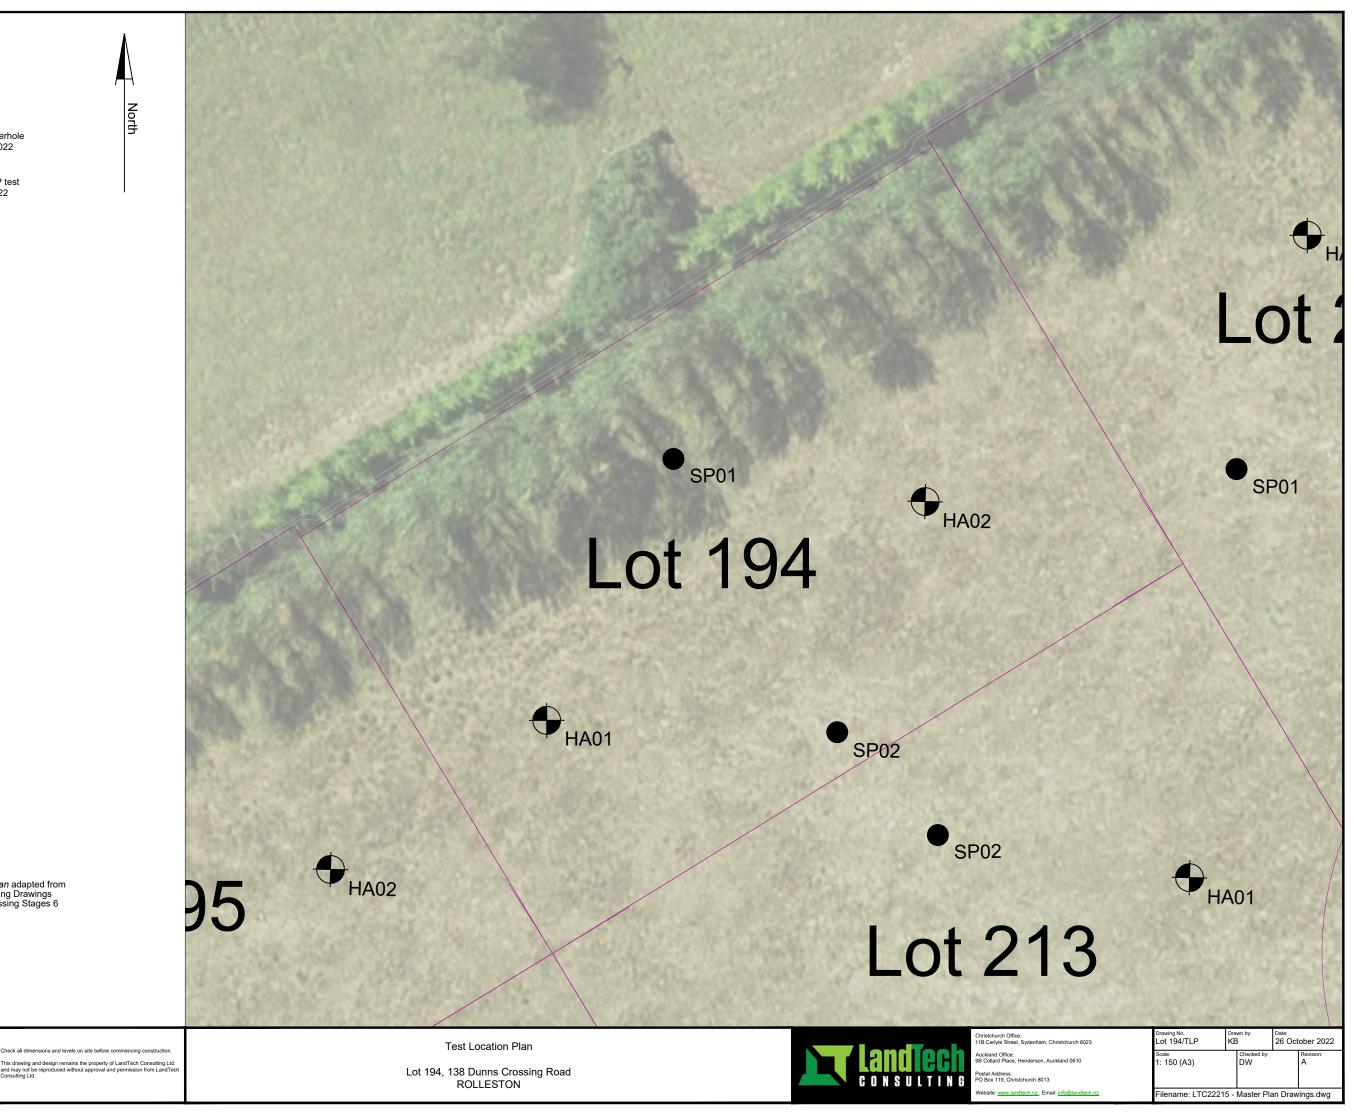
Boundary information on this *Test Location Plan* adapted from Patterson Pitts Group Drawing titled Engineering Drawings Gould Developments 138 & 5/144 Dunns Crossing Stages 6 & 7

LandTech investigated the site on 26 October 2022, comprising two hand auger holes with corresponding Scala Penetrometer tests and two additional Scala Penetrometer tests. The test locations were measured from lot boundaries and/or surveyed centre pegs and are approximate only. The test locations are shown on the LandTech *Test Location Plan*, Drawing No. Lot 194/ TLP attached to this report.

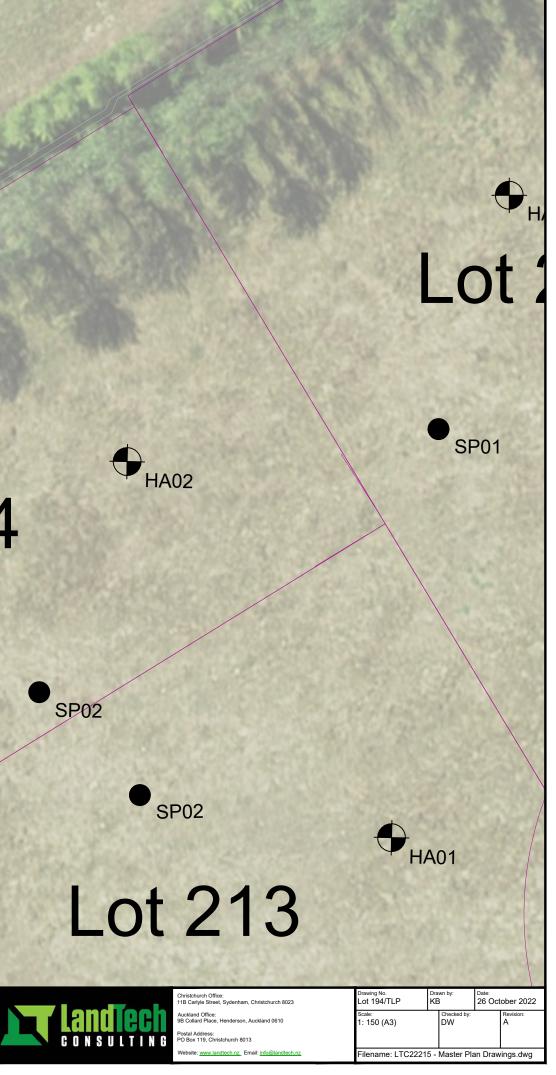
and	looh		Goulds Devel	opments Limit	ed							Auge	erhole I	No.: L	ot 194	i - HA	01
Ь	C	ONSUI	TINC	-	Lot Specifics 138 & 5/144 E	Ounns Crossin	ıq, Rolleston								Sheet I	No.: 1	of 1		
	/pe: tarted	LTC22 50mm : 26-Oct d: 26-Oct	2215 Hand Auger t-22			Coordinate Reduced Lo Ground Co	es: evel:	NZTM2000: 42.50m (LVI Near Level, Not Encount	D137) Fill	158.89,	N5170	025.67		Calibra Calibra	Vane N ation Fa ation Da	actor: ate:			KB
ЪЧ	e	Бo			Deer				er ((Shea	r Streng		-situ Fiel	d Testing nic Cone		a) Pene	trome	ter
Stratigraphy	Depth (m)	Graphic Log	Soil description in	accordance w Enginee		Field Classification Geotechnical Societ	and Description of S ty Inc, 2005	oil and Rock for	Groundwater Level (m)	Depth (m)	● Pea ● Rei			Depth (m)	w Count		ila Blow 100n	/ Cour hm	
Topsoil / Fill	-		Fine to mediu sand, brown, v	ım subrour very stiff, c	d to rounded (lry, non-plastic	gravelly SILT, c, [ENGINEER	some fine to m RED FILL].	ledium		_				-0.1 -0.2	8 11		٩

-		-		End of Aug	gerhole: 0.2m				-				-0.3	16				
	-				[TOO DENS	E TO AUGER	R]			-				-0.4	27				٩
	-									-									7
	0.5 _									0.5 _				-0.5	40

The soil conditions encountered within the hand auger holes were logged by LandTech technical staff in accordance with New Zealand Geotechnical Society *Guideline for the Description of Soil and Rock for Engineering Purposes* (2005). The hand auger logs are attached to this report.
