Project No: LTC22215

**RE: SHALLOW SOIL TEST REPORT
LOT 114, 138 DUNNS CROSSING ROAD**

LandTech Consulting Ltd (LandTech) were engaged by Gould Developments Limited to carry out lot specific shallow soil testing for the subdivision at 138 Dunns Crossing Road. This shallow soil test report is for Lot 114 of the subdivision herein referred to as the site. The purpose of the shallow soil testing is to confirm subsurface conditions and provide geotechnical recommendations with regards to future residential foundations within the site.

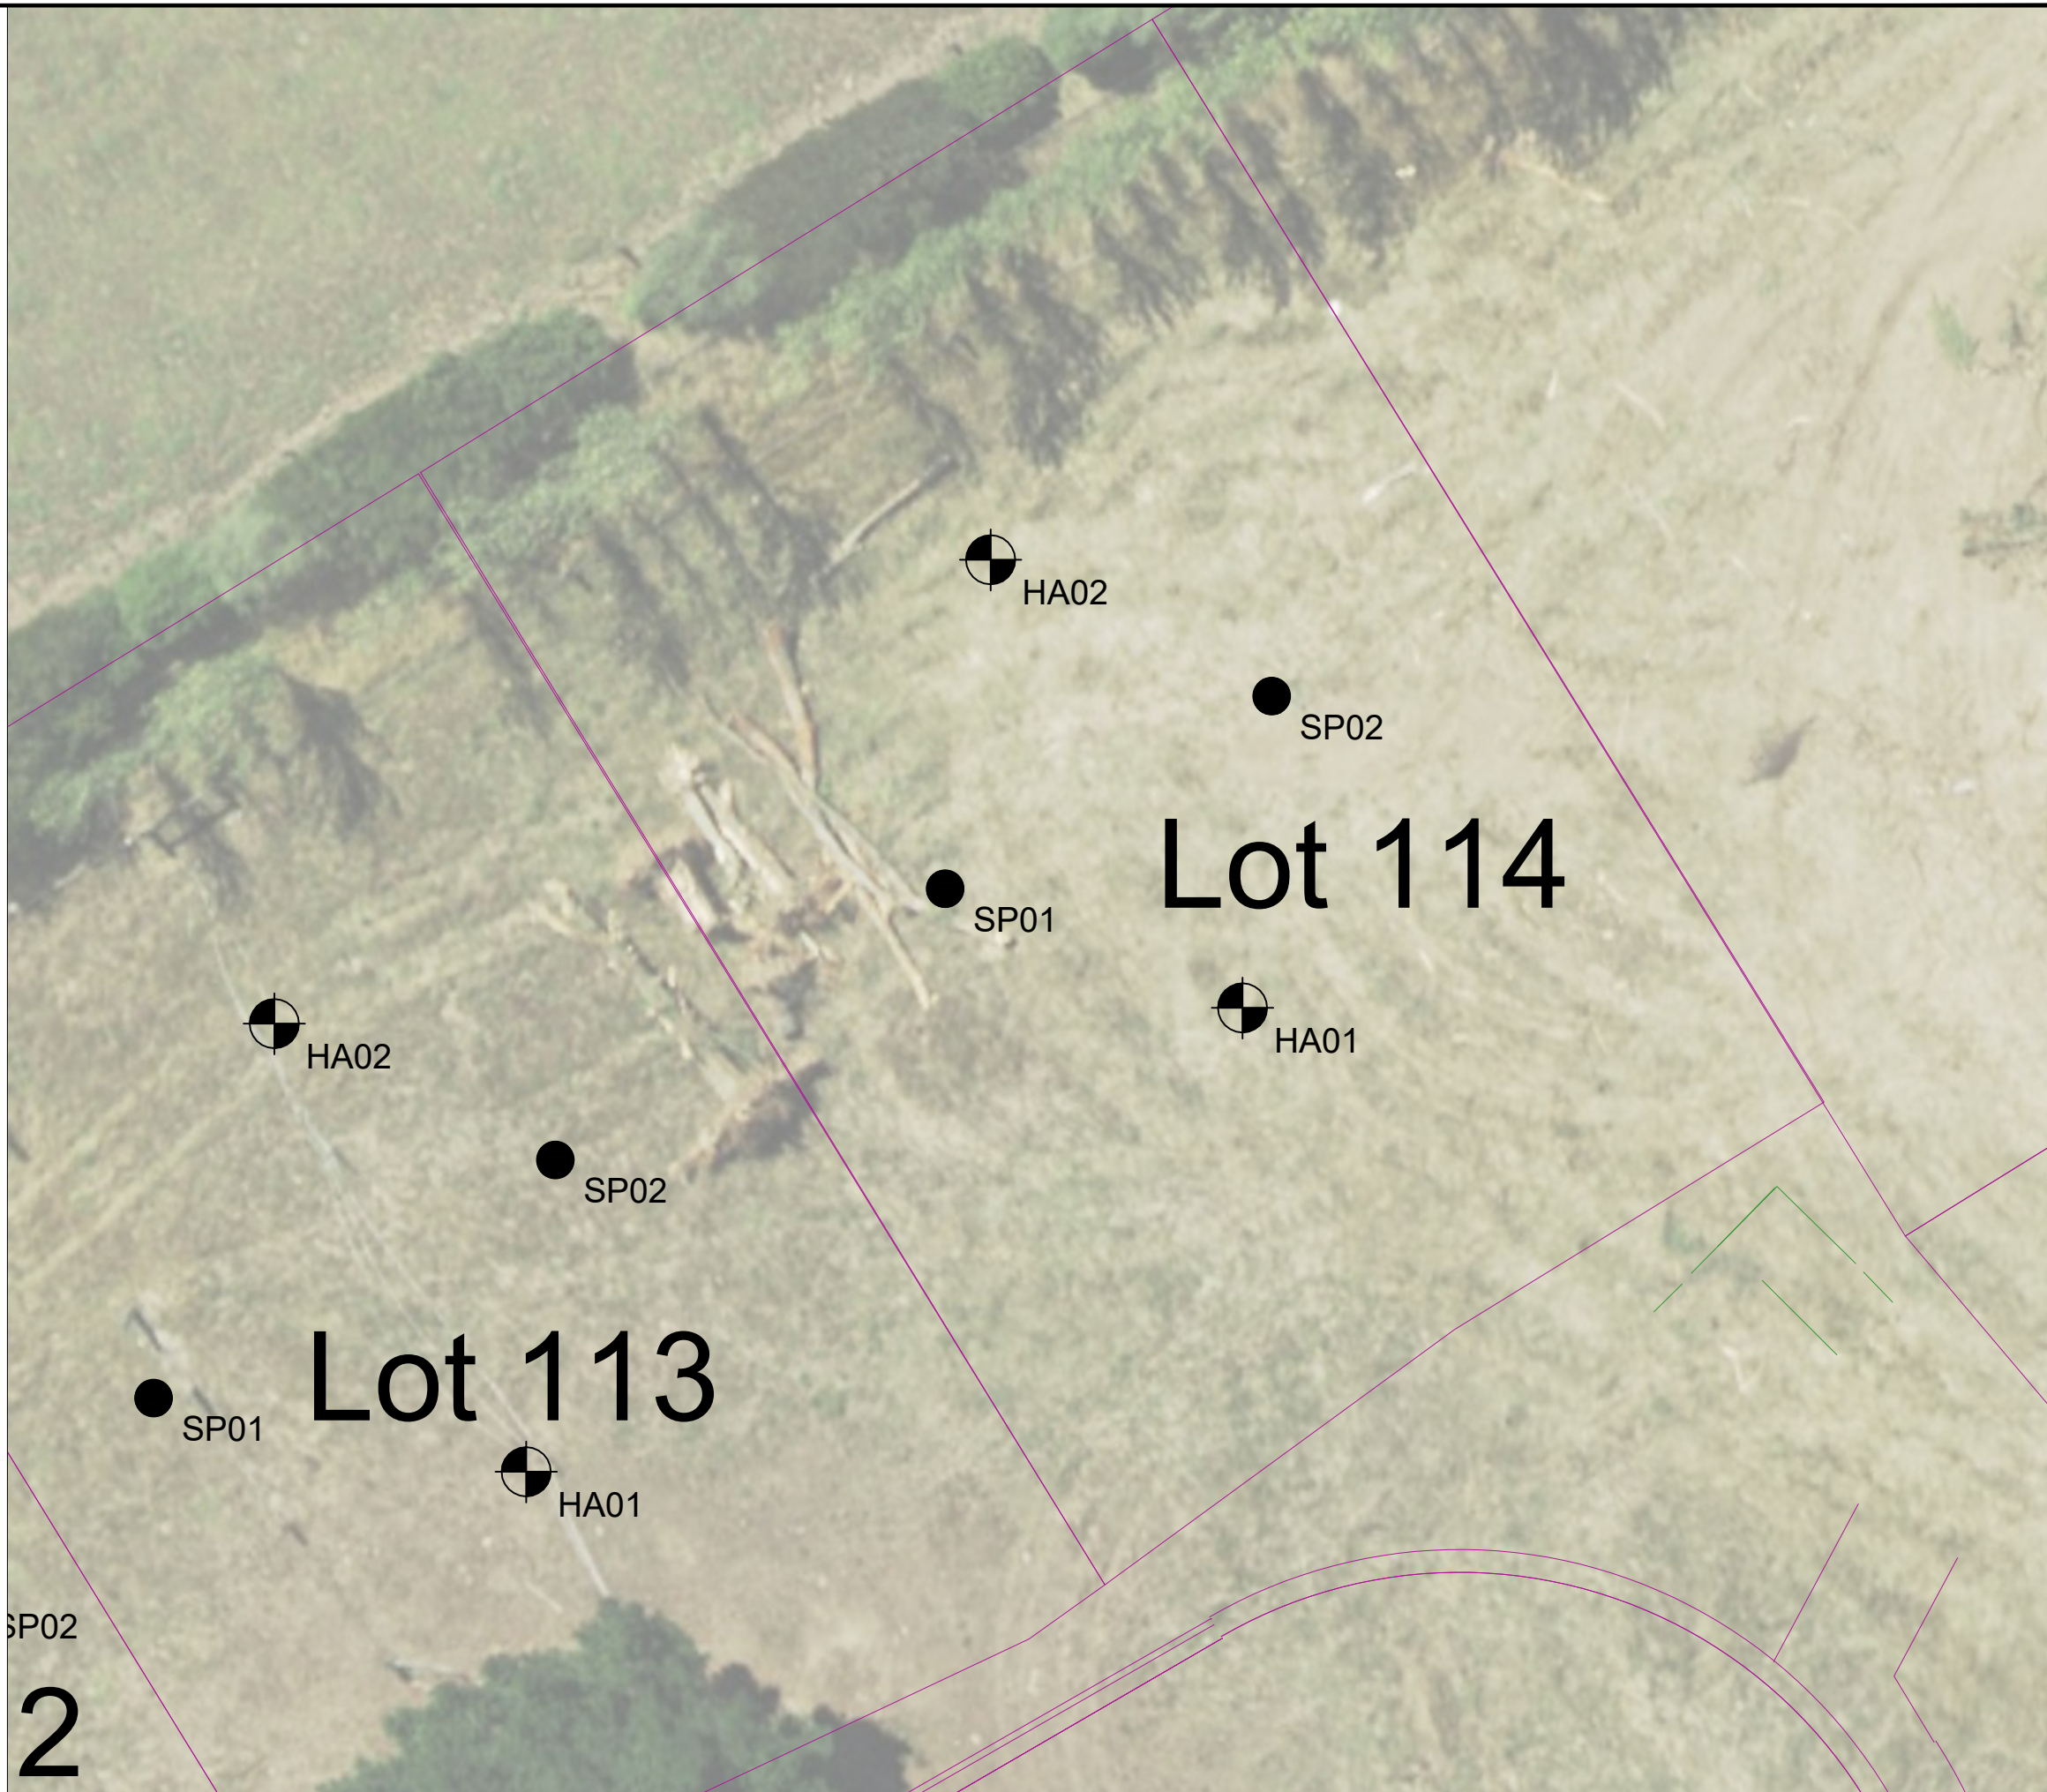
Boundary information on this *Test Location Plan* adapted from LINZ website: www.data.linz.govt.nz (accessed 15 Septemebr 2022)

LandTech investigated the site on 16 September 2022, comprising two hand auger holes with corresponding Scala Penetrometer tests and two additional Scala Penetrometer tests. The test locations were measured from lot boundaries and/or surveyed centre pegs and are approximate only. The test locations are shown on the LandTech *Test Location Plan*, Drawing No. Lot 114/ TLP attached to this report.

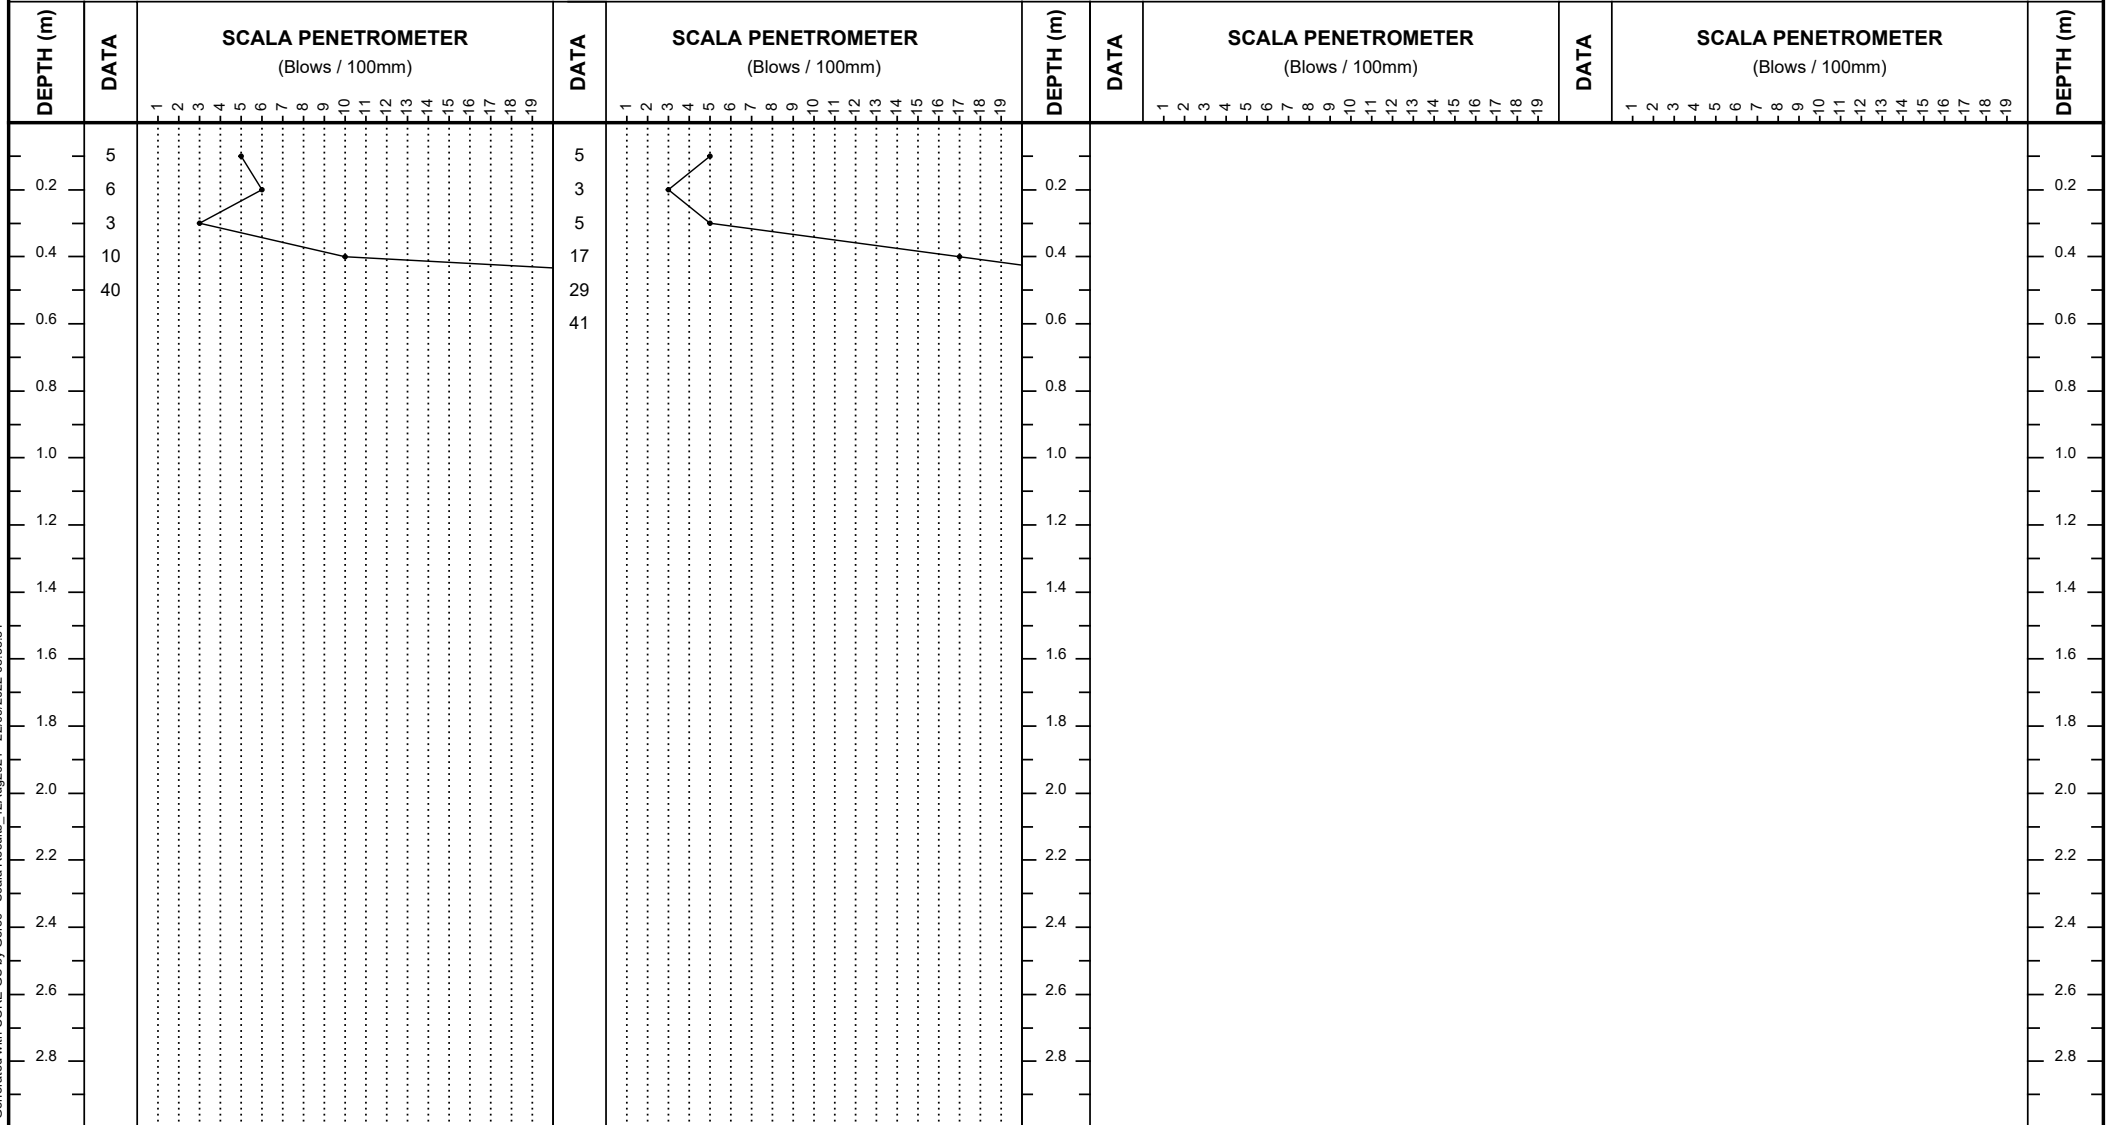
Tested By: KP
Ground Conditions: Near Level, Fill
Coordinates: NZTM2000 E 1549262.73
 N 5170148.66
Test Date: 16-Sep-22
