Project No: LTC22215

**RE: SHALLOW SOIL TEST REPORT
LOT 143, 138 DUNNS CROSSING ROAD**

LandTech Consulting Ltd (LandTech) were engaged by Gould Developments Limited to carry out lot specific shallow soil testing for the subdivision at 138 Dunns Crossing Road. This shallow soil test report is for Lot 143 of the subdivision herein referred to as the site. The purpose of the shallow soil testing is to confirm subsurface conditions and provide geotechnical recommendations with regards to future residential foundations within the site.

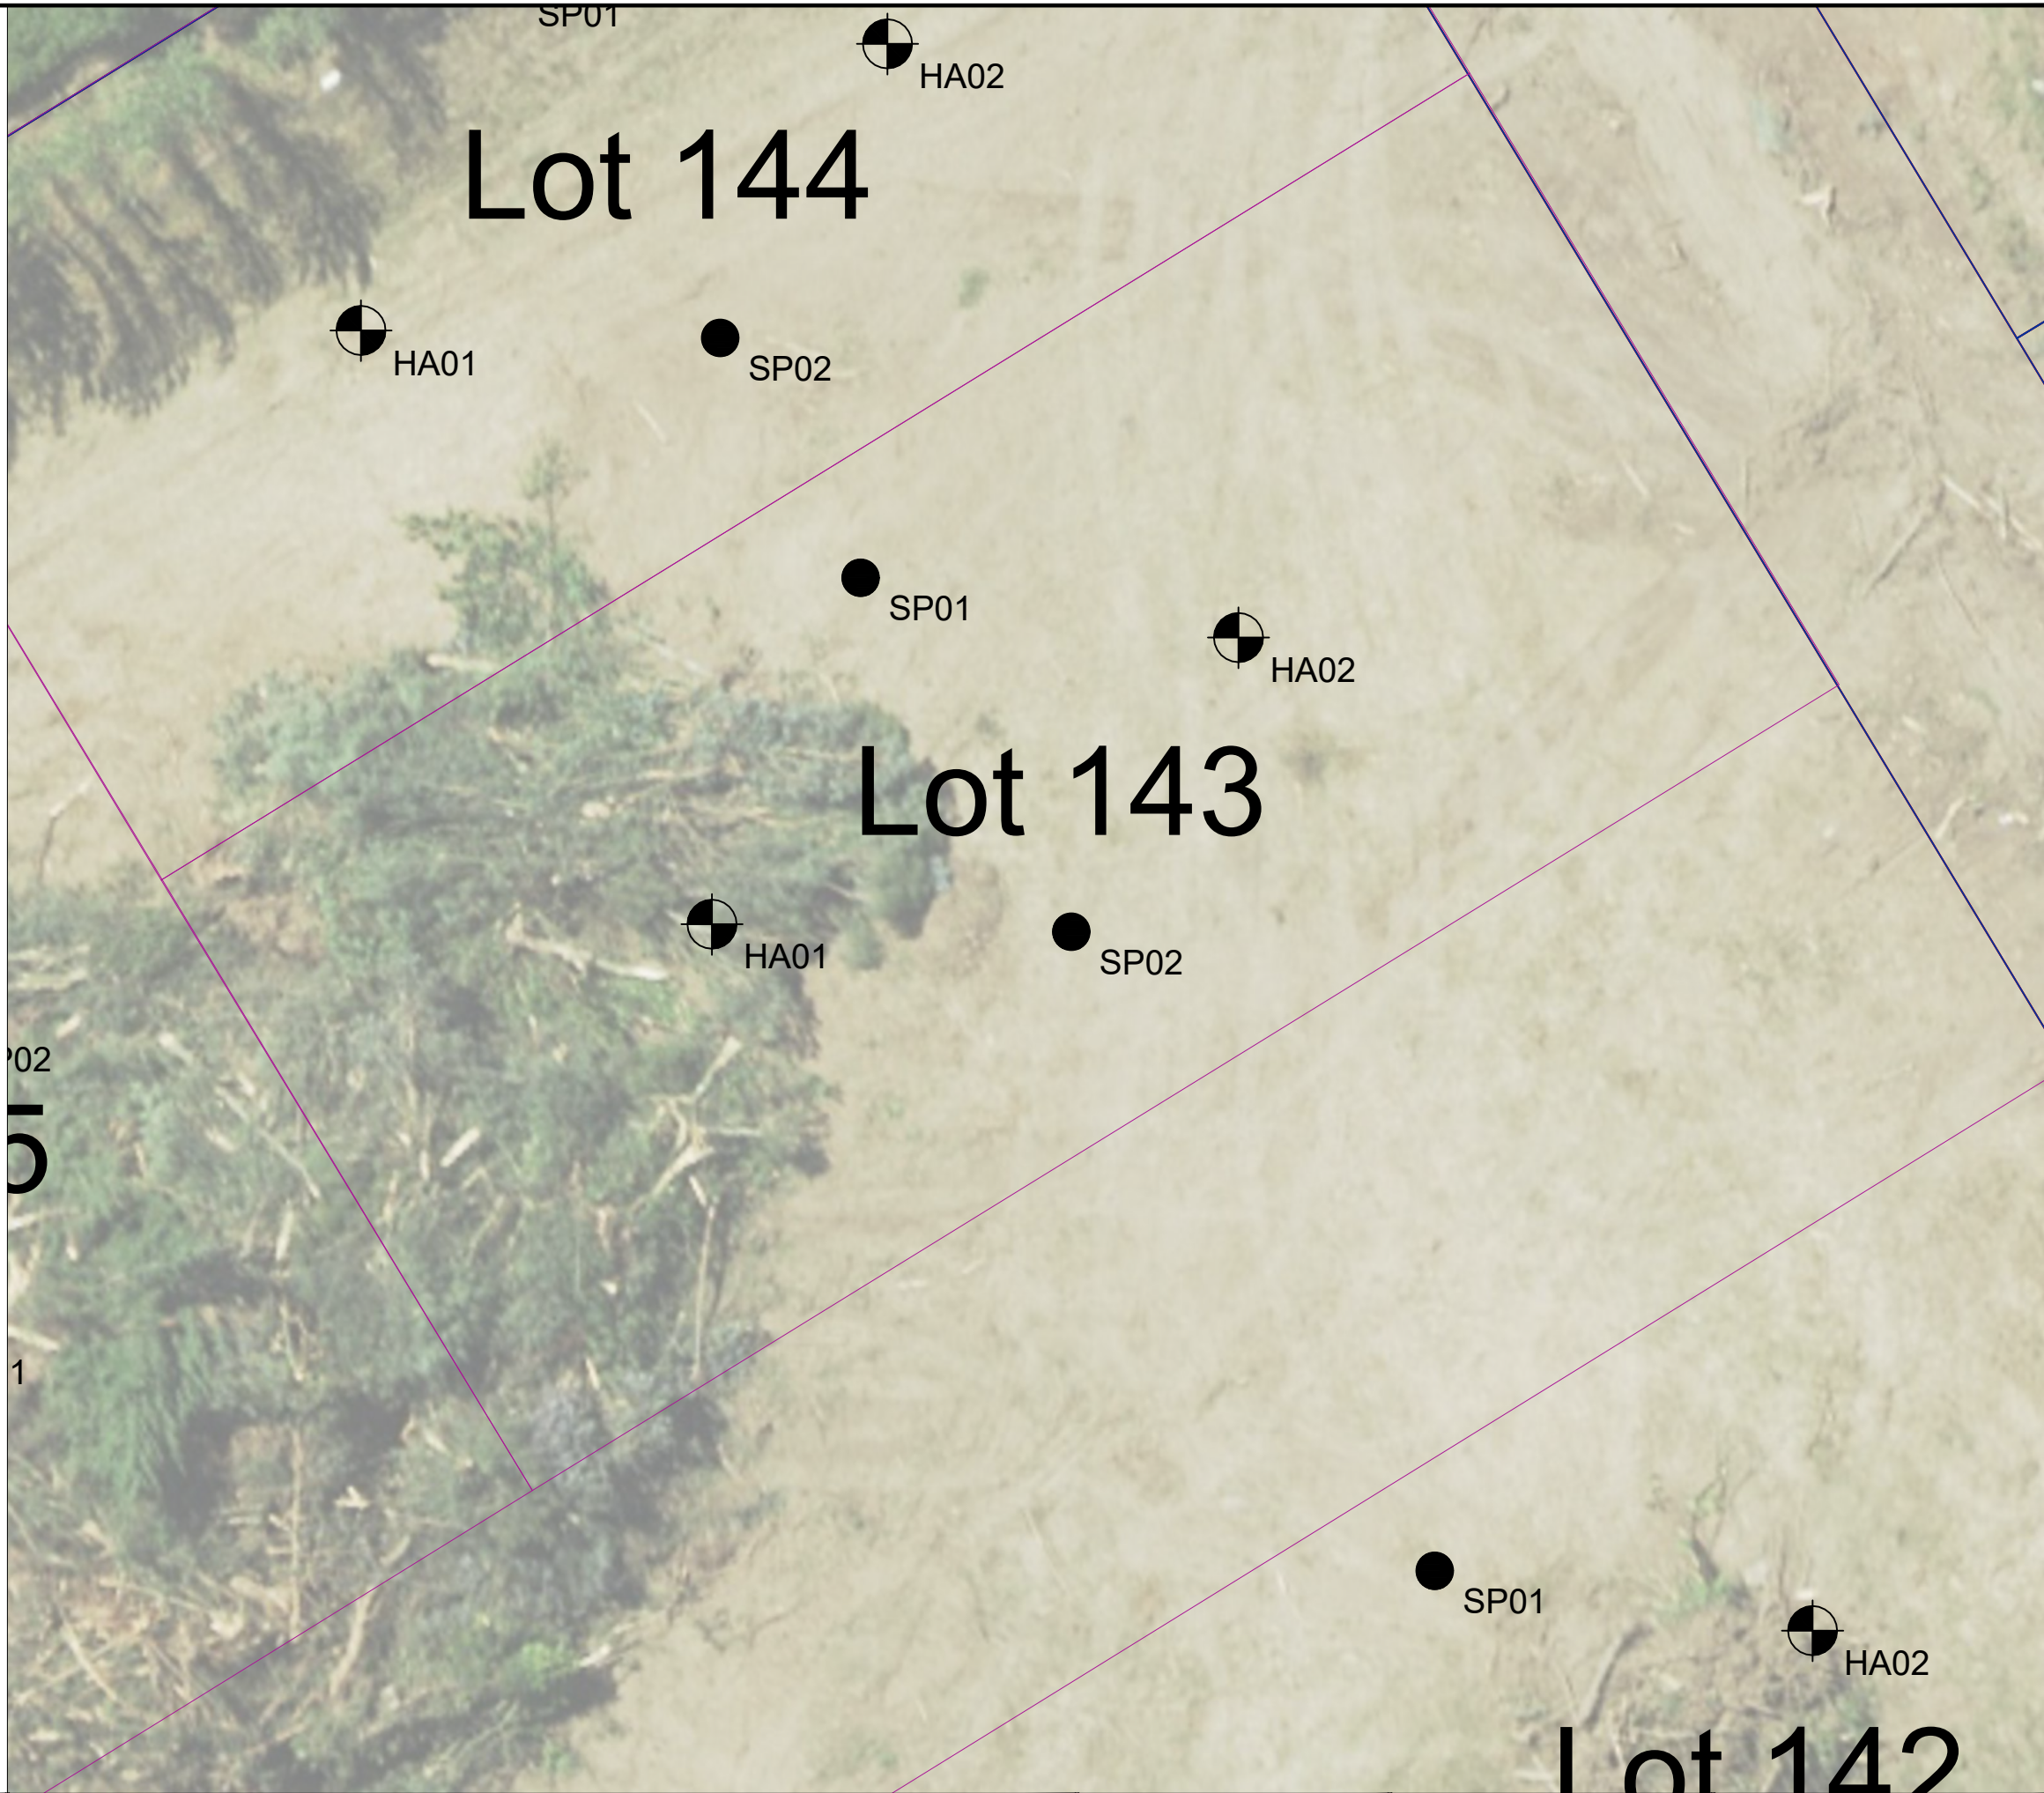
KEY:

-   HA01 LandTech Consulting Ltd. augerhole locations, drilled 16 September 2022
-   SP01 LandTech Consulting Ltd. DCP test location, tested 16 September 2022
-   Proposed boundary

- Locations of features approximate only
- Original sheet size A3
- Boundary information on this *Test Location Plan* adapted from LINZ website: www.data.linz.govt.nz (accessed 15 September 2022)

LandTech investigated the site on 16 September 2022, comprising two hand auger holes with corresponding Scala Penetrometer tests and two additional Scala Penetrometer tests. The test locations were measured from lot boundaries and/or surveyed centre pegs and are approximate only. The test locations are shown on the LandTech *Test Location Plan*, Drawing No. Lot 143/ TLP attached to this report.

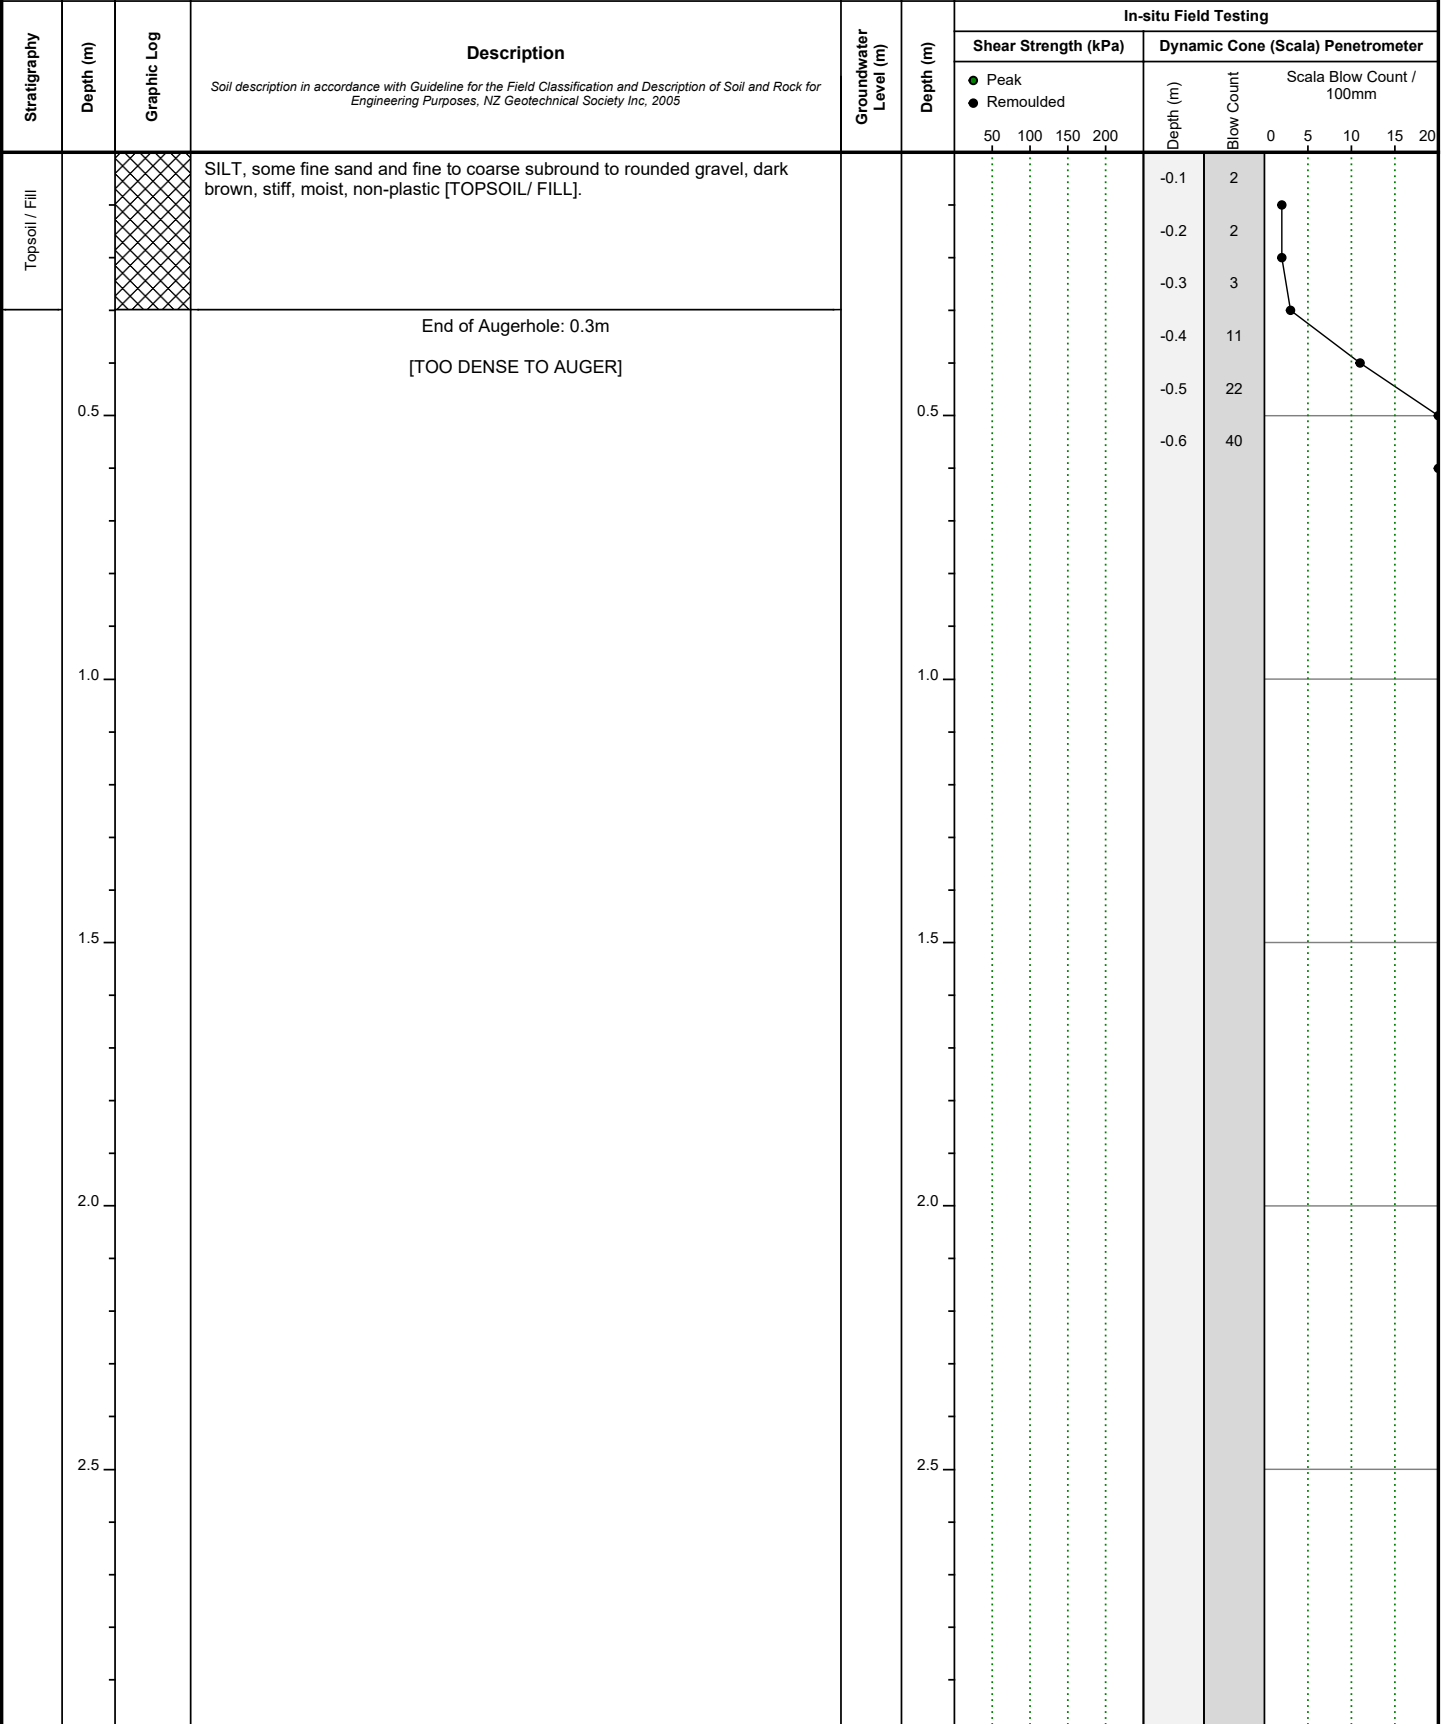
Sheet No.: 1 of 1

Project No.: LTC22215 **Coordinates:** NZTM2000: E1549302.70, N5170161.39 **Logged By:** KP
Drill Type: 50 mm Hand Auger **Reduced Level:** 42.50m (LVD137) **Shear Vane No.:**
Date Started: 16-Sep-22 **Ground Conditions:** Near Level, Topsoil & Gravel **Calibration Factor:**
Date Finished: 16-Sep-22 **Groundwater Level (m):** Not Encountered **Calibration Date:**

In-situ testing in accordance with the following standards:
 Scala Penetrometer Testing: NZS 4402:1988, Test 6.5.2, Dynamic Cone Penetrometer
 Shear Vane Testing: Guideline for Hand Held Shear Vane Test, NZGS, August 2001

The soil conditions encountered within the hand auger holes were logged by LandTech technical staff in accordance with New Zealand Geotechnical Society *Guideline for the Description of Soil and Rock for Engineering Purposes* (2005). The hand auger logs are attached to this report.

The hand auger holes encountered topsoil/fill material from the ground surface to approximately 0.2m to 0.3m depths, underlain by inferred natural gravel. Groundwater was not encountered during testing. Scala Penetrometer testing at each of the four locations returned results between 2 and 40+ blows per 100mm penetration at the test positions, encountering refusal at depths between 0.5m and 0.7m below present ground level.

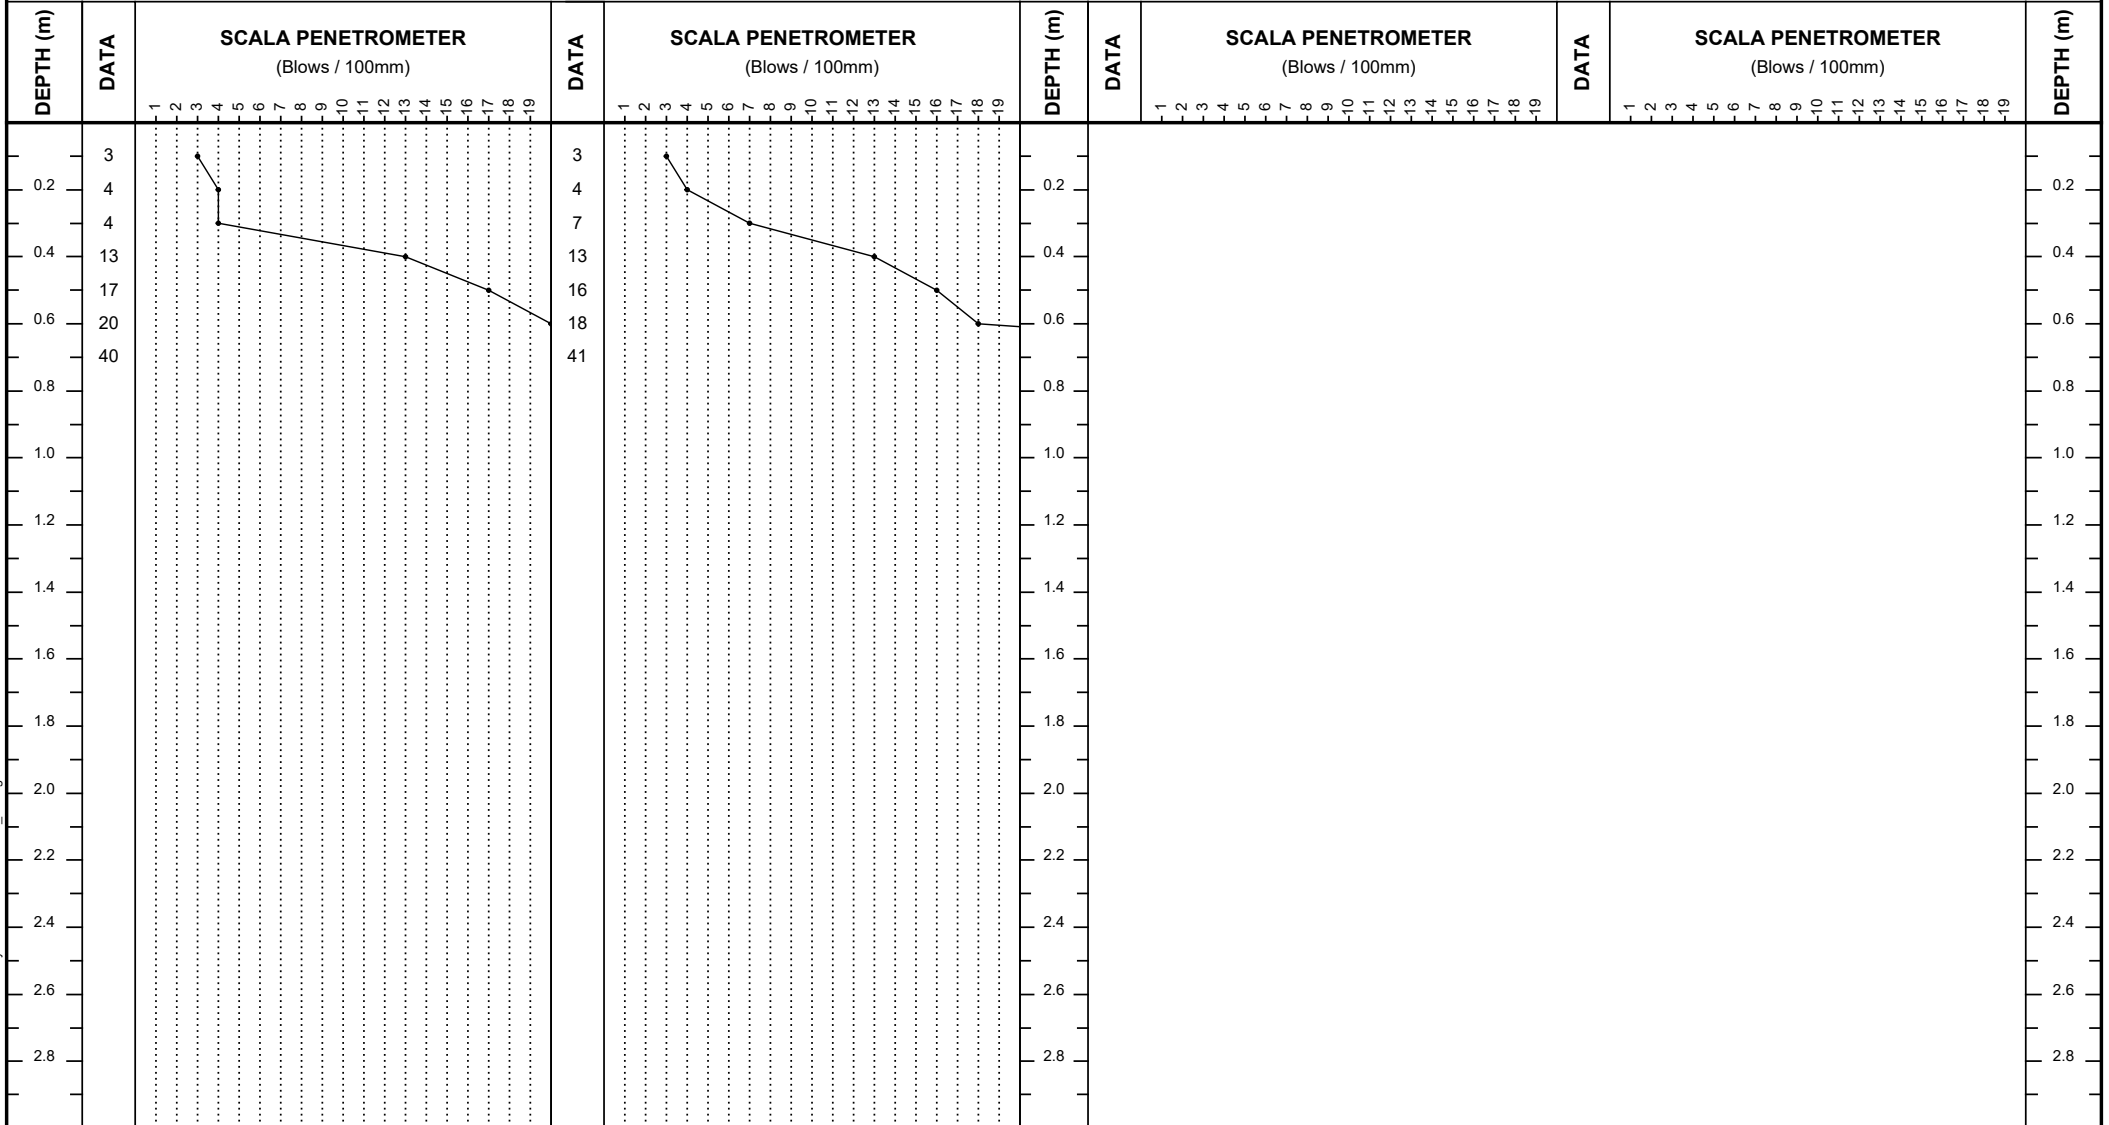
Tested By: KP
 Ground Conditions: Near Level, Fill
 Coordinates: NZTM2000 E 1549306.05
 N 5170169.18
 Test Date: 16-Sep-22

Tested By: KP
 Ground Conditions: Near Level, Fill
 Coordinates: NZTM2000 E 1549310.79
 N 5170161.22
 Test Date: 16-Sep-22

The Dynamic Cone (Scala) Penetrometer testing procedure was carried out in accordance with NZS 4402:1988, Test 6.5.2, *Dynamic Cone Penetrometer*. The Scala penetrometer test results are attached to this report.
