Project No: LTC22215

Gould Developments Limited

**RE: SHALLOW SOIL TEST REPORT
LOT 111, 138 DUNNS CROSSING ROAD**

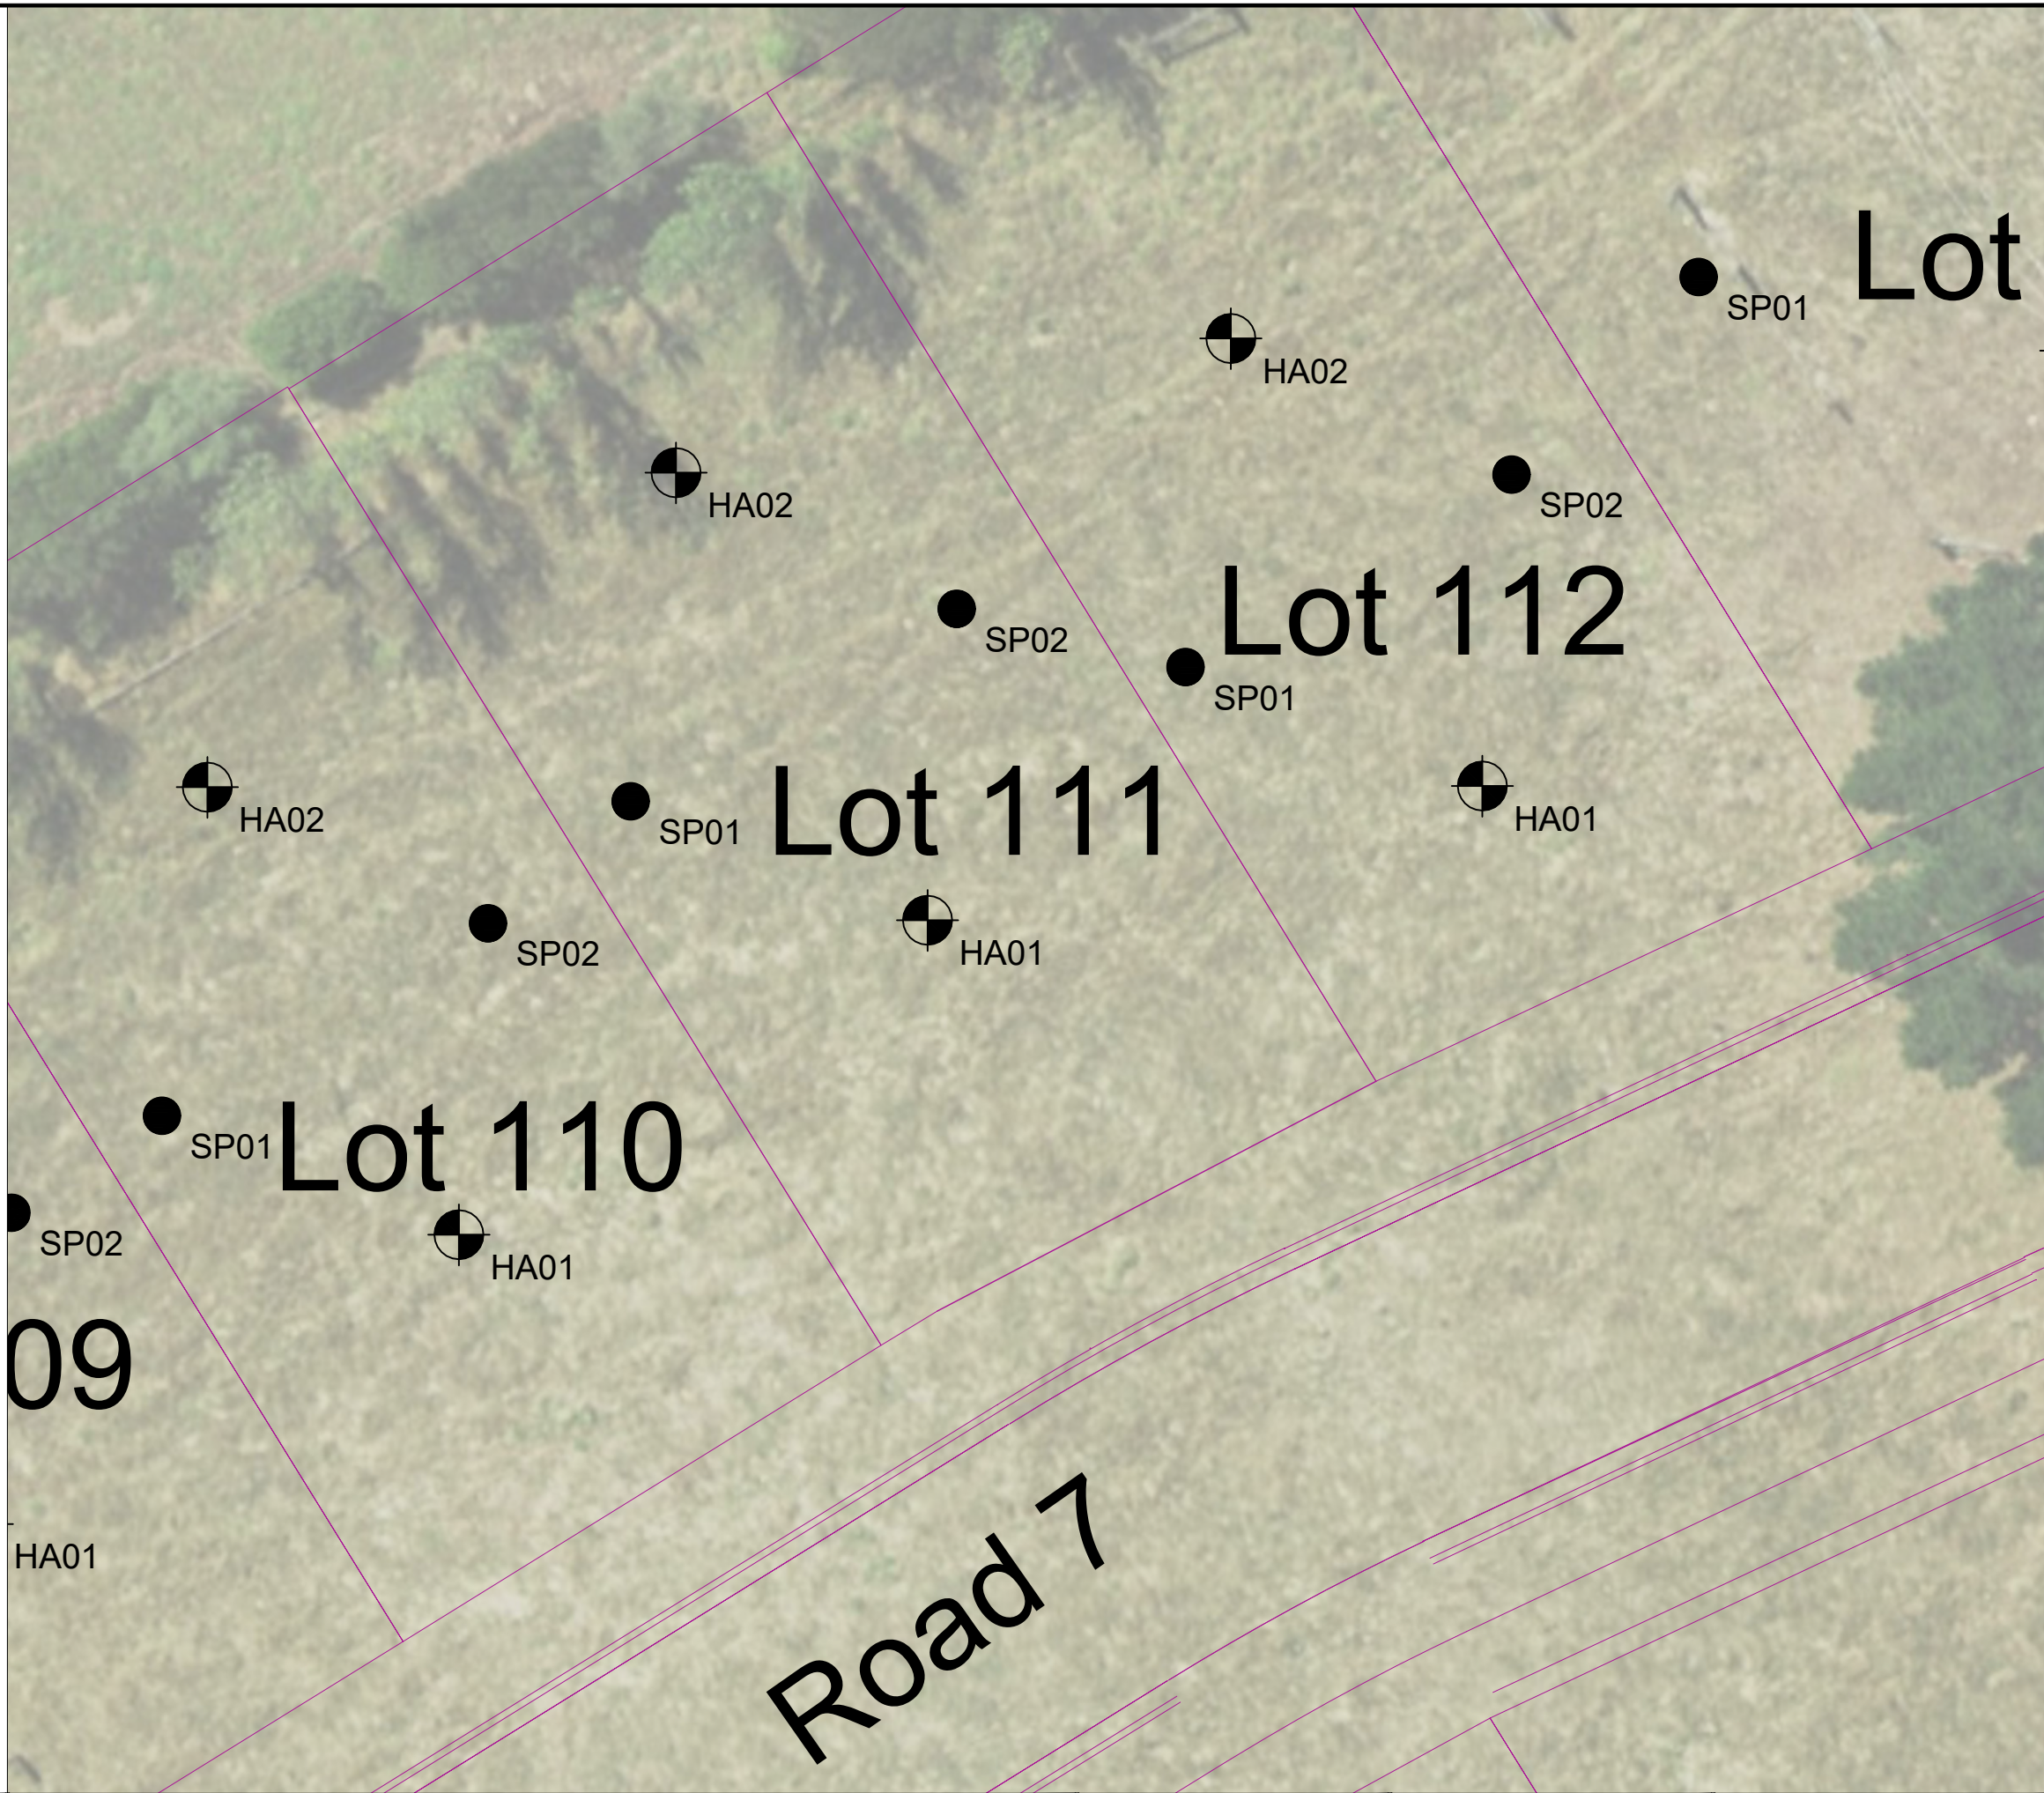
KEY:

-   HA01 LandTech Consulting Ltd. augerhole locations, drilled 16 September 2022
-   SP01 LandTech Consulting Ltd. DCP test location, tested 16 September 2022
-   Proposed boundary

LandTech investigated the site on 16 September 2022, comprising two hand auger holes with corresponding Scala Penetrometer tests and two additional Scala Penetrometer tests. The test locations were measured from lot boundaries and/or surveyed centre pegs and are approximate only. The test locations are shown on the LandTech *Test Location Plan*, Drawing No. Lot 111/ TLP attached to this report.

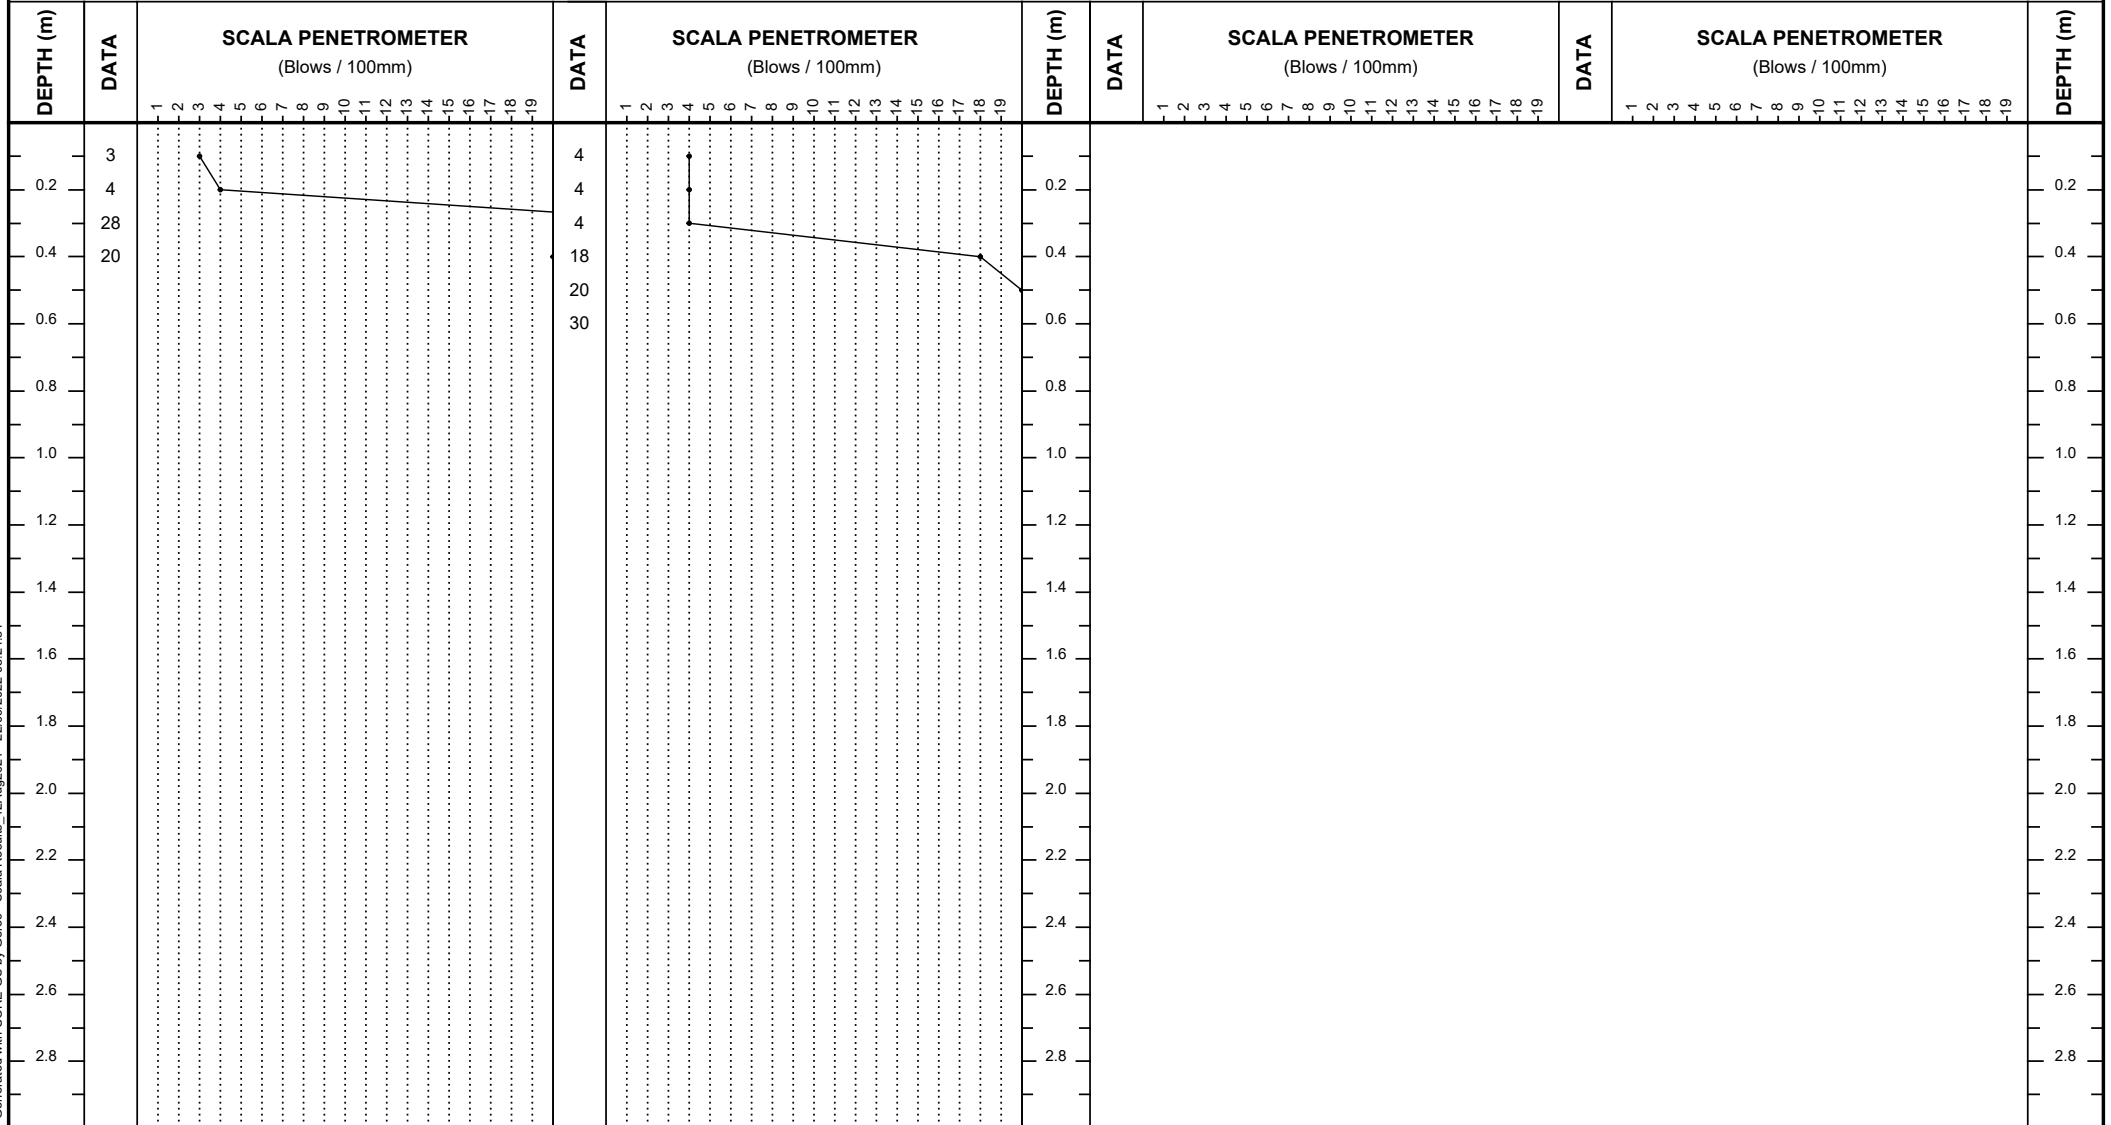
Tested By: KP
Ground Conditions: Near Level, Fill
Coordinates: NZTM2000 E 1549213.53
 N 5170121.07
Test Date: 16-Sep-22

Tested By: KP
Ground Conditions: Near Level, Fill
Coordinates: NZTM2000 E 1549220.88
 N 5170125.41
Test Date: 16-Sep-22
