Project No: LTC22215

Gould Developments Limited

**RE: SHALLOW SOIL TEST REPORT
LOT 108, 138 DUNNS CROSSING ROAD**

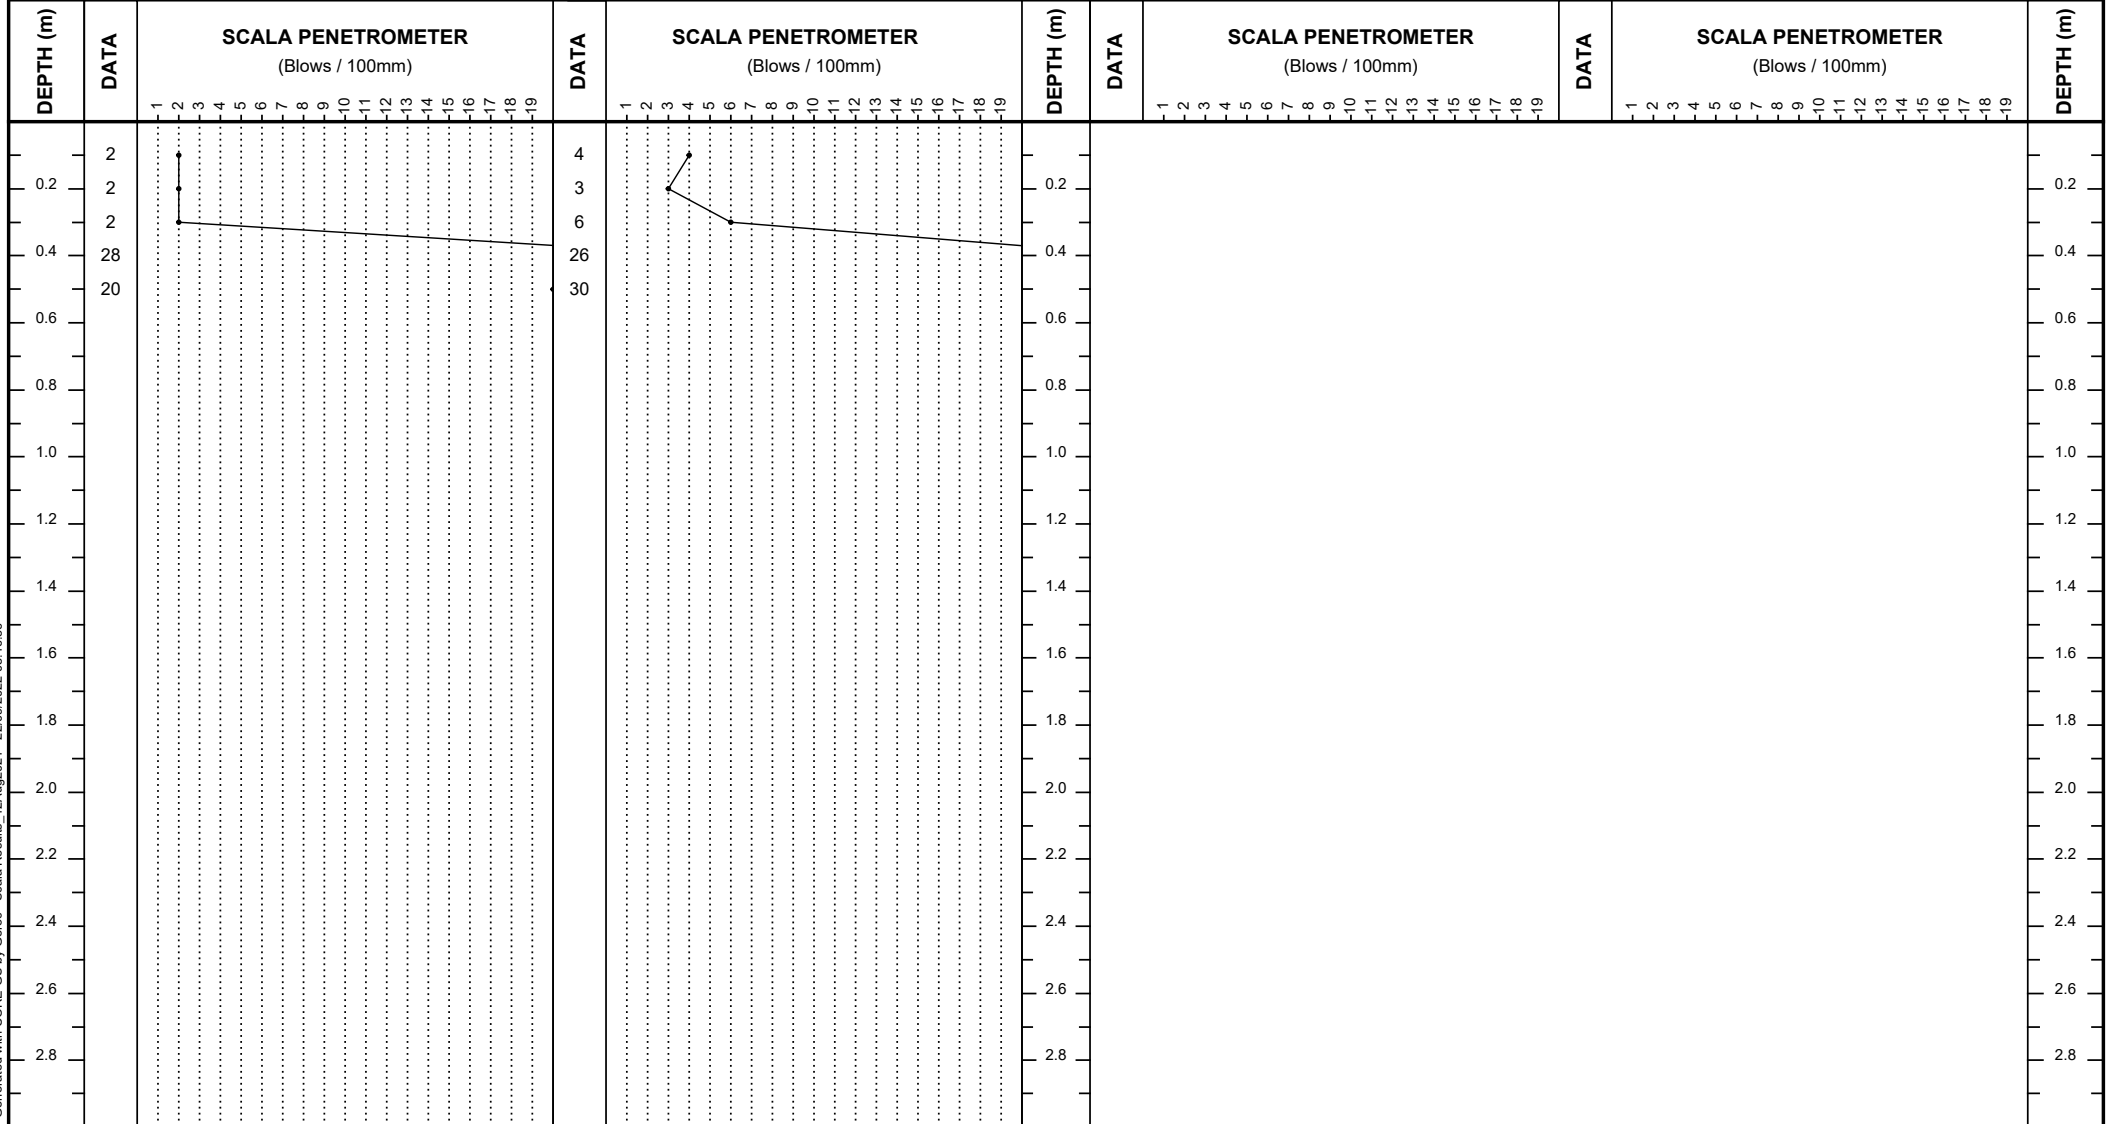
Tested By: KP
Ground Conditions: Near Level, Fill
Coordinates: NZTM2000 E 1549177.11
 N 5170098.35
Test Date: 16-Sep-22

Tested By: KP
Ground Conditions: Near Level, Fill
Coordinates: NZTM2000 E 1549179.11
 N 5170101.35
Test Date: 16-Sep-22

The Dynamic Cone (Scala) Penetrometer testing procedure was carried out in accordance with NZS 4402:1988, Test 6.5.2, *Dynamic Cone Penetrometer*. The Scala penetrometer test results are attached to this report.
