Project No: LTC22215

**RE: SHALLOW SOIL TEST REPORT
LOT 109, 138 DUNNS CROSSING ROAD**

Lot 109, 138 Dunns Crossing Road
 ROLLESTON

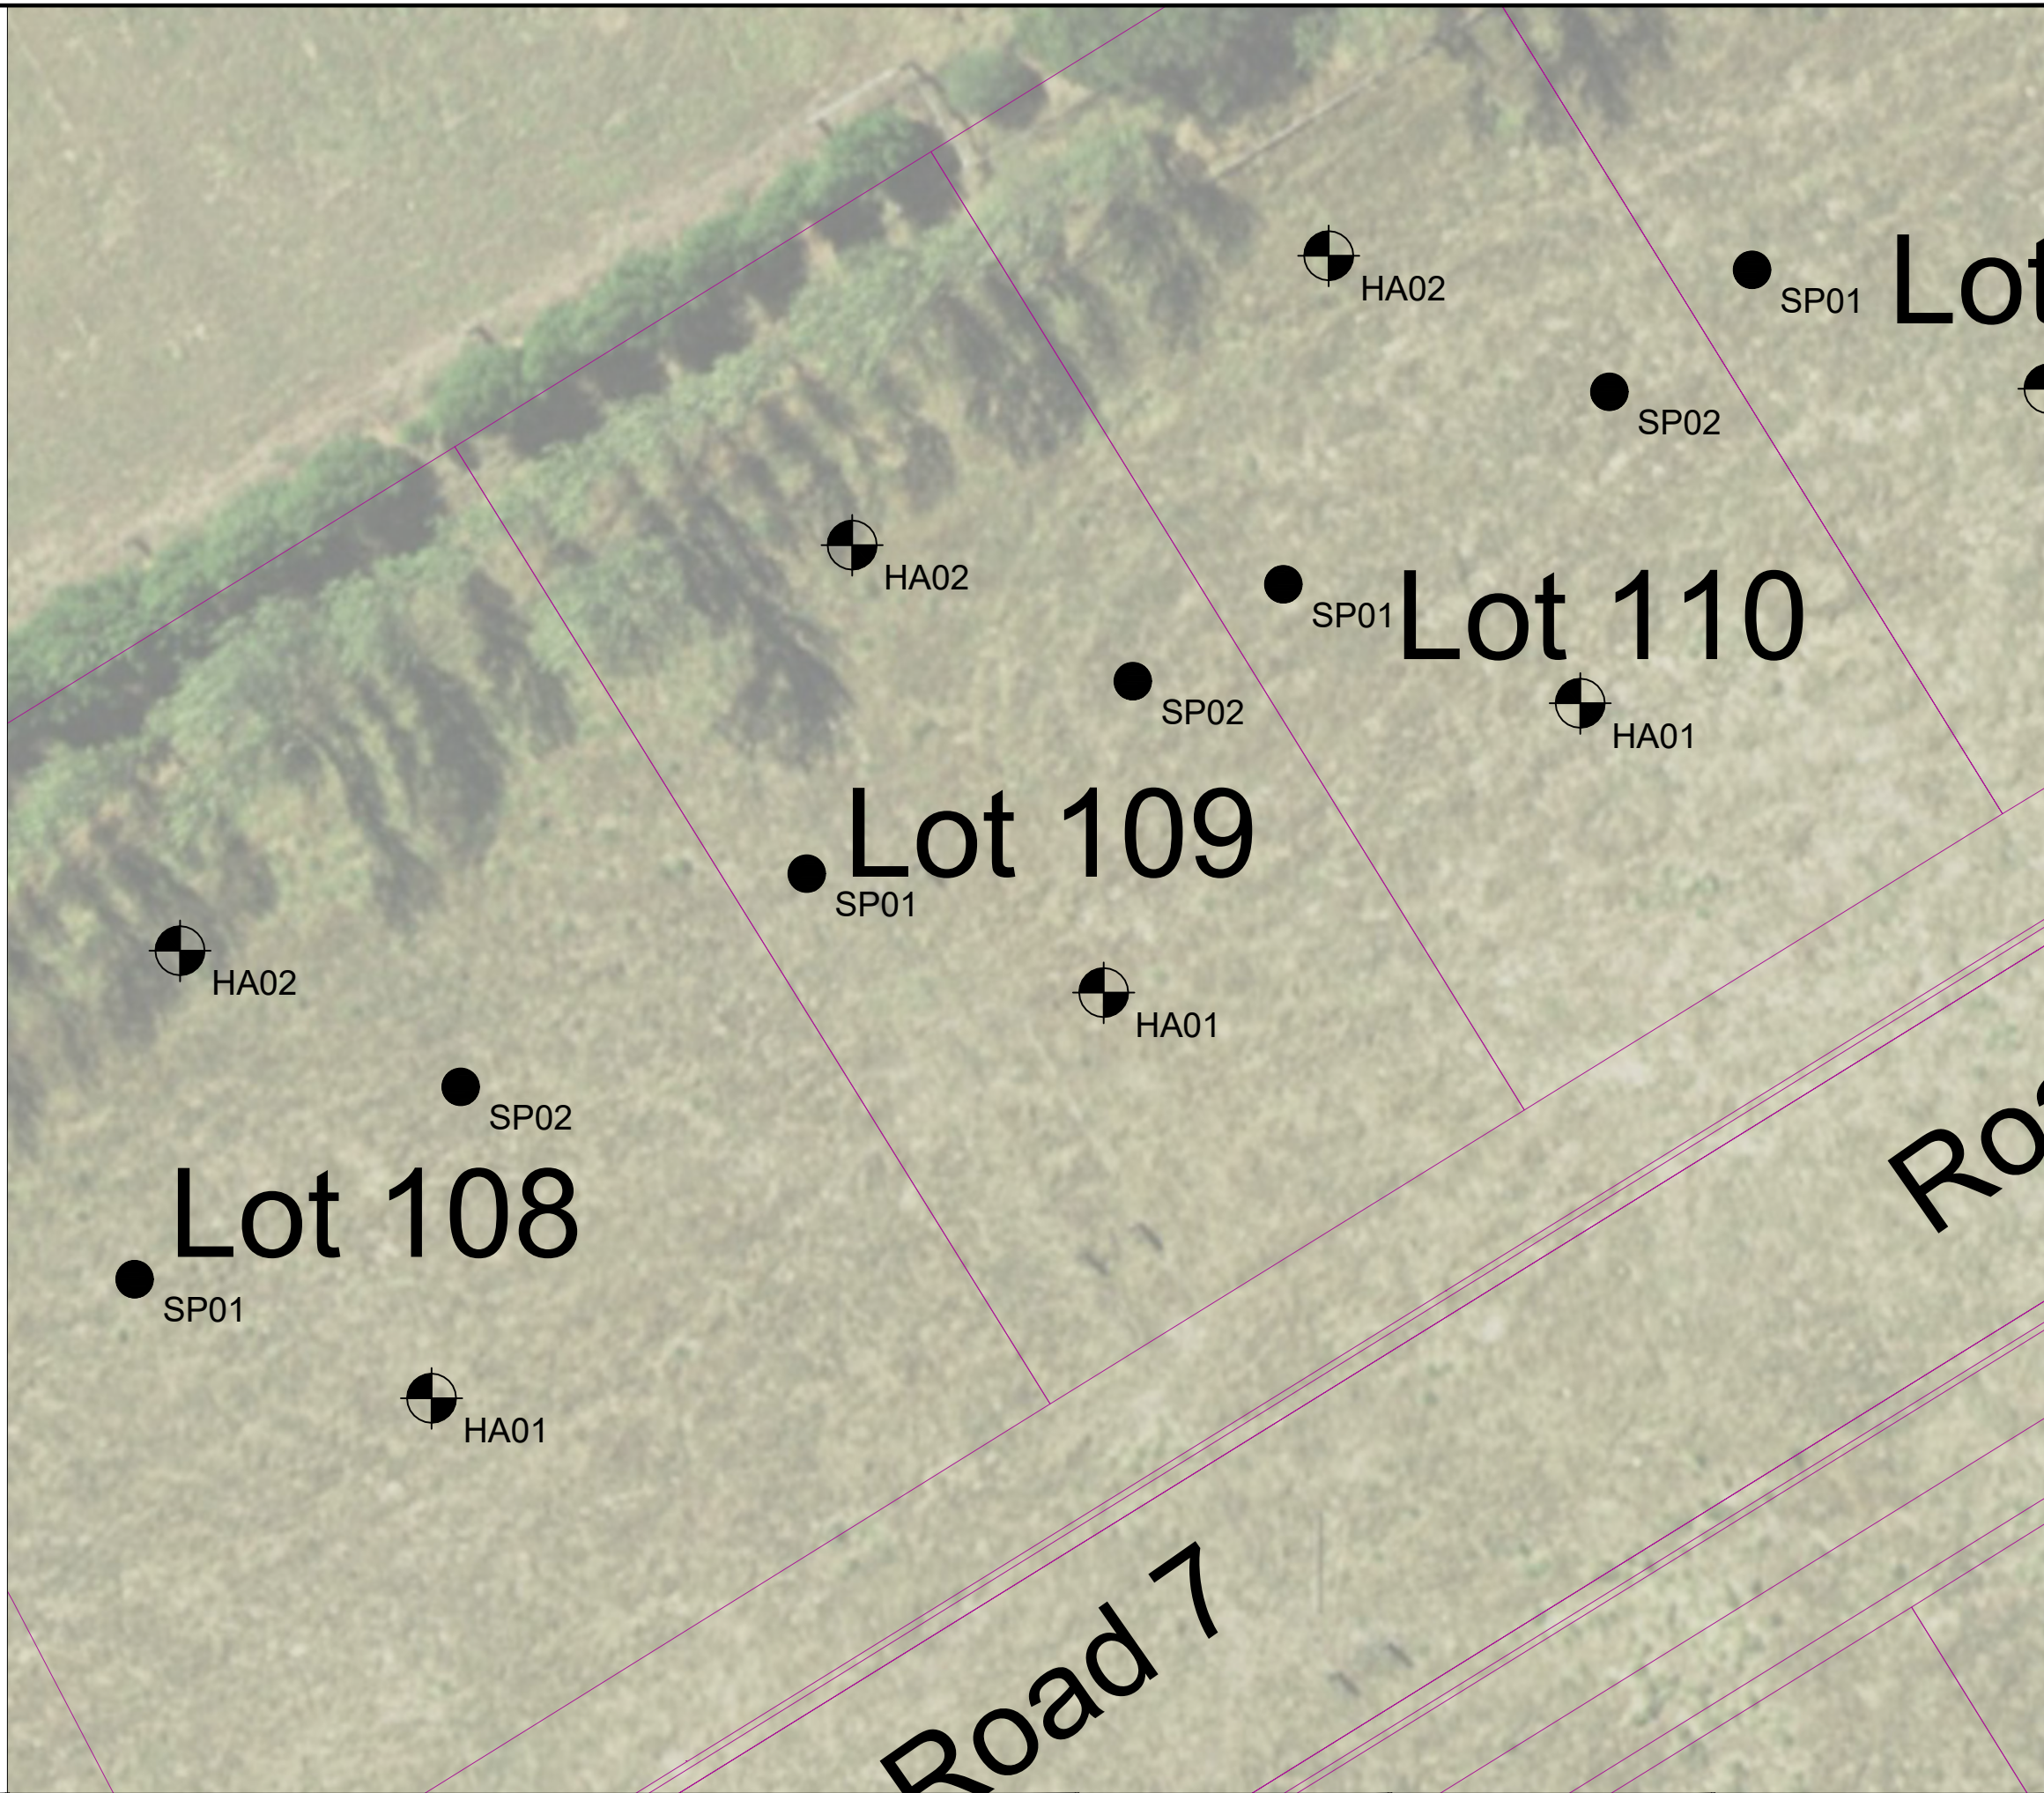
Test Location Plan

LandTech investigated the site on 16 September 2022, comprising two hand auger holes with corresponding Scala Penetrometer tests and two additional Scala Penetrometer tests. The test locations were measured from lot boundaries and/or surveyed centre pegs and are approximate only. The test locations are shown on the LandTech *Test Location Plan*, Drawing No. Lot 109/ TLP attached to this report.

-   HA01 LandTech Consulting Ltd. augerhole locations, drilled 16 September 2022
-   SP01 LandTech Consulting Ltd. DCP test location, tested 16 September 2022
-   Proposed boundary

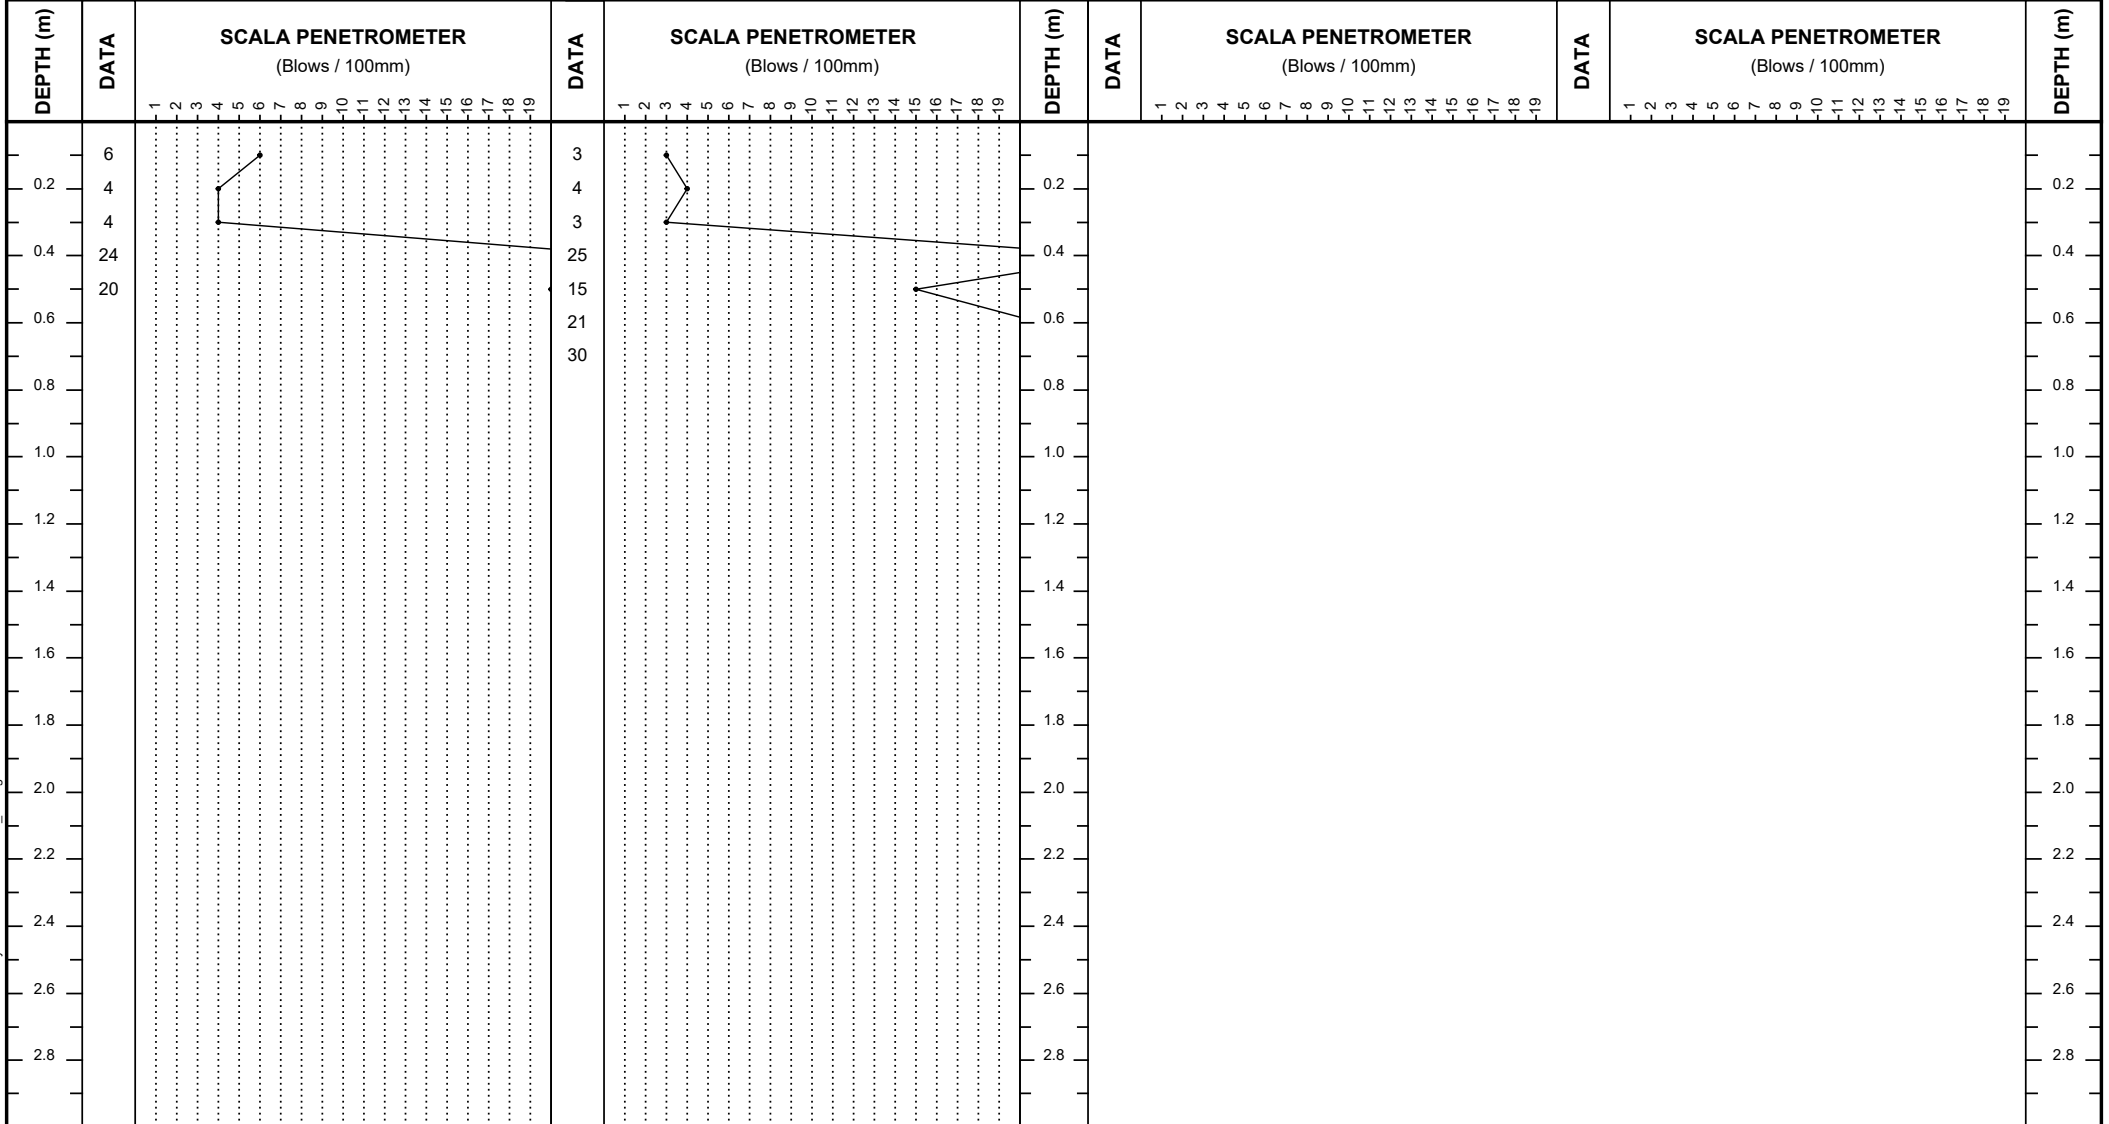
Lot 109 - SP01

The hand auger holes encountered topsoil/fill material from the ground surface to approximately 0.1m to 0.3m depths, underlain by inferred natural gravel. Groundwater was not encountered during testing. Scala Penetrometer testing at each of the four locations returned results between 3 and 30 blows per 100mm penetration at the test positions, encountering refusal at depths between 0.5m and 0.7m below present ground level.

Tested By: KP
Ground Conditions: Near Level, Fill
Coordinates: NZTM2000 E 1549192.25
 N 5170107.48
Test Date: 16-Sep-22

Tested By: KP
Ground Conditions: Near Level, Topsoil & Gravel
Coordinates: NZTM2000 E 1549199.59
 N 5170111.81
Test Date: 16-Sep-22
