Project No: LTC22215

**RE: SHALLOW SOIL TEST REPORT  
LOT 120, 138 DUNNS CROSSING ROAD**

**Test Location Plan**  
 Lot 120, 138 Dunns Crossing Road  
 ROLLESTON

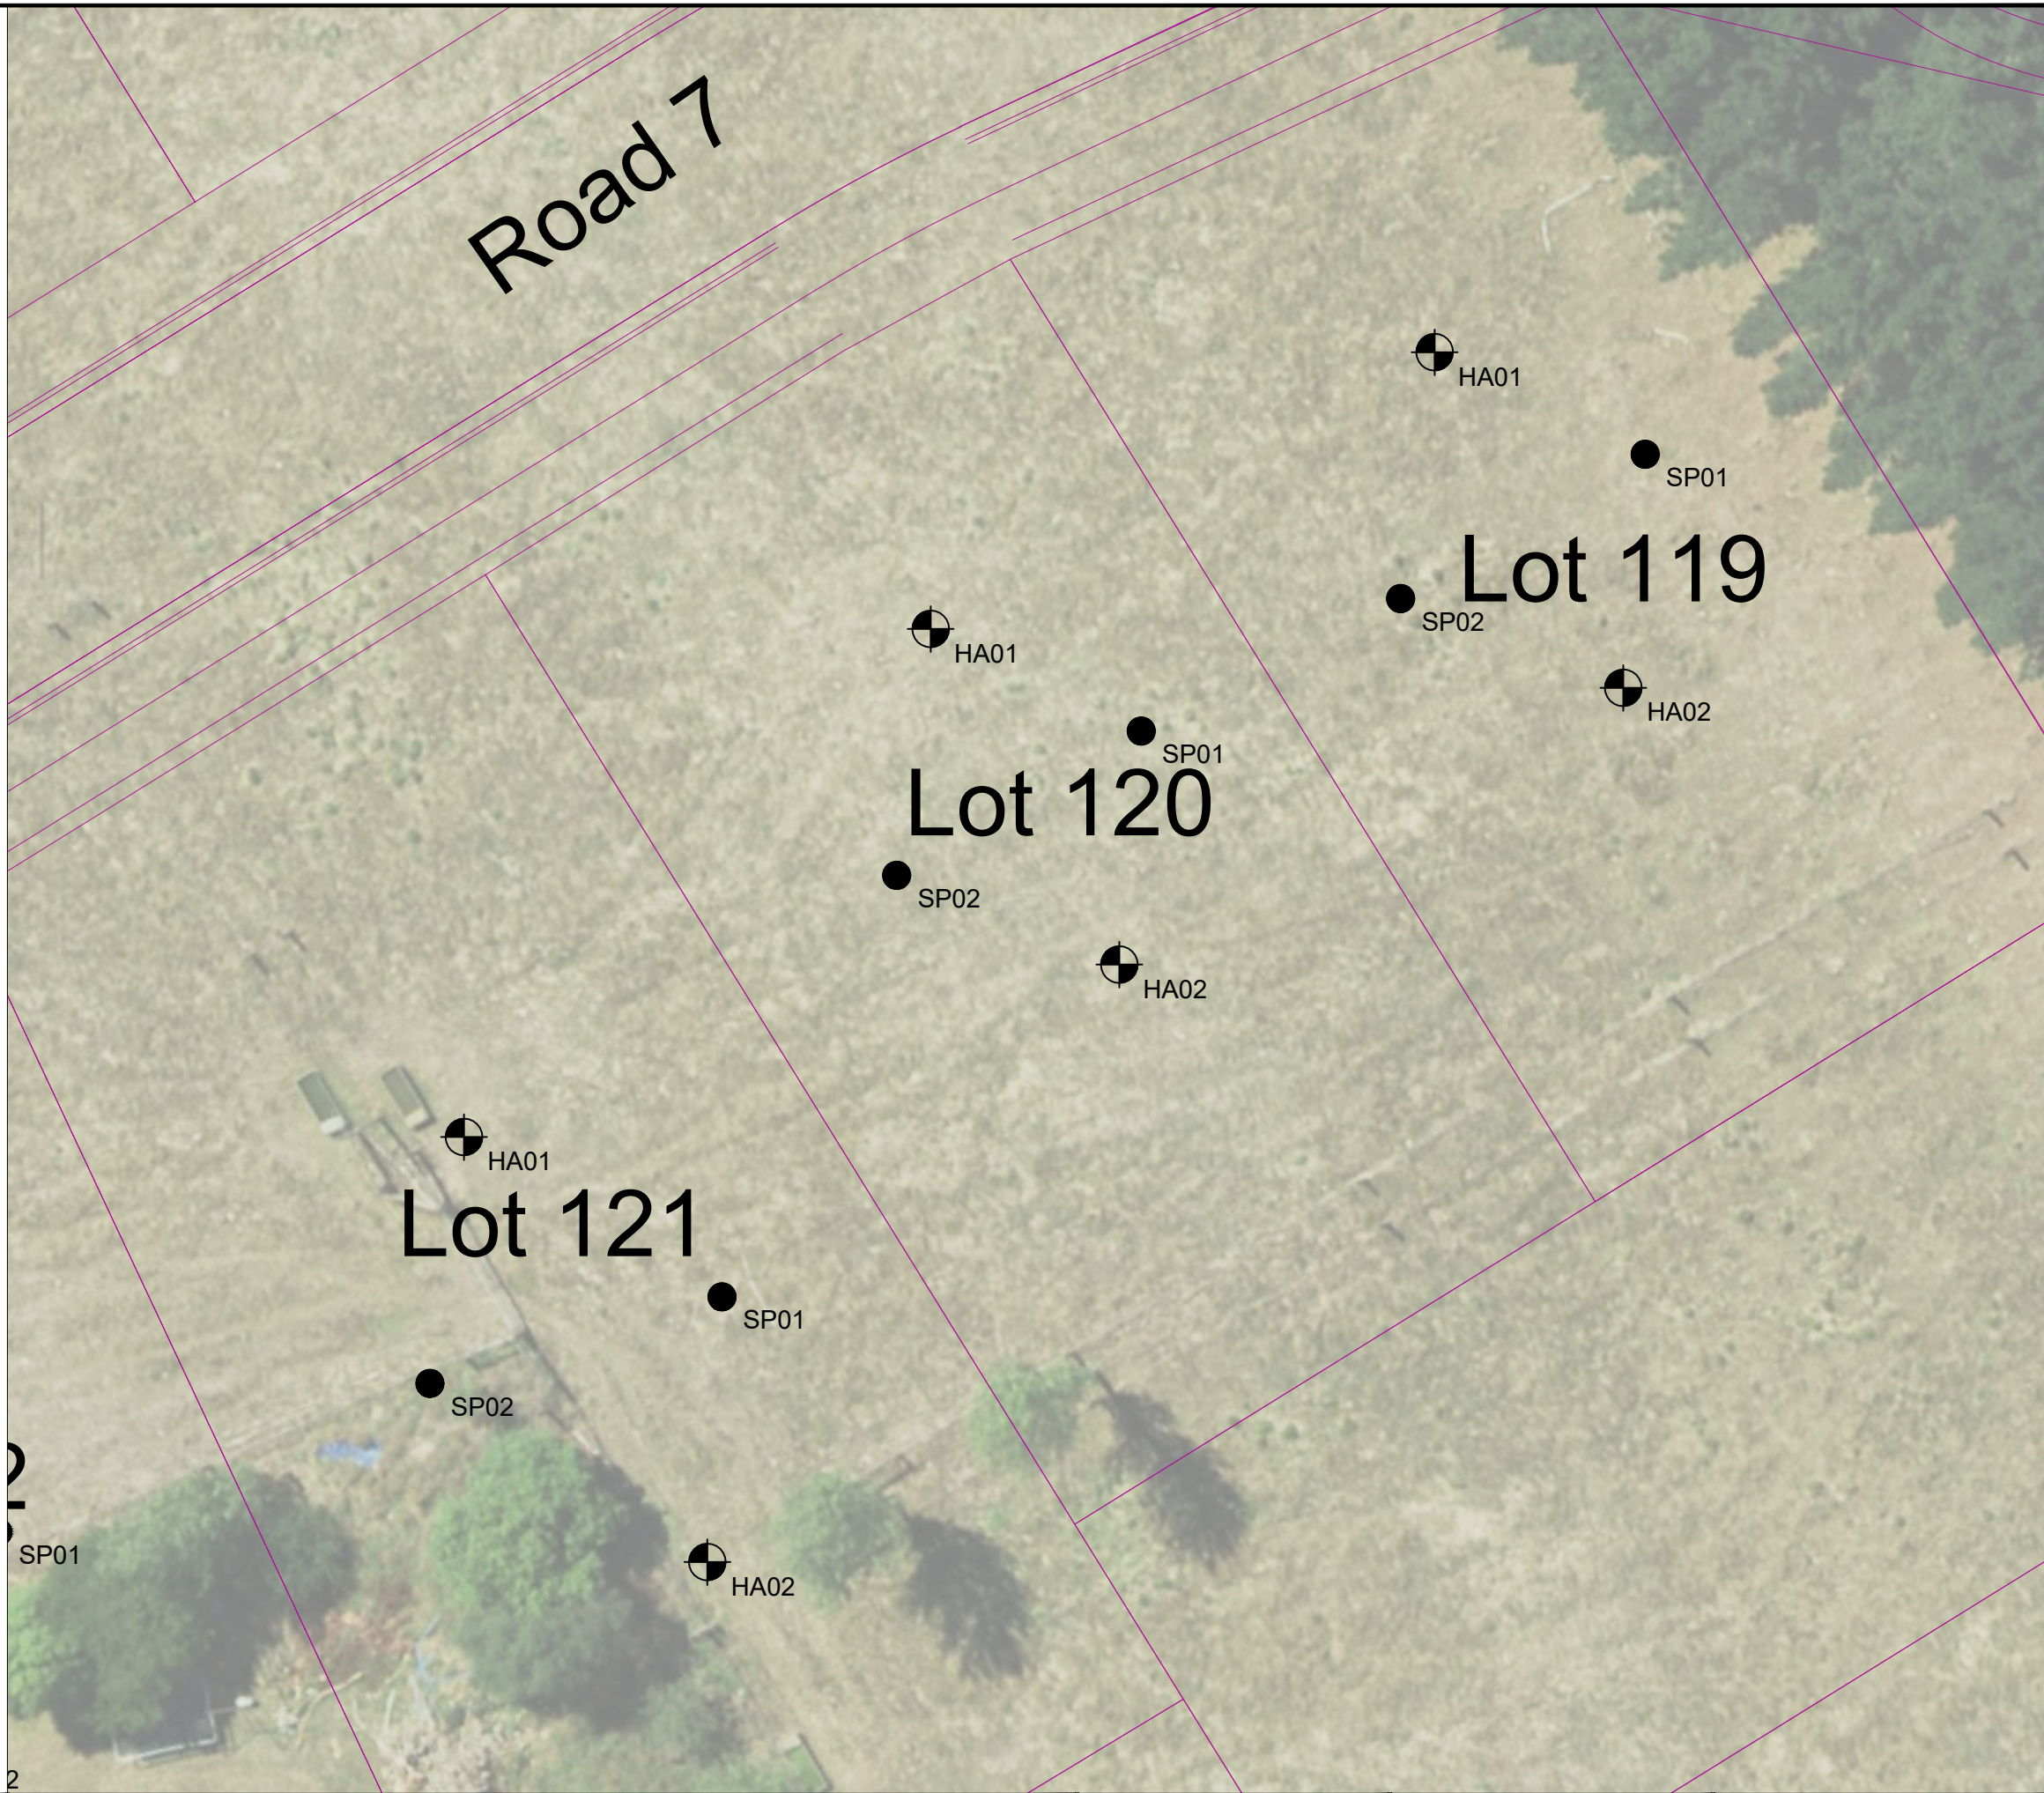
Drawing No: Lot 120/TLP	Drawn by: KB	Date: 15 September 2022
Scale: 1: 200 (A3)	Checked by: DW	Revision: A
Filename: LTC22215 - Master Plan Drawings.dwg

LandTech investigated the site on 19 September 2022, comprising two hand auger holes with corresponding Scala Penetrometer tests and two additional Scala Penetrometer tests. The test locations were measured from lot boundaries and/or surveyed centre pegs and are approximate only. The test locations are shown on the LandTech *Test Location Plan*, Drawing No. Lot 120/ TLP attached to this report.

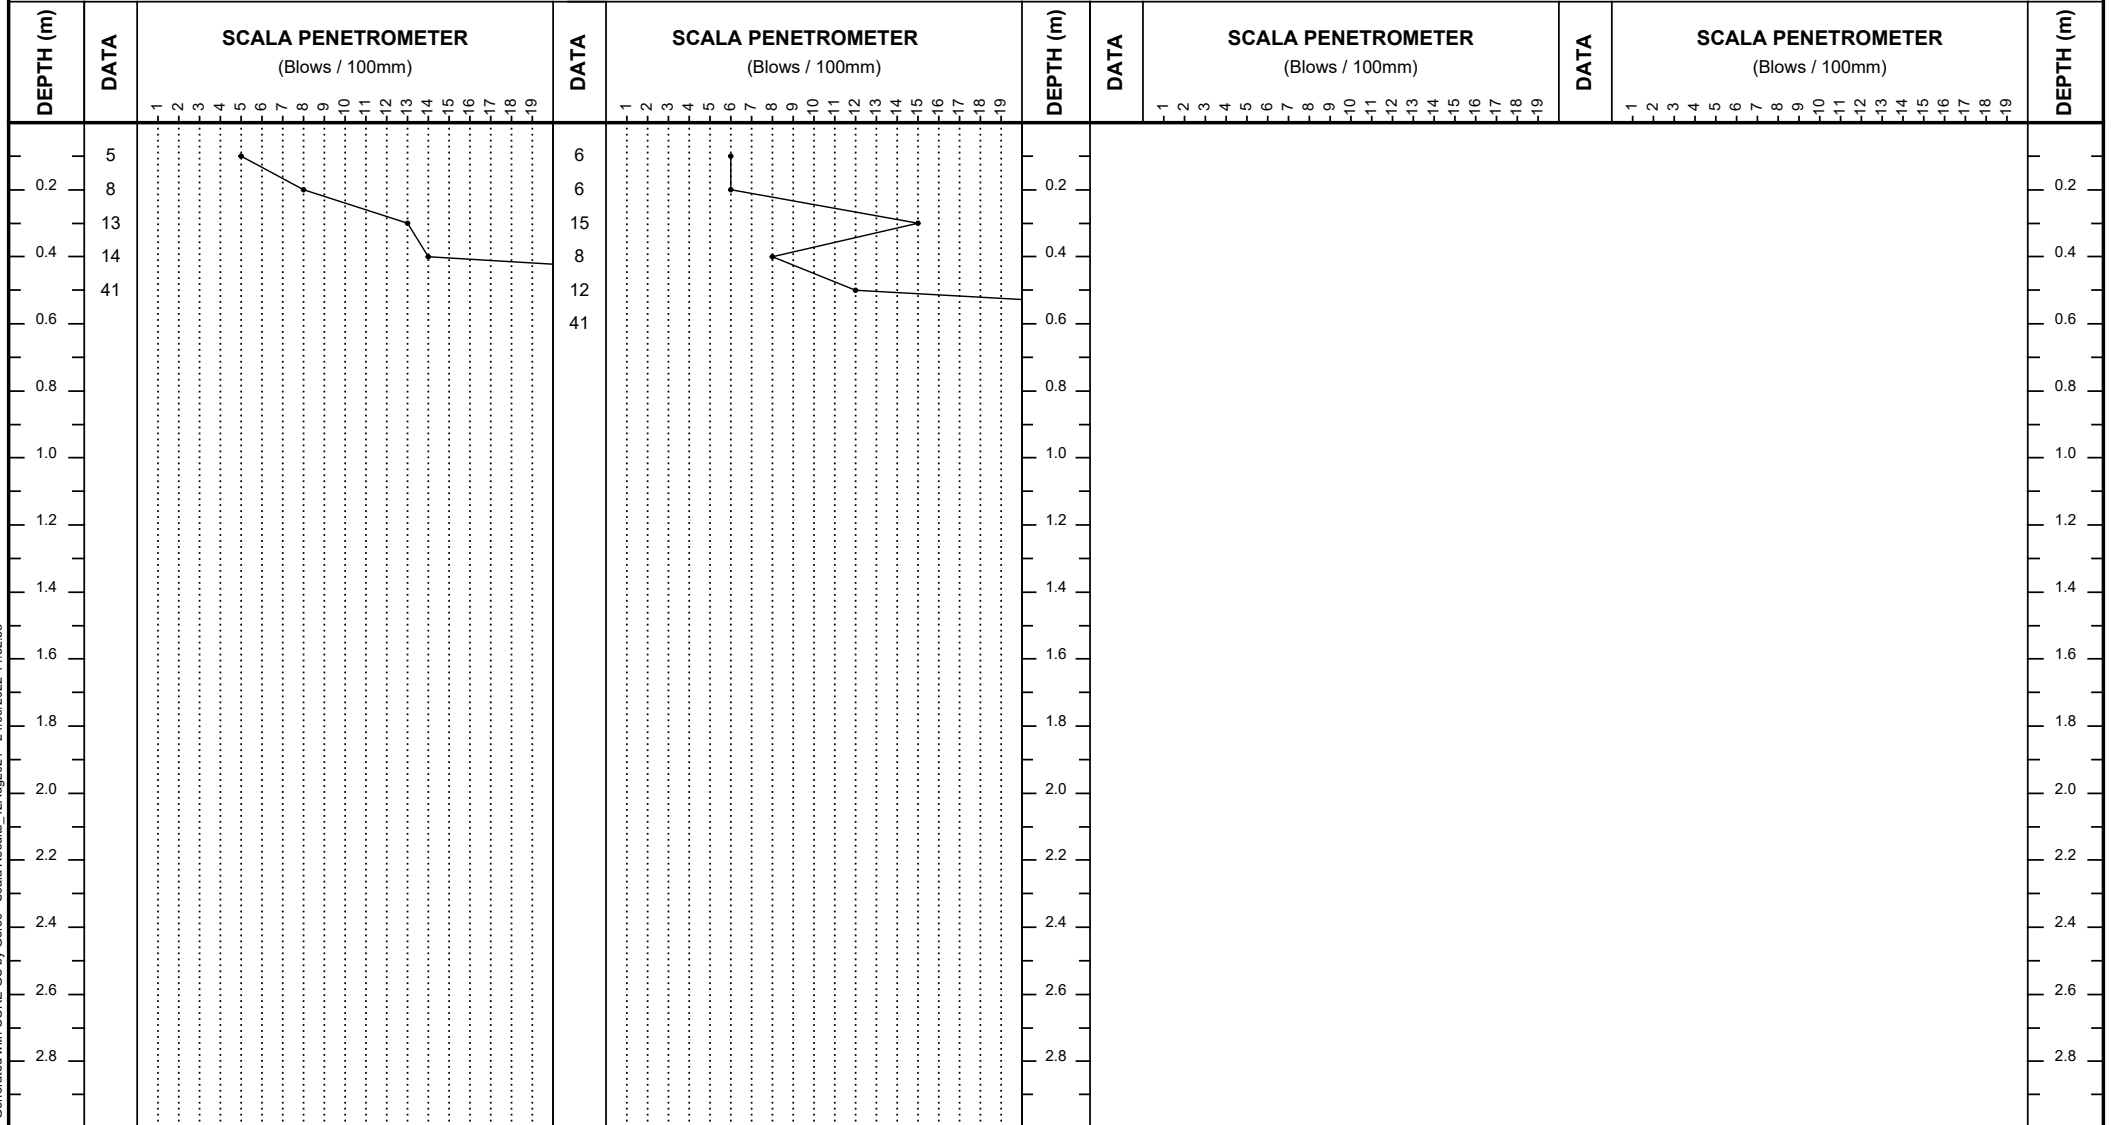
**Lot 120 - SP01**

The hand auger holes encountered topsoil/fill material from the ground surface to approximately 0.1m depths, underlain by inferred natural gravel. Groundwater was not encountered during testing. Scala Penetrometer testing at each of the four locations returned results between 3 and 40+ blows per 100mm penetration at the test positions, encountering refusal at depths between 0.5m and 0.6m below present ground level.

**Tested By:** KB  
**Ground Conditions:** Near Level, Fill  
**Coordinates:** NZTM2000 E 1549236.82  
 N 5170086.27  
**Test Date:** 19-Sep-22

**Tested By:** KB  
**Ground Conditions:** Near Level, Fill  
**Coordinates:** NZTM2000 E 1549229.48  
 N 5170081.94  
**Test Date:** 19-Sep-22
